NUCLEAR REGULATORY COMMISSION

Reports No. 50-295/90024(DRP); 50-304/90026(DRP)

Facility Name: Zion Nuclear Generating Station, Units 1 and 2

Inspection Summary

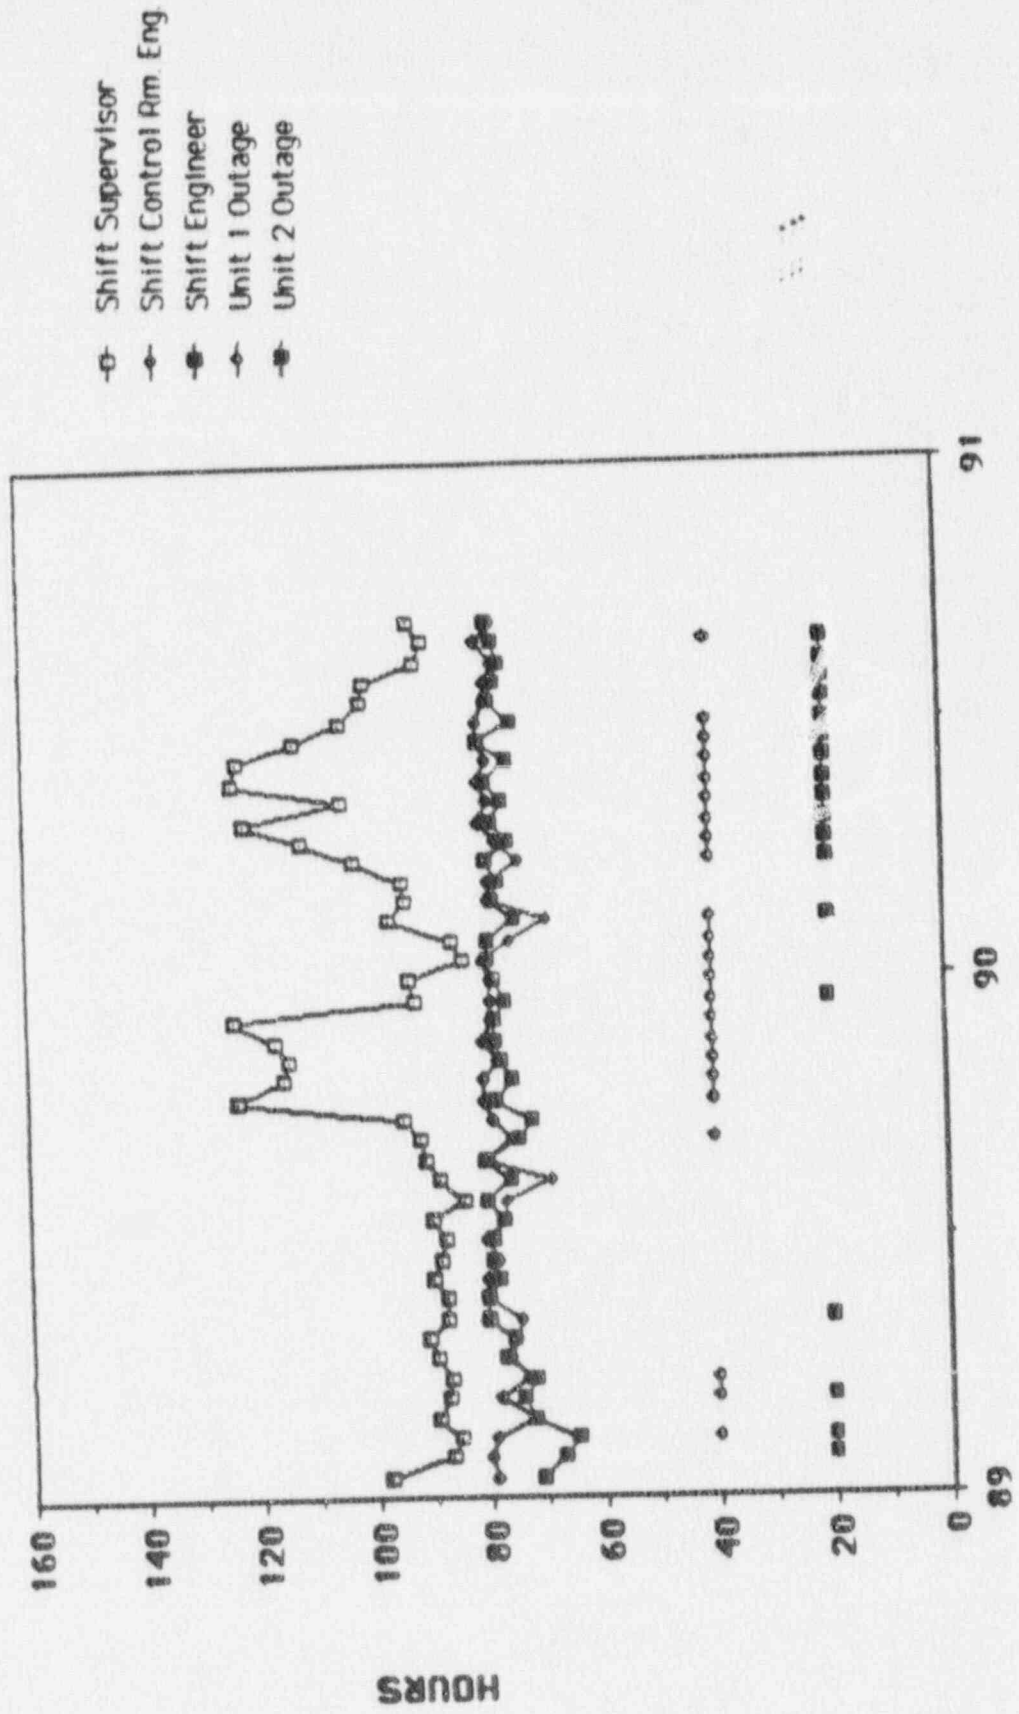
FIGURE 1. OPERATIONS

(AVERAGE HOURS WORKED PER TWO WEEK PAY PERIOD)

Figures 1, 2, and 3 show the average hours worked per pay period (14 days) by various positions in the operations department. The graphs in these figures reveal that shift supervisors, nuclear station operators, equipment operators, and equipment attendants began working significantly more hours when the units were in outage. However, the shift control room engineers and the shift engineers maintained a nominal 40-hour workweek, regardless of plant conditions.

An analysis of work schedules by seven experts in chronobiology, fatigue, and shift scheduling, indicated that schedules similar to those observed at Zion were "unsatisfactory" with respect to maintaining performance over a period of more than four weeks. Furthermore, the literature suggests that 20 hours of overtime every two weeks may actually double human error rates. Figures 1 through 7 reveal that Zion personnel frequently worked 20 to 50 hours of overtime in a two-week period.

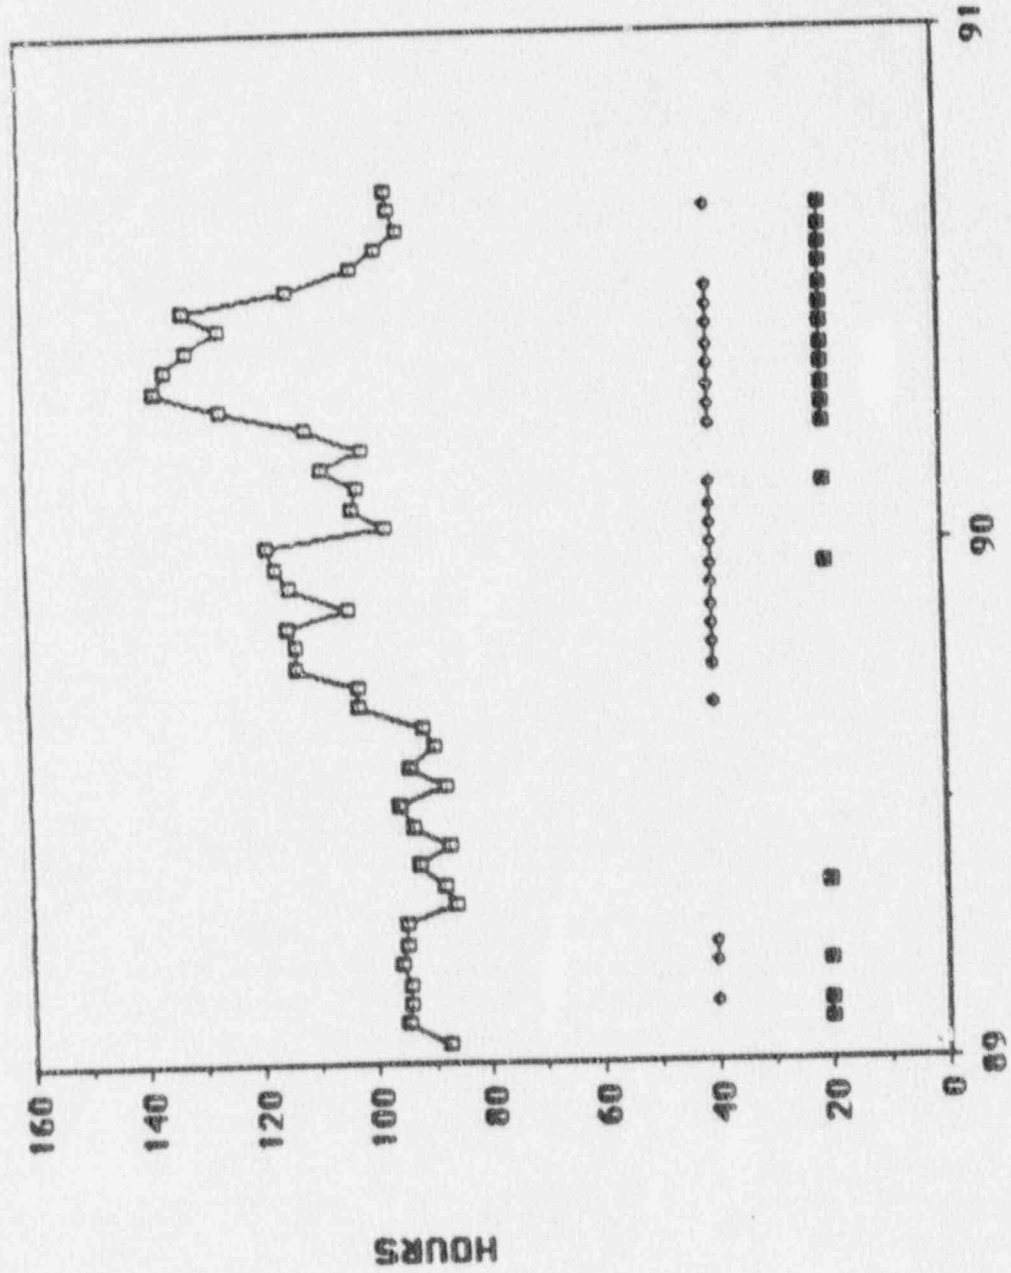
FIGURE 2. OPERATIONS

(AVERAGE HOURS WORKED PER TWO WEEK PAY PERIOD)

For the pay periods from March through June of 1990, nuclear station operators averaged over 125 hours worked every two weeks (Figure 2), and non-licensed operations personnel averaged at least 130 hours every two weeks (Figure 3). The continuous nature of these long workdays raises a concern that the risk of human error may have increased because of the cumulative effects of fatigue.

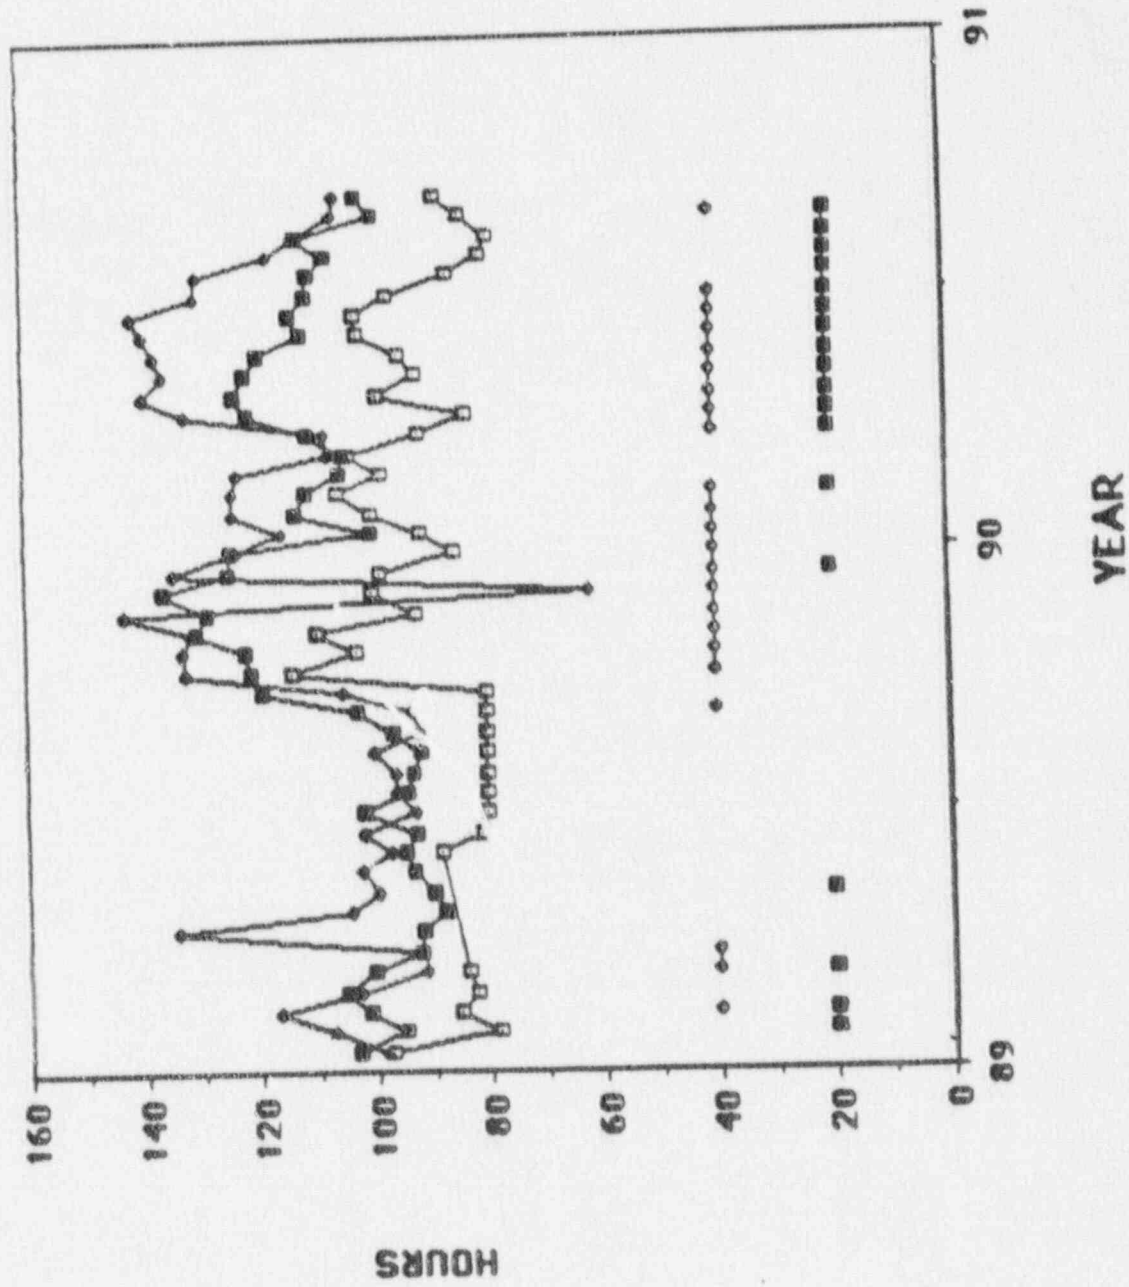
FIGURE 3. OPERATIONS

(AVERAGE HOURS WORKED PER TWO WEEK PAY PERIOD)

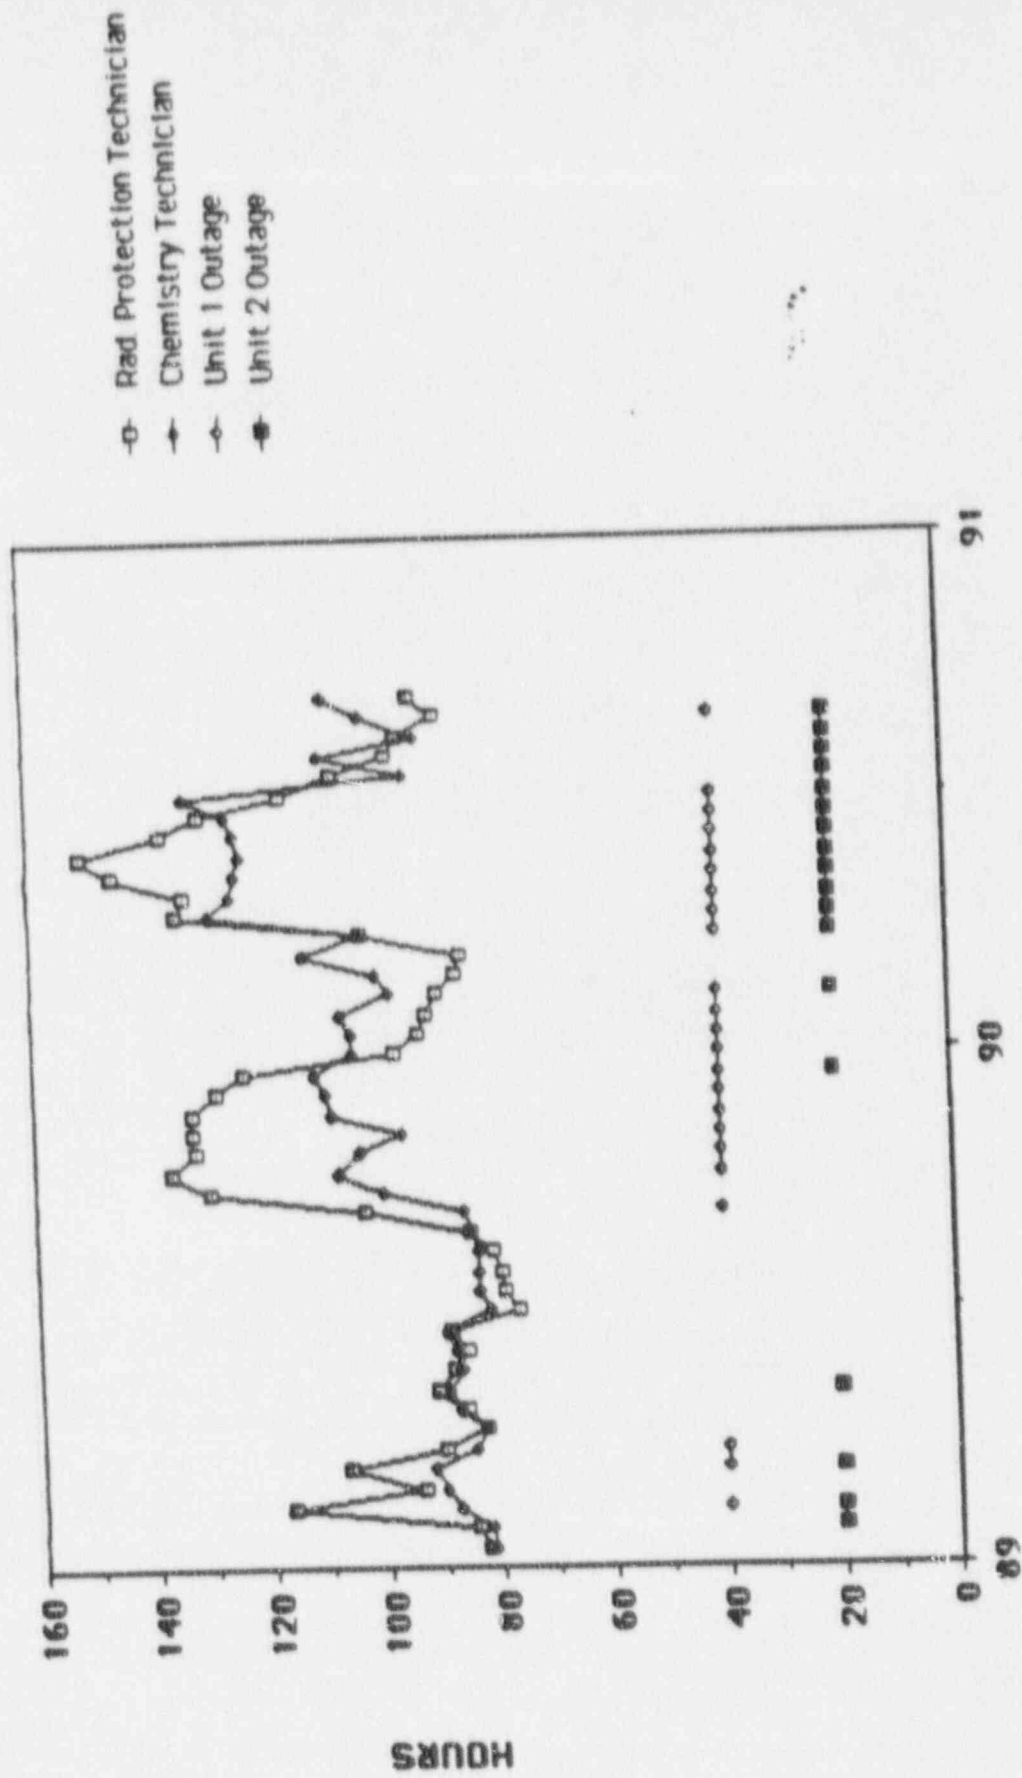
FIGURE 4. RADIATION PROTECTION AND CHEMISTRY
 (AVERAGE HOURS WORKED PER TWO WEEK PAY PERIOD)

Personnel in the radiation protection and chemistry technician positions experienced an increase in workload during the outage periods, but the overtime worked by radiation protection technicians was particularly high (Figure 4). During the 10th pay period of 1990, for example, 23 technicians worked an average of 150 hours in 14 days. With respect to the long term effects of continuous overtime, the radiation protection technicians continued to work excessive hours during both major outage periods. Individuals often worked 10 to 12 hours a day, 7 days a week for extended periods of time. From September through November of 1989, and from March through May of 1990, these technicians maintained work schedules of 130 or more hours worked every 2 weeks for 8 weeks and 12 weeks, respectively. However, not all personnel in these departments performed safety-related work. Following implementation of ZAP-09 on April 26, 1990, a "duty technician" was assigned to each shift to be responsible for safety-related duties. Each day, work schedules were reviewed to identify individuals that would qualify to work as the duty technician.

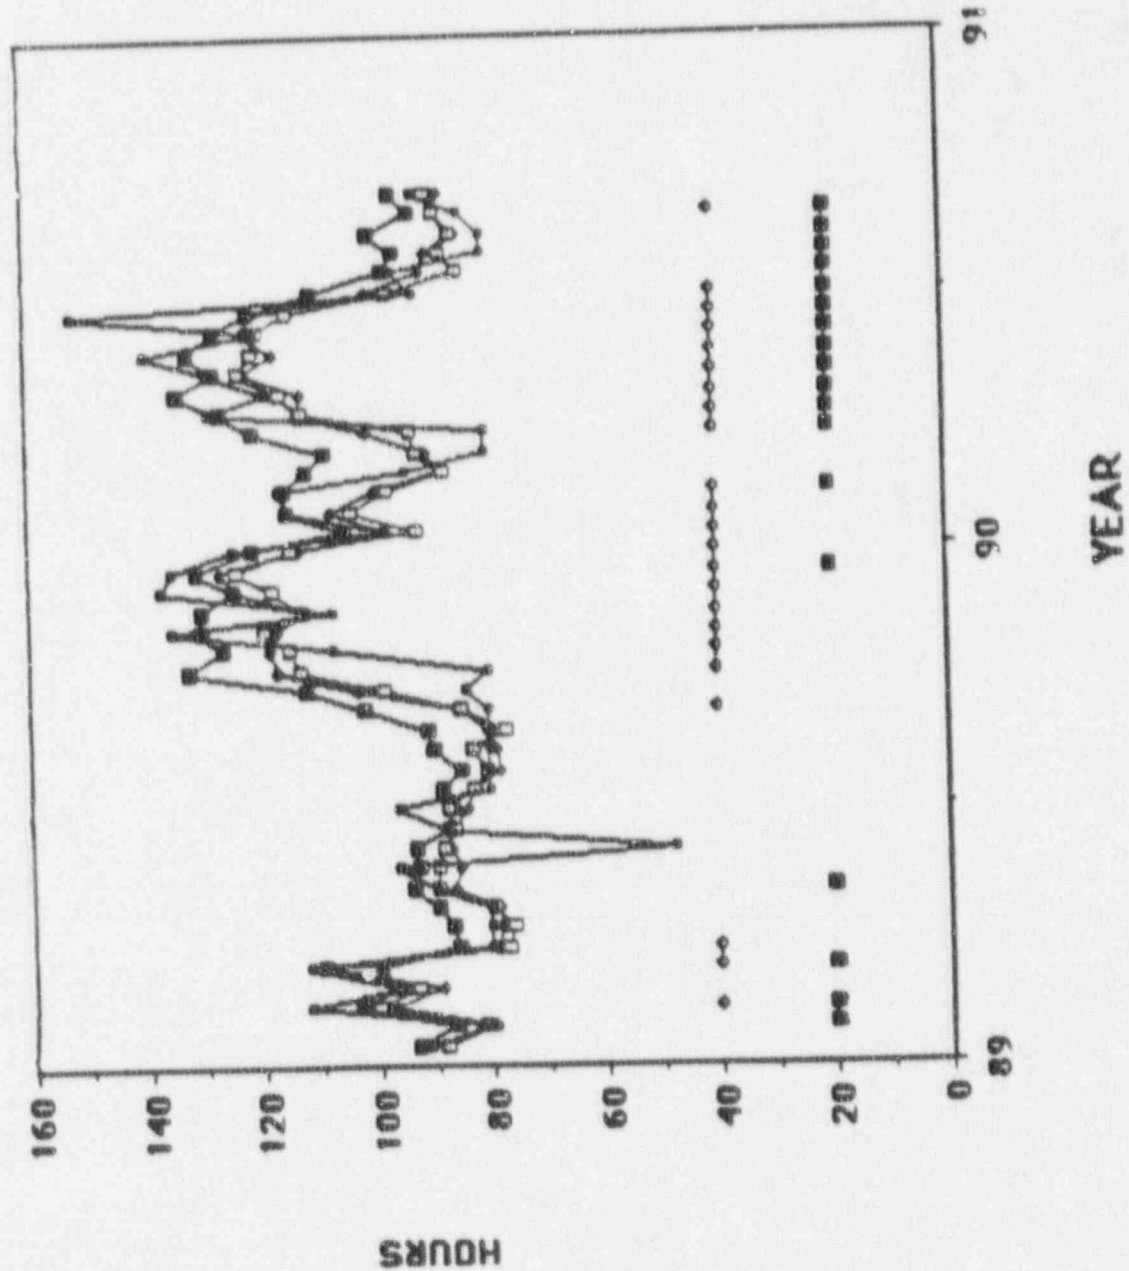
FIGURE 5. MECHANICAL MAINTENANCE

(AVERAGE HOURS WORKED PER TWO WEEK PAY PERIOD)

Mechanical maintenance supervisors, A-men, and B-men all increased their overtime hours during the outages (Figure 5). The plot for the senior mechanic represents one employee, and thus exhibits more extreme fluctuations. The two major peaks in Figure 5 show averages of 130 to 140 hours per pay period.

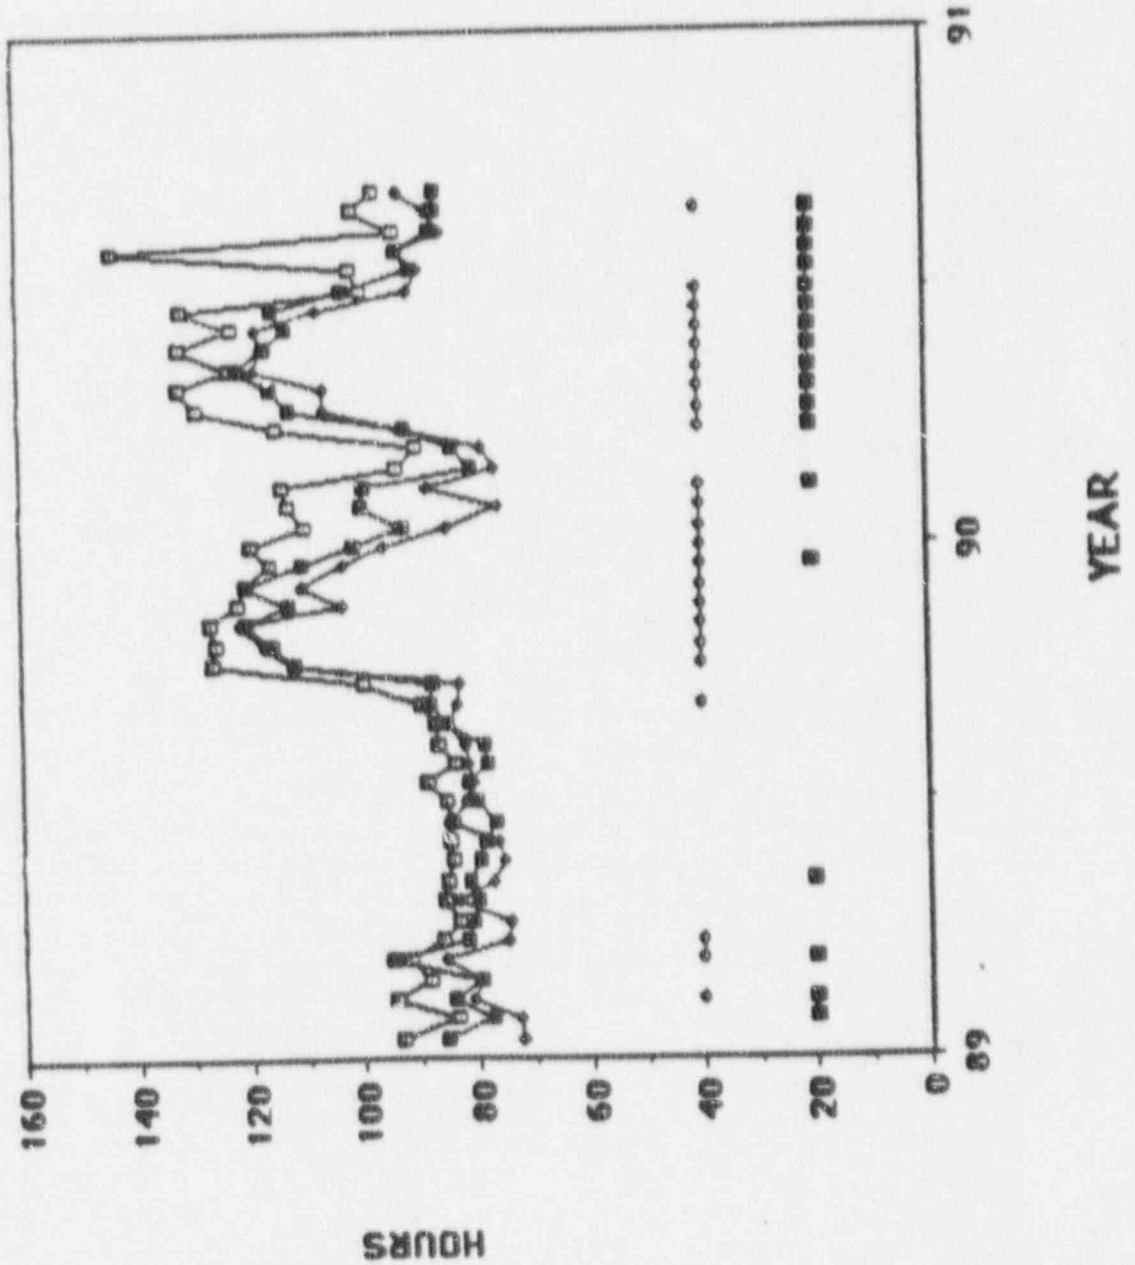
FIGURE 6. INSTRUMENT MAINTENANCE

(AVERAGE HOURS WORKED PER TWO WEEK PAY PERIOD)

Although overtime for personnel in instrument maintenance (Figure 6) increased significantly during the outages, the average number of hours, even during peak workload periods, remained at or less than 130 per pay period.

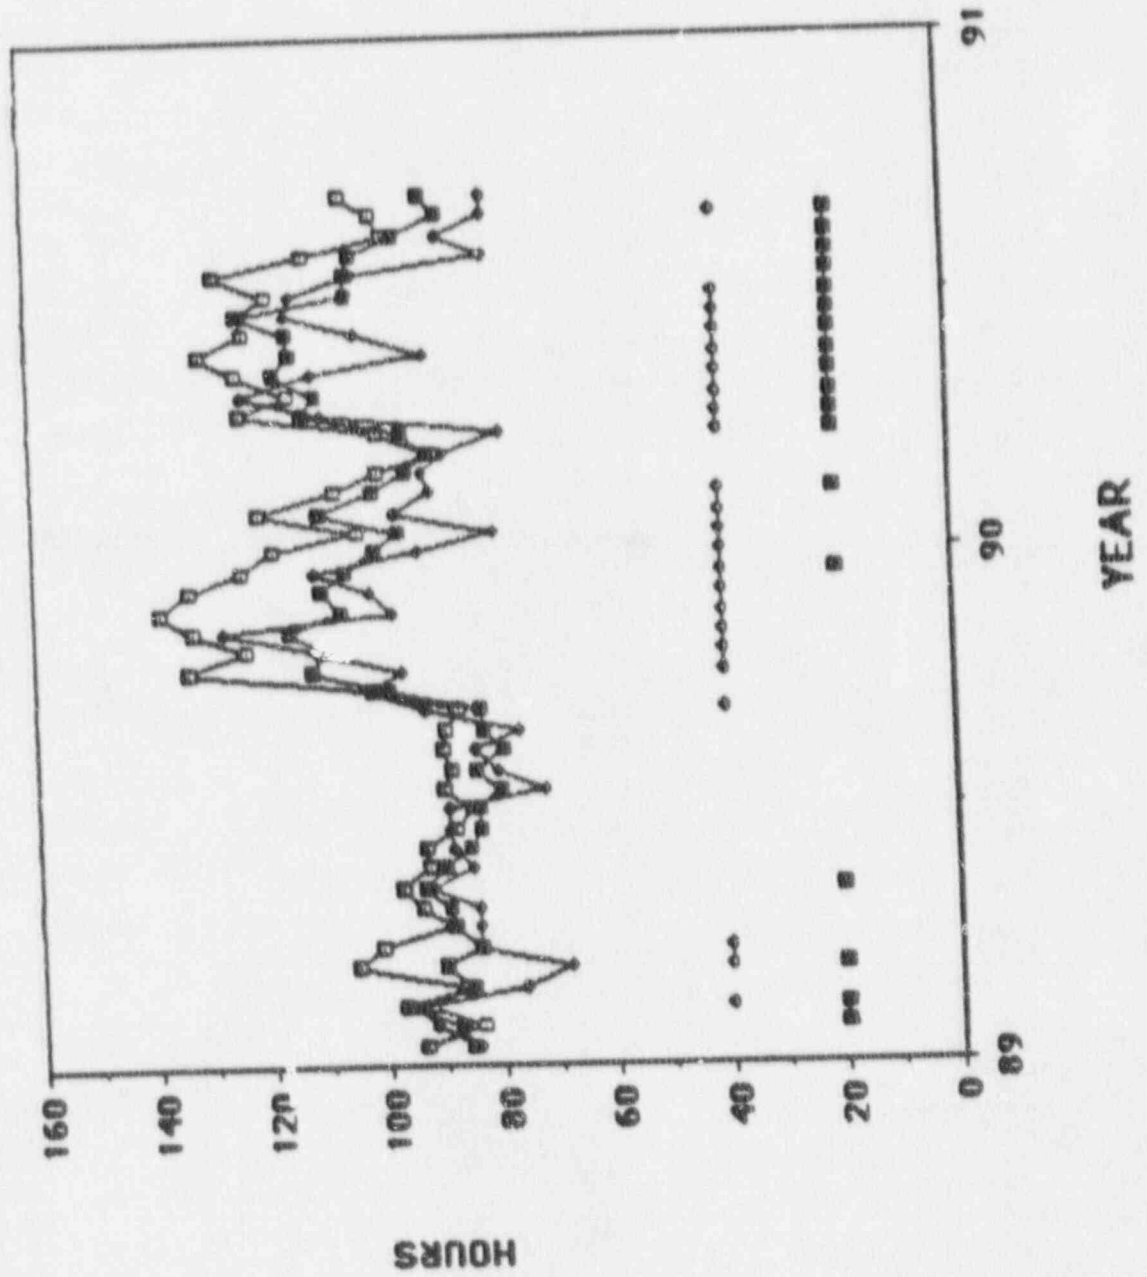
FIGURE 7. ELECTRICAL MAINTENANCE

(AVERAGE HOURS WORKED PER TWO WEEK PAY PERIOD)

Electrical maintenance personnel (Figure 7) experienced an increase in workload during outages. During the first major outage (September through December of 1989), electrical maintenance supervisors worked an average of 120 to 140 hours every two weeks, and these same employees worked an average of 120 to 130 hours every two weeks during most of the second major outage (February through August, 1990). Other electrical maintenance personnel also worked more overtime during these two time periods, although the difference was not as significant.
