ISHAM, LINCOLN & BEALE
COUNSELORS AT LAW

February 3, 1983

In the Matter of)	
)	Docket Nos. 50-329-OM
CONSUMERS POWER COMPANY)	50-330-OM
)	50-329-OL
(Midland Plant, Units 1)	50-330-OL
and 2))

1. List of Category I structures not included in Seismic Margin Review (see Tr. 9720).
2. List of Underground Pipe & Conduit hit by Drilling (Tr. 10137).
3. Certain "Raw Data" from Quality Improvement Plan (Tr. 10146; there is no promise to provide this data but we said we would consider doing so.)

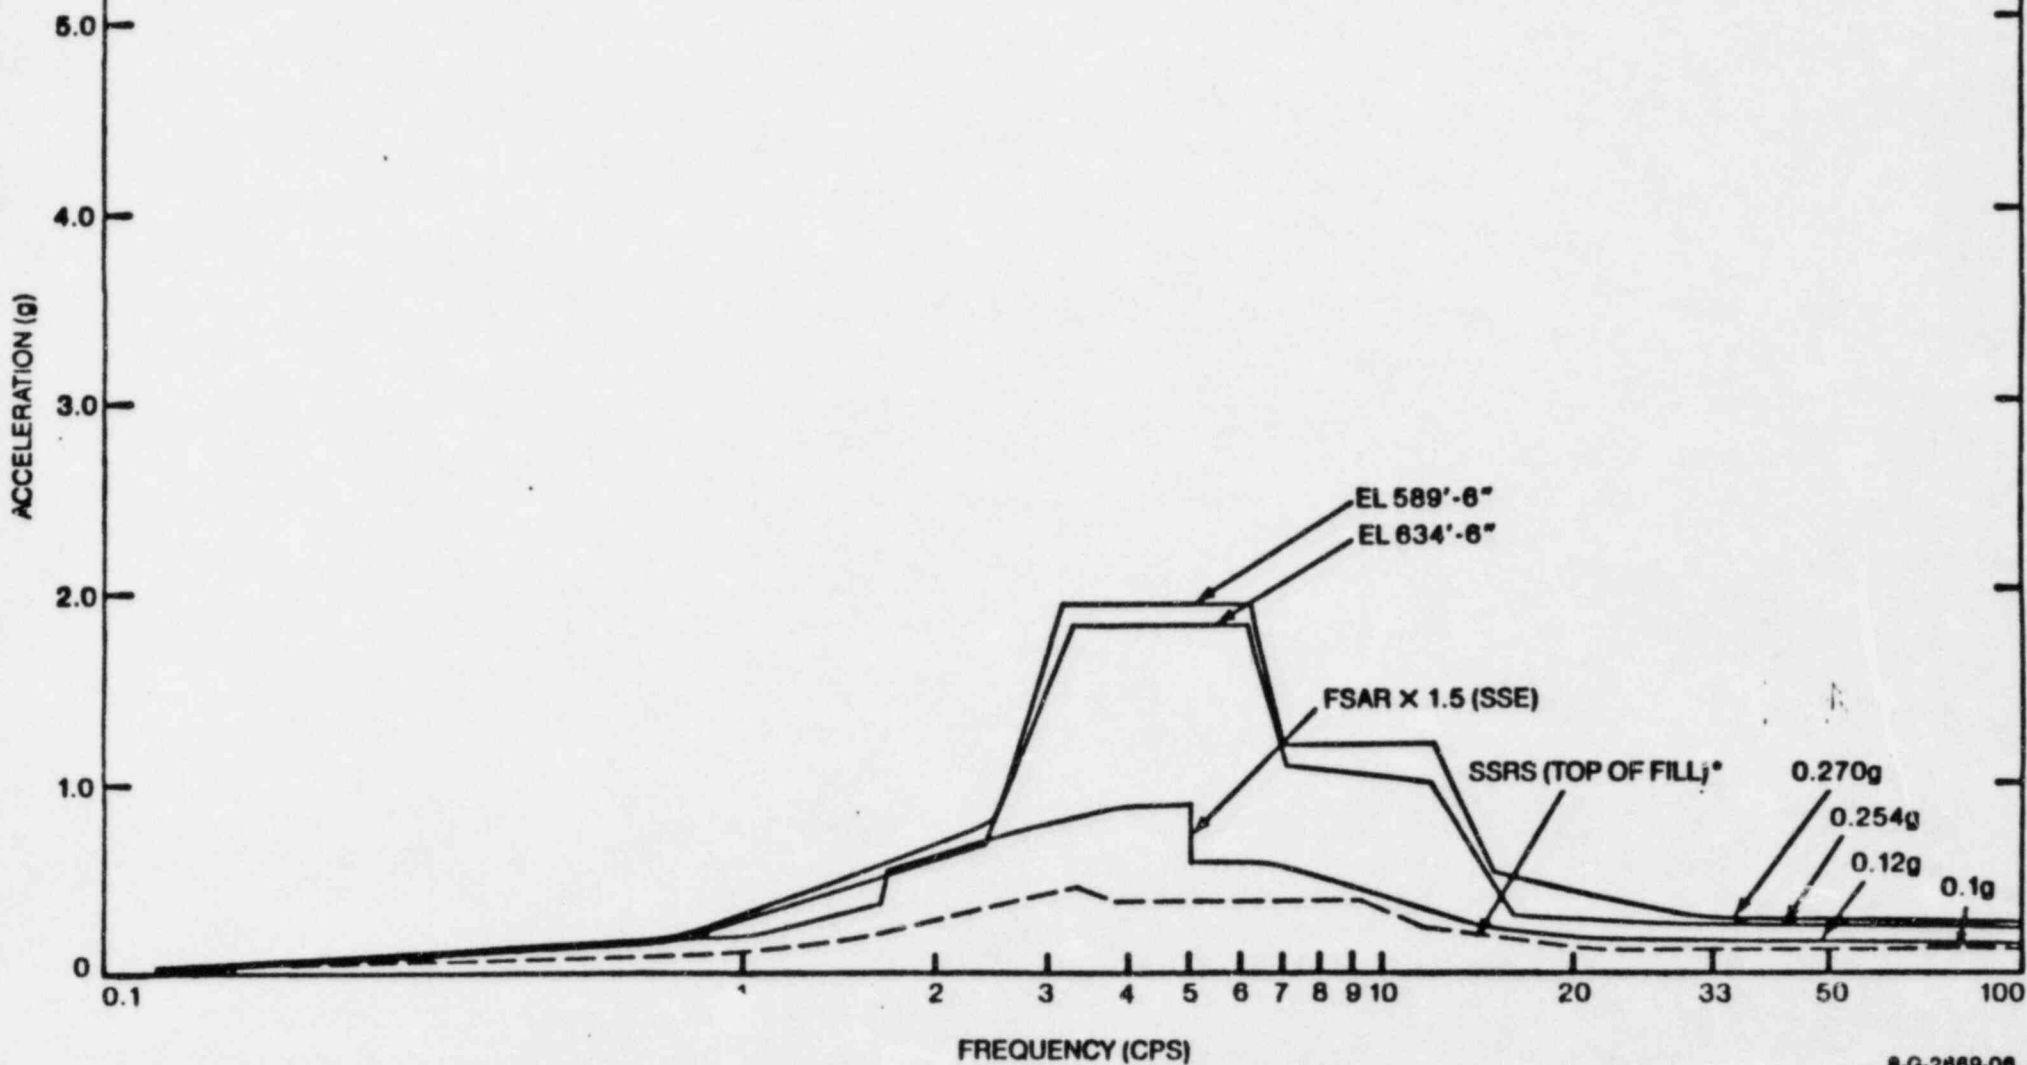
Figure 6

SERVICE WATER PUMP STRUCTURE
VERTICAL DIRECTION
DAMPING RATIO: 0.5%
SSE GROUND ACCELERATION

Figures 1 through 3, which are applicable to the supply lines, compare the floor response spectra at different elevations inside the SWPS to the site specific response spectra for the top of the fill and to 1.5 x FSAR SSE ground response spectra. Figures 4 through 6 make the same comparison for the return lines. Figure 1, for example, shows that for the enveloping spectra the zero period acceleration is 0.332g, compared to 0.149g for the SSRS and 0.18g for 1.5 x FSAR SSE. (For underground piping outside the building the zero period acceleration is an appropriate basis for comparison.)

The seismic analyses described in A and B above used floor response spectra derived from 0.5% damping rather than the current FSAR requirement of 2% damping. This is a significant source of additional conservatism for piping inside the structure, but it does not add significant conservatism for underground piping outside the SWPS. All of the spectra shown in Figures 1 through 6 are for 0.5% damping.^{2/}

^{2/} There is a minor drafting error in all of the figures which has no effect on the matters discussed in this affidavit. The NRC Staff and Applicant have agreed that the SSRS developed by Western Geophysical should be modified to coincide with the Housner spectrum at long periods (low frequencies). This is not shown in the attached figures. However, the low frequency portions of the response spectra are not important in the seismic analysis of buried piping. In other words, only the right sides of Figures 1 through 6 are relevant for purposes of this discussion.
