U.S. NUCLEAR REGULATORY COMMISSION
REGION I

Docket/Report No.: 50-443/91-02

Licensee: Public Service Company of New Hampshire, New Hampshire Yankee
(NHY) Division

Facility: Seabrook Station, Seabrook, New Hampshire

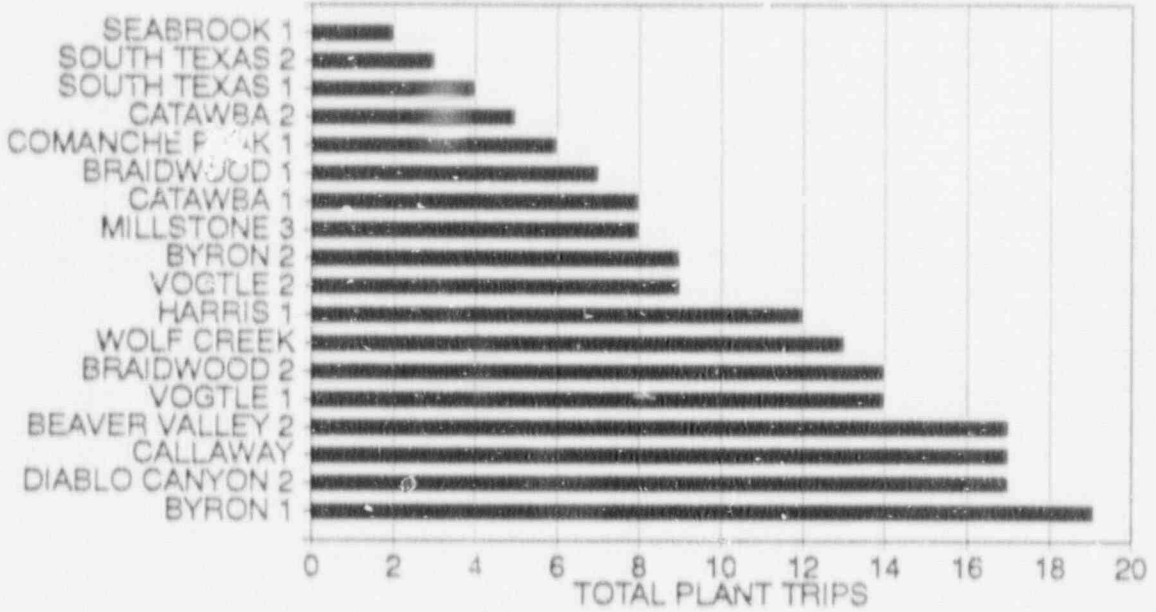
PLANT TRIPS
 — DURING STARTUP TESTING —
 (Westinghouse 4-Loop PWRs)

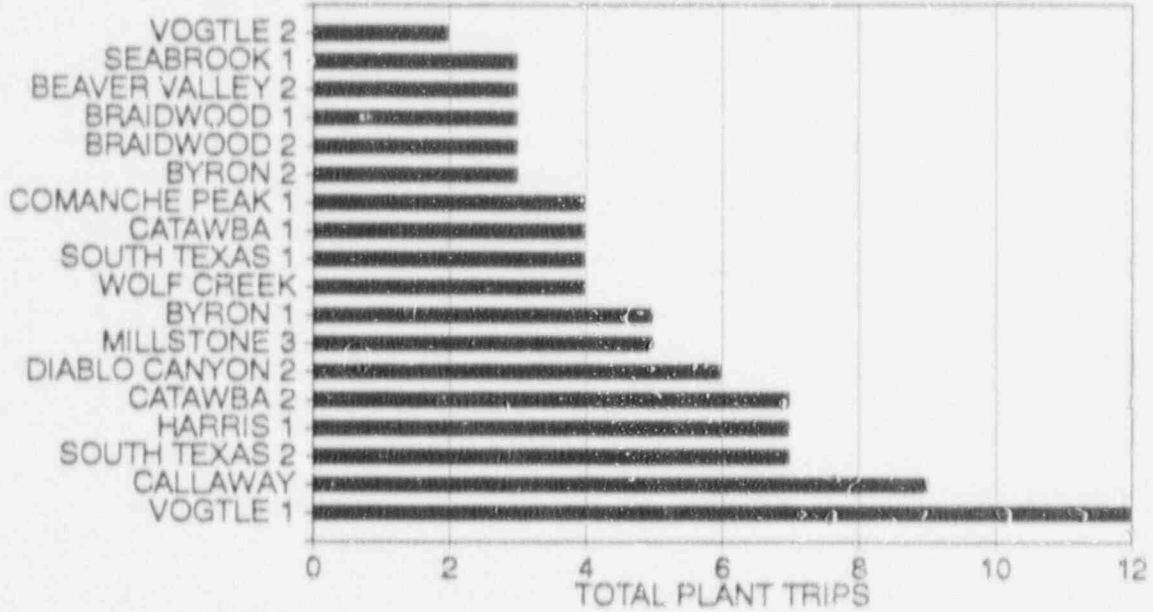
PLANT TRIPS
 — FIRST SIX MONTHS OF FULL POWER OPERATION —
 (Westinghouse 4-Loop PWRs Licensed Since 1984)
