NRC MEETING
ENGINEERING AND
TECHNICAL SUPPORT
MARCH 19, 1991

SOUTH TEXAS PROJECT
ELECTRIC GENERATING STATION

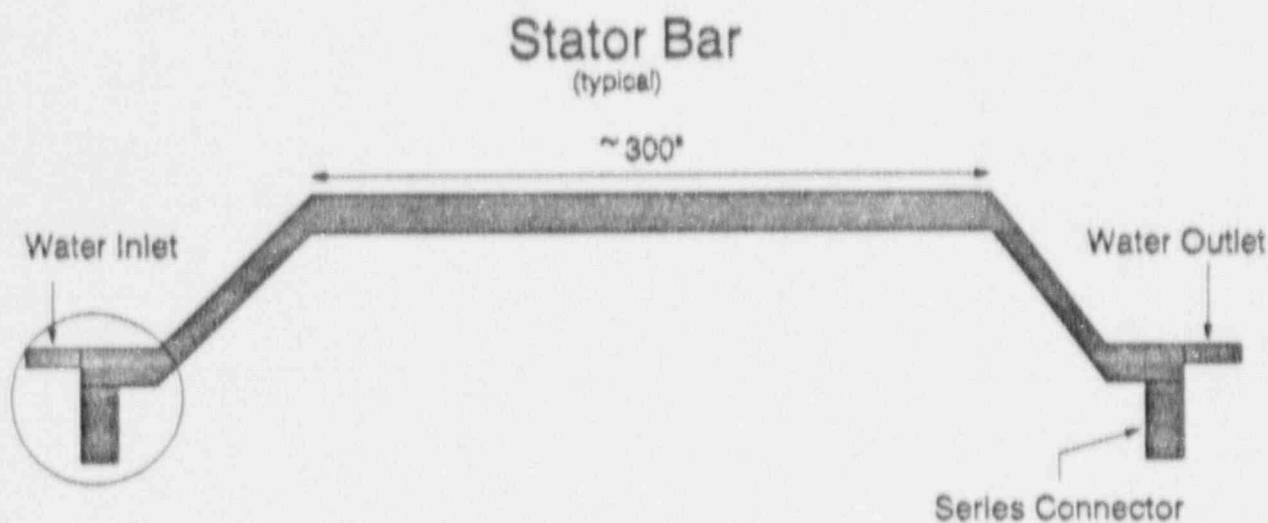
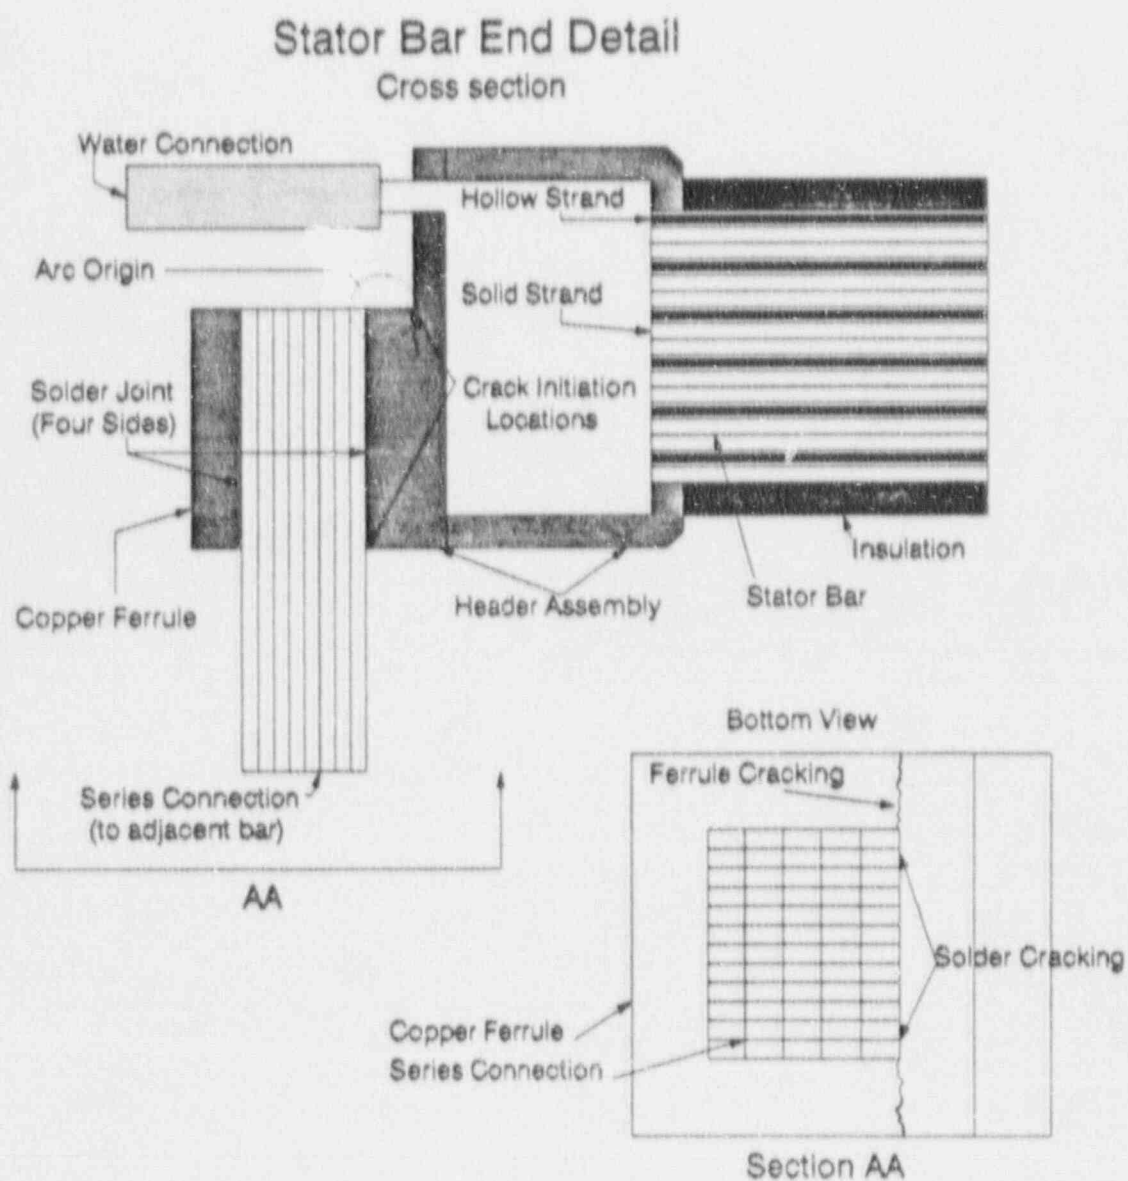
FAILURE MECHANISM

- END TURN STRUCTURAL BRACING LOOSENEED (INVESTIGATION IN PROGRESS TO DETERMINE MOST PROBABLE CAUSES).
- NORMAL MAGNETIC FORCES CREATED VIBRATORY STRESSES AND FURTHER DEGRADED END TURN BRACING.
- VIBRATION IS TRANSMITTED TO END TURNS OF THE STATOR COILS AS A RESULT OF THE DEGRADED END TURN STRUCTURAL BRACING.
- FATIGUE CRACK DEVELOPMENT IN END TURN HEADER CAP SERIES CONNECTION SOLDER JOINT.
- FATIGUE CRACK PROPAGATION INTO END TURN HEADER CAP FERRULE.
- COMPLETE SEPARATION OF SERIES CONNECTION FROM END TURN HEADER CAP.
- ELECTRICAL ARC WITH RESULTANT VAPORIZATION OF SURROUNDING COPPER.
- ELECTRICALLY CONDUCTIVE PATH TO GROUND AT WATER SUPPLY HEADER VIA COPPER VAPOR.
- GROUND FAULT RELAY ACTUATION AND GENERATOR TRIP.
- METALLURGICAL ANALYSES BY WESTINGHOUSE AND HL&P CONFIRM FATIGUE CRACKING MECHANISM.

- THE UNIT 1 GENERATOR FAILURE WAS THE RESULT OF FATIGUE CRACKING OF THE STATOR COIL FERRULE INDUCED BY EXCESSIVE END TURN VIBRATION.
- HL&P, WESTINGHOUSE AND AN INDEPENDENT CONSULTANT ARE ALL ACTIVELY WORKING TO IDENTIFY THE MOST PROBABLE CAUSES OF THE EXCESSIVE AND TURN VIBRATION.
