Subject: Braidwood Station Units 1 and 2

Additional FSAR Information NRC Docket Nos. 50-456/457

The Attachment to this letter provides our response to Questions 241.1, 241.2, 241.7, and a revision to 241.6-3. Our FSAR will be amended to include the information contained in the Attachment to this letter as appropriate. Additionally, in supplement to Question 361.5 Part (a), photographs with identifiable sections of the excavations of the main power block have been sent directly to Ms. Janice A. Stevens as listed in the Attachment.

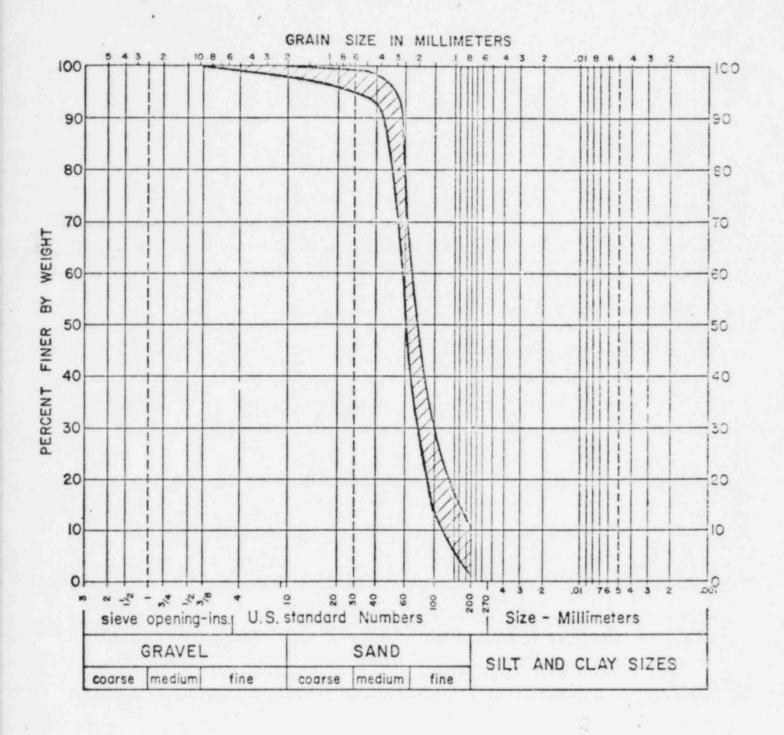
. FIGURE Q241.2-1 GRAIN SIZE ENVELOPE, SAND BACKFILL, ESWP WITHIN ESCP

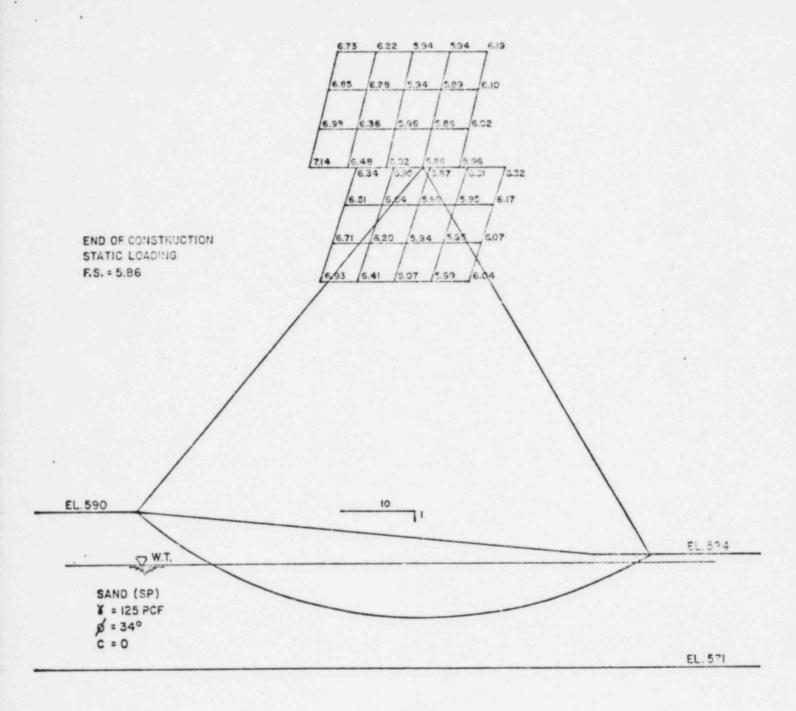
GLACIAL TILL \$ = 140 PCF \$ = 30° \(\frac{1}{2} = 190 PSF

BEDROCK

STATIC ESCP SLOPE

STABILITY ANALYSIS

- 1. The critical section of the ESCP slope analyzed for static stability is given in Figure Q241.7-1. The analysis is for end of construction condition with a minimum factor of safety of 5.9 as discussed in Subsection 2.5.6.5.1.2.
- 2. The seismic coefficient used in evaluating the dynamic stability of the ESCP slope by pseudostatic method of analysis was 0.2g. The minimum factor of safety is 1.3 as discussed in Subsection 2.5.6.5.1.2. The ESCP slope has also been analyzed with a seismic coefficient of 0.26g and the minimum factor of safety is 1.1.
- 3. The dynamic stability of the ESCP slope by finite element methods was not performed because the pseudostatic analysis used yields conservatiave results and a greater minimum

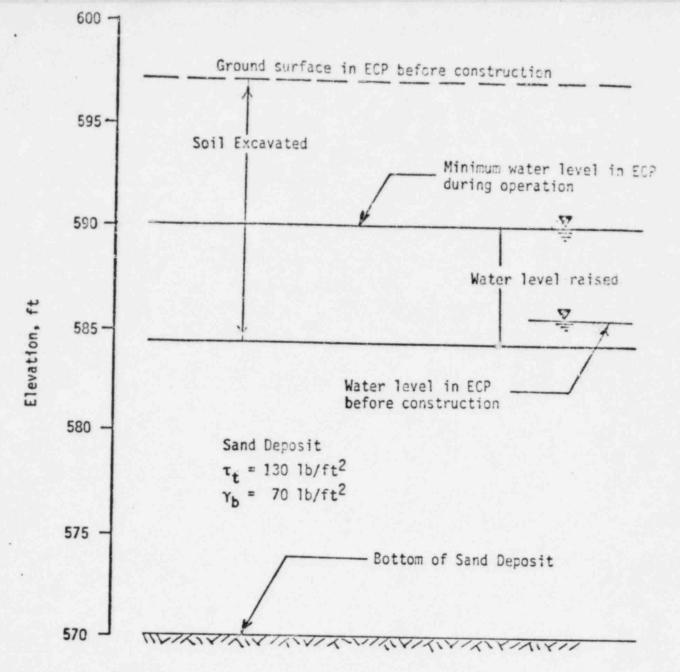
Before	Cons	truc	tion
			-

$\overline{\sigma}_{b}$		σh
el.ft	1b/ft2	Ko	1b/ft2
577.5	2085	0.40	834
575.0	2260	0.40	900
570.0	2610	0.40	1040

RATIO WITHIN SAND DEPOSIT

DURING OPERATION AT EL 584 FT

The induced stresses, (τ_d) , and the stresses required to cause $\pm 10\%$ strain (τ_f) for level ground at elevation 590 feet are compared in Figures 2.5-116 and 2.5-117, and for level ground at elevation 584 feet in Figures Q241.7-3 and Q241.7-4. Figures Q241.7-3 and Q241.7-4 are plots of data from Table Q241.7-3 which correspond to average relative density conditions.
