Environmental Qualification Operating Events Review

SCIENTECH Report No. SCIE-NRC-223-93

November 29, 1993

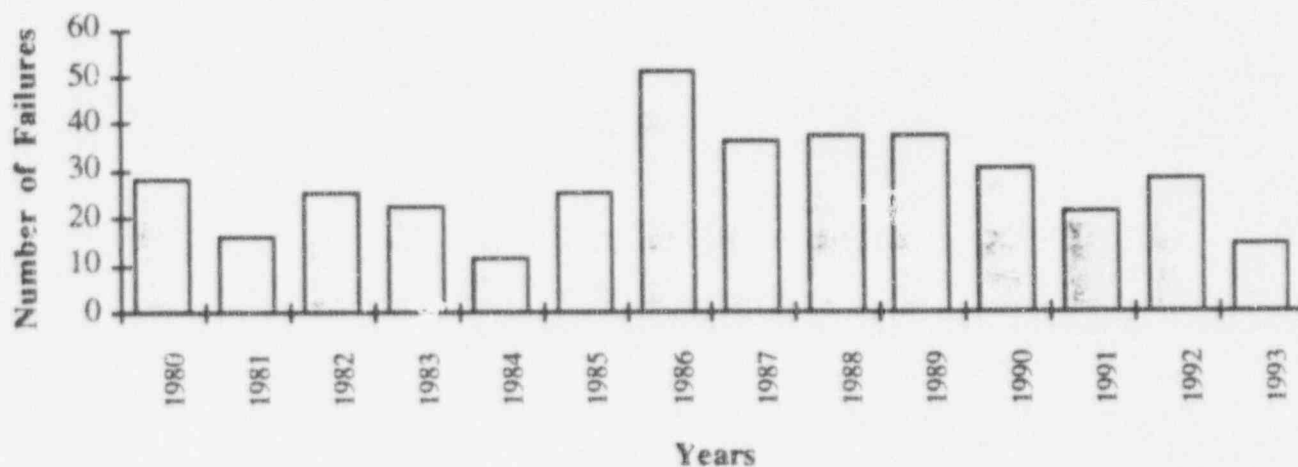
Figure 3-1 Total Failures vs. Year

To aid in the analysis of the data listed in Appendix C and summarized in Table 2-1, these data were arrayed in a histogram, as shown on Figure 3-1, to display the results by year. For the total number of failures, the heaviest year was 1986, when 52 EQ failures were identified. The quietest year was 1984, when there were only 12. After declining since 1986, EQ failures picked up again in 1992. Despite the fact that the SCIENTECH EQ Team had reports for only parts of 1993, there is indication that 1993 may be one of the worst years for EQ failures.
