UNITED STATES OF AMERICA
NUCLEAR REGULATORY COMMISSION

In the Matter of)
)
PACIFIC GAS AND ELECTRIC CO.)
)
(Diablo Canyon Nuclear Power)
Plant, Unit 1))

PETITION PURSUANT TO
10 CFR 2.206

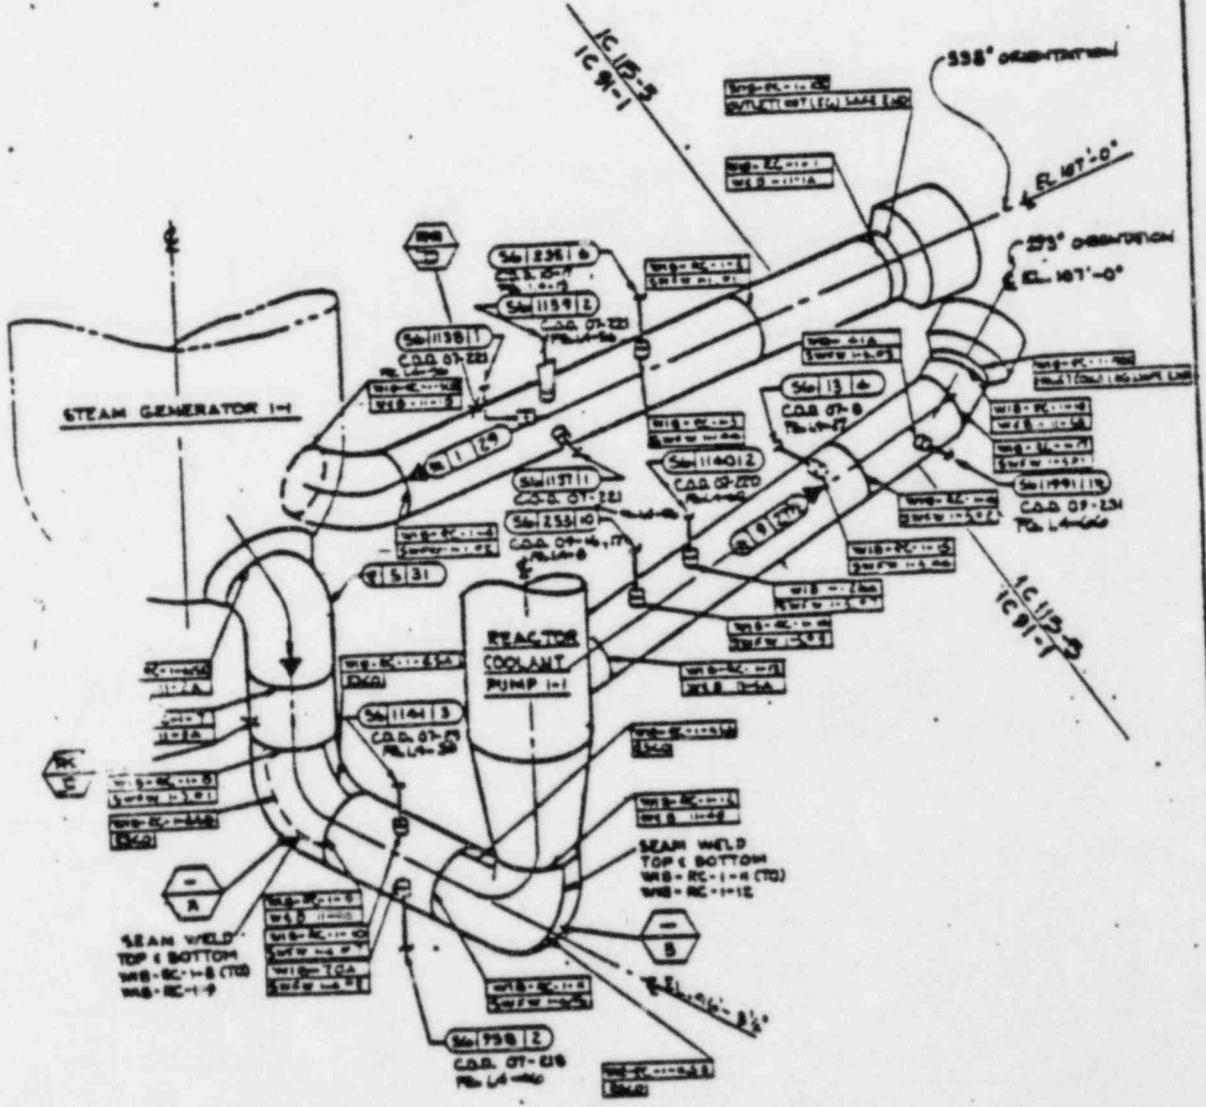
DIABLO CANYON UNIT 1 INSERVICE EXAMINATION ISOMETRIC			
PACIFIC GAS AND ELECTRIC COMPANY			
AREA: 54-118107-30 P&ID OBJECT: REACTOR SYSTEM RCS			
REV. NO.	DATE	LINE NO.	BY
REV. 001	03/11/80	0 - 1 - 00	CHERRY, GATTISON
REV. 002	03/11/80	0 - 0 - 01	CHERRY
REV. 003	03/11/80	0 - 0 - 02	CHERRY
PAGE: 1 of 1			DATE:

LINE NO.	DESCRIPTION
0-0-00	REACTOR COOLANT IN DUCT LOOP 1
0-0-01	REACTOR COOLANT IN SUCT LOOP 1
0-0-02	REACTOR COOLANT OUT LOOP 1

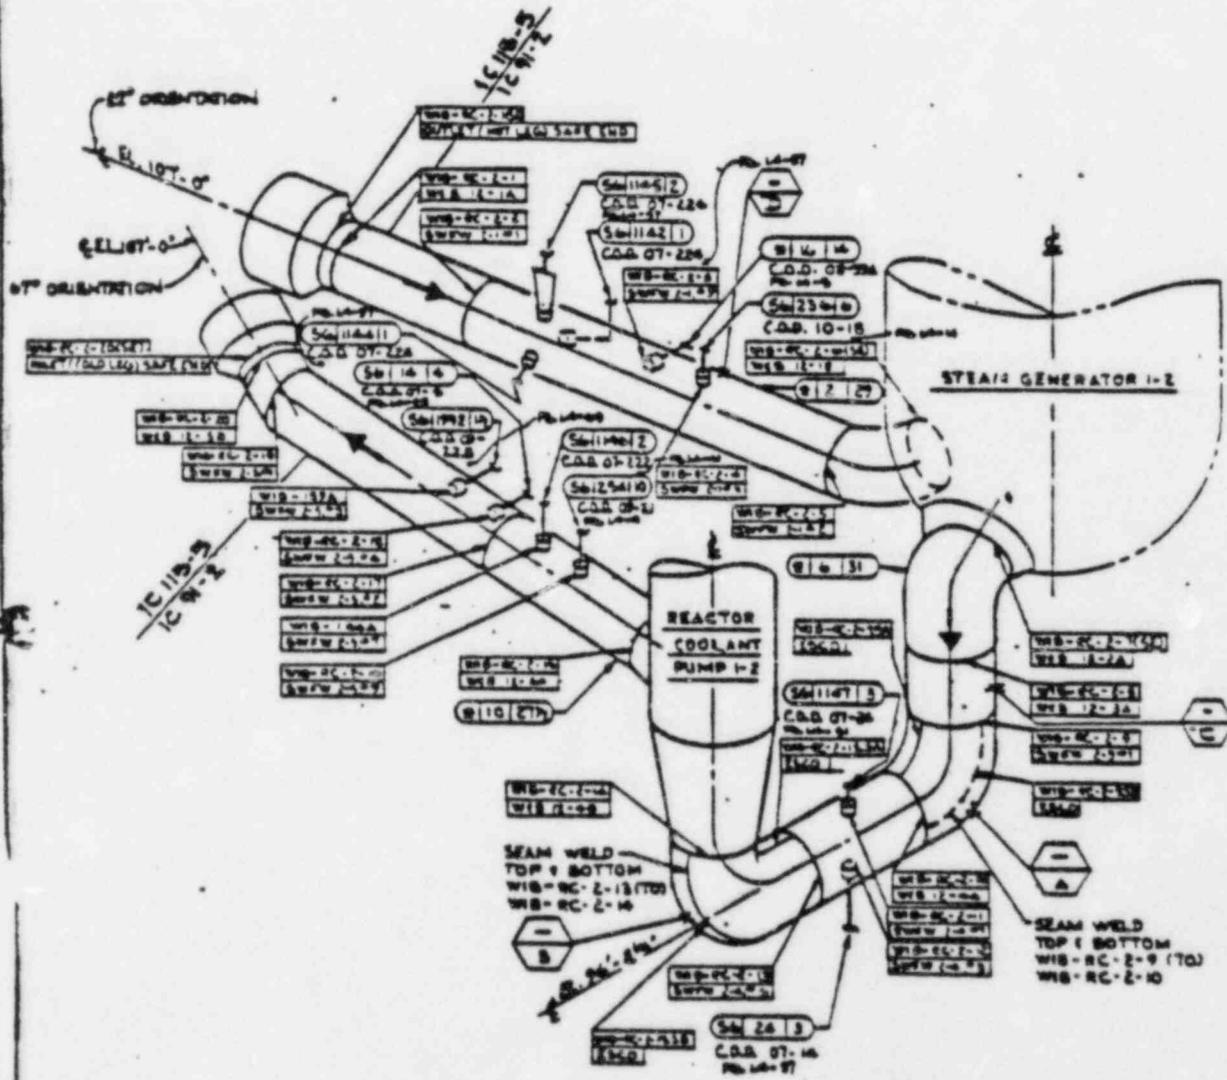
FIGURE III-3

DIABLO CANYON UNIT 1
INSERVICE EXAMINATION ISOMETRIC

LINE NO.	DESCRIPTION	AREA: T-10	DATE: 10/05/81	PAID CODE: CD/DW/SYSTEM: ECS
0-0100	REACTOR COOLANT OUT LOOP 2	RC 1-2	016	DATE: 8-2-81
0-0101	REACTOR COOLANT IN LOOP 2			DATE: 8-5-81
0-0102	REACTOR COOLANT IN DISCH LOOP 2			DATE: 8-22-81
0-0103	DESCRIPTION			DATE: 11-6-81

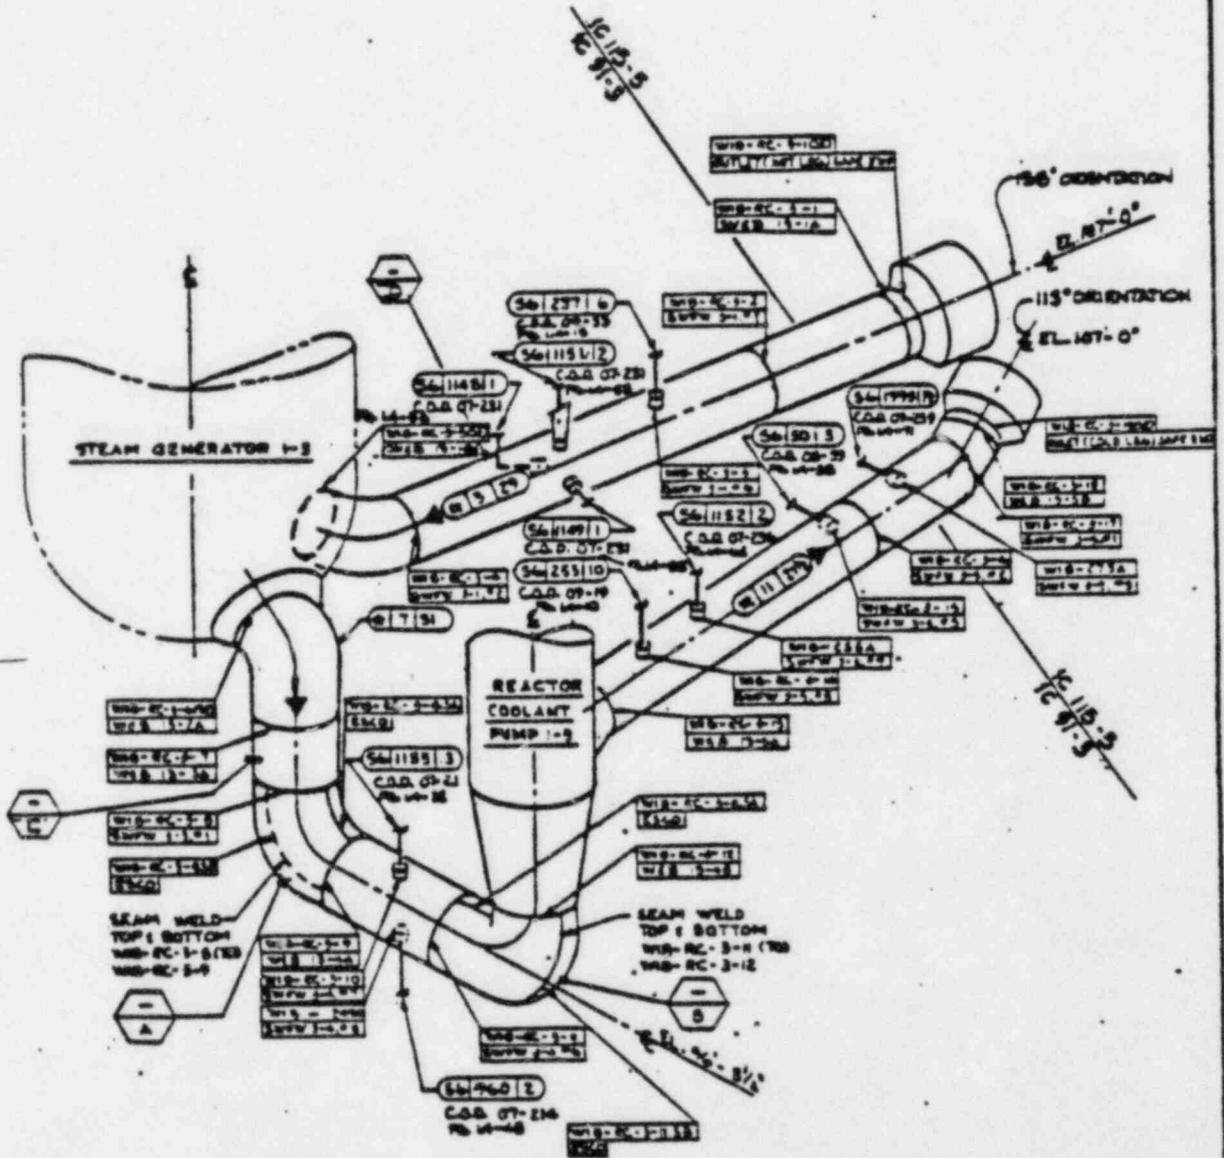
FIGURE III-4

DIABLO CANYON UNIT 1			
INSERVICE EXAMINATION ISOMETRIC			
PACIFIC GAS AND ELECTRIC COMPANY			
AREA: F10 100 FT. 3A P&ID COORDINATED BY: SYSTEM RCS			
REV. NO.	ASPL	LINE NO.	DRAWN: S.GATTISON
RE 1-3	059	0-3-89	DATE:
		0-1-91	APPROV:
		0-4-92	DATE:
		PAGE: 1, 2, 3

LINE NO.	DESCRIPTION
0-3-89	REACTOR COOLANT OUT. LOOP 3
0-1-91	REACTOR COOLANT PP BUG LOOP 3
0-4-92	REACTOR COOLANT PP DRUG LOOP 3

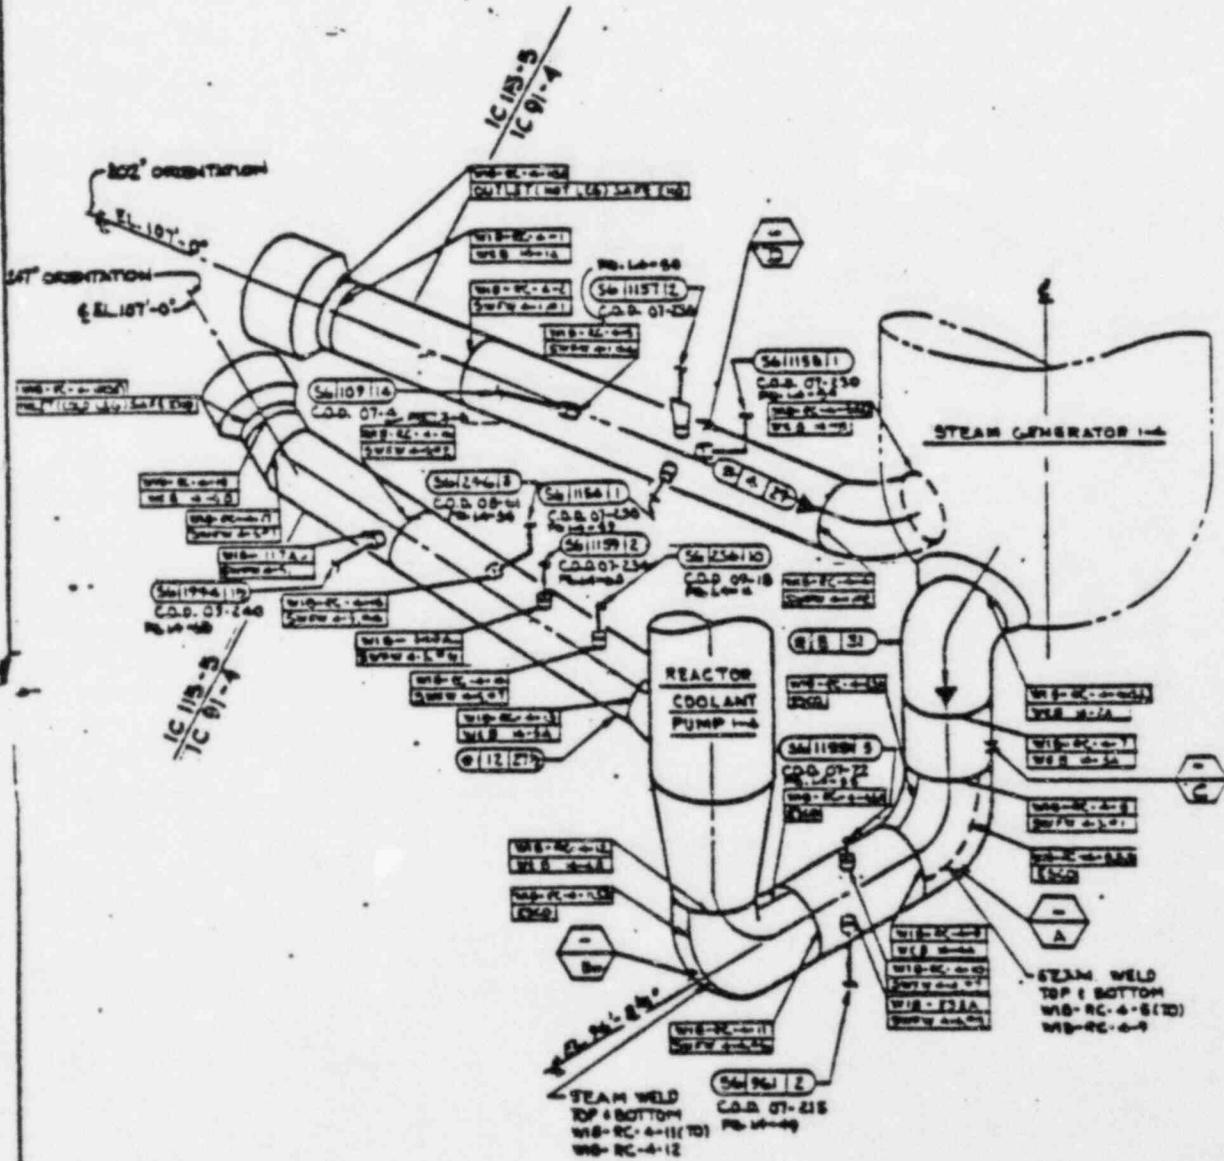
DIABLO CANYON UNIT 1
INSERVICE EXAMINATION ISOMETRIC

PACIFIC GAS AND ELECTRIC COMPANY
