Commonwealth Edison

Subject: Byron Station Units 1 and 2
Braidwood Station Units 1 and 2
Safety-Related D.C. System
Additional Information
NRC Docket Nos. 50-454/455 and 50-456/457

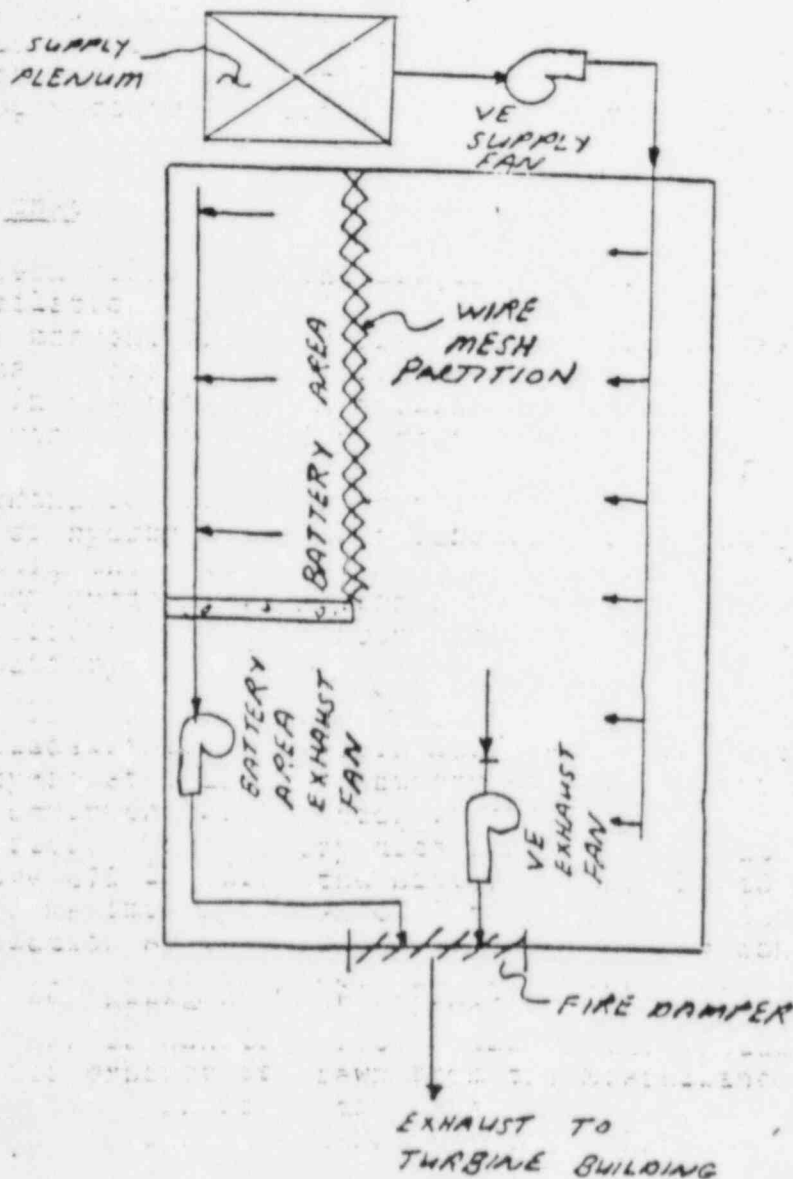
Figure 1 illustrates the equipment arrangement and air flow for the Miscellaneous Electric Equipment Room ventilation system. The safety-related 125V DC Battery Area is a part of the Miscellaneous Electric Equipment Room, which is enclosed by a three-hour fire-rated barrier. The battery area exhaust ventilation system will remove 475 CFM from the battery area.

All of the makeup air for the battery area exhaust is drawn from the Miscellaneous Electric Equipment Room. In order to purge (i.e., sweep) the total volume of the battery area, the exhaust duct is located adjacent to the wall opposite the wire mesh partition. The exhaust ductwork is located at the highest practical point in the room (i.e., immediately under the intermediate roof structural steel) and extends over the entire length of the rear battery rack.

Miscellaneous Electric Equipment Room
(and Battery Area) Ventilation System (Typical)
