U. S. NUCLEAR REGULATORY COMMISSION
REGION I

Docket No.: 50-293
Report No.: 50-293/91-24
Licensee: Boston Edison Company
800 Boylston Street
Boston, Massachusetts 02199
Facility: Pilgrim Nuclear Power Station
Location: Plymouth, Massachusetts
Dates: October 1 - November 11, 1991
Inspectors: J. Macdonald, Senior Resident Inspector
D. Kern, Resident Inspector
A. Keller, Intern

Pilgrim Inspection Report 50-293/91-24

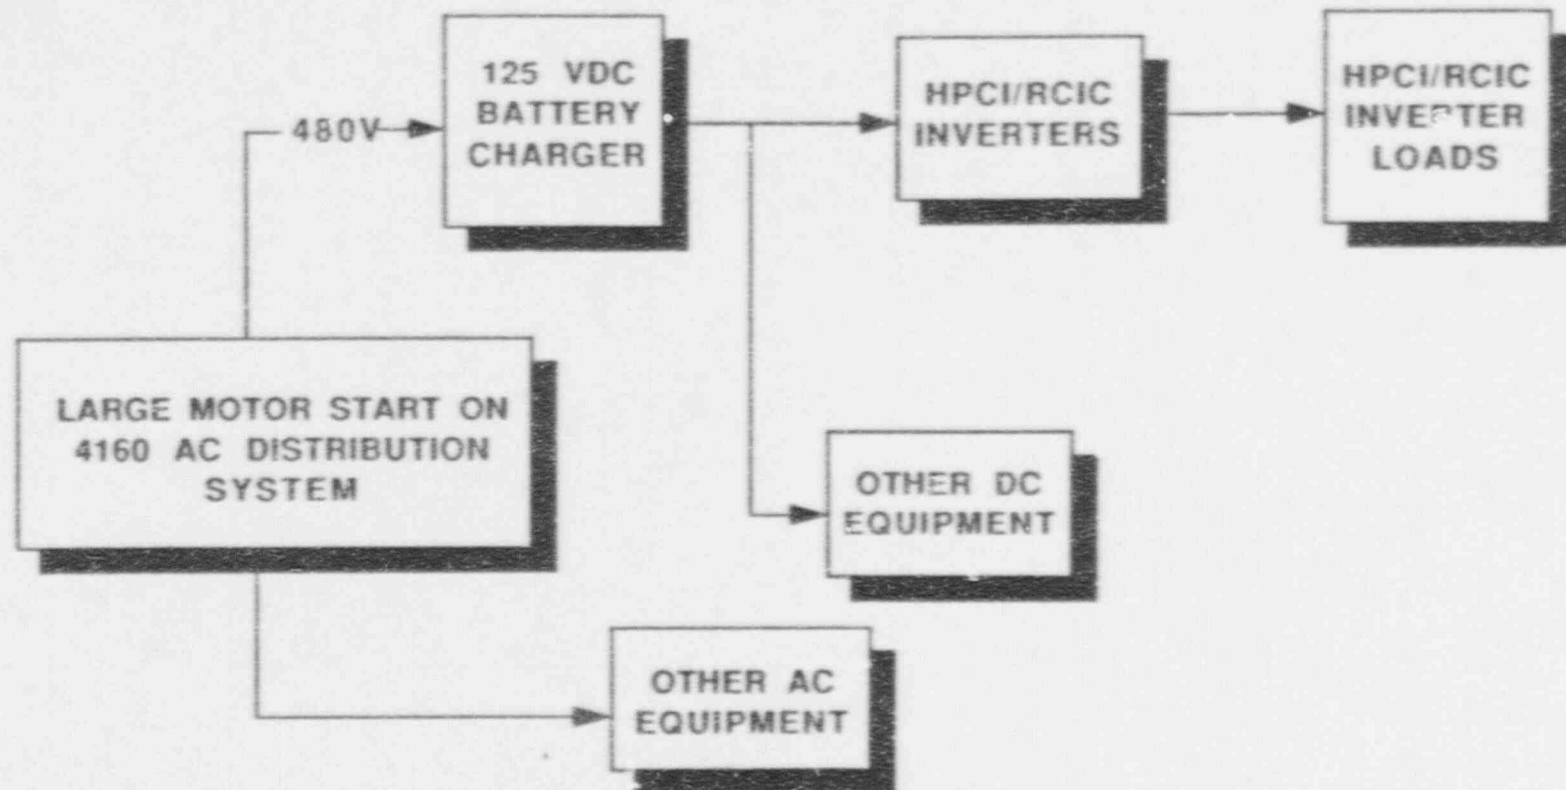
Effect Of Transients Understood

- BATTERIES MEET 8HR MISSION TIME
- HPCI/RCIC OPERABLE WHEN REQUIRED

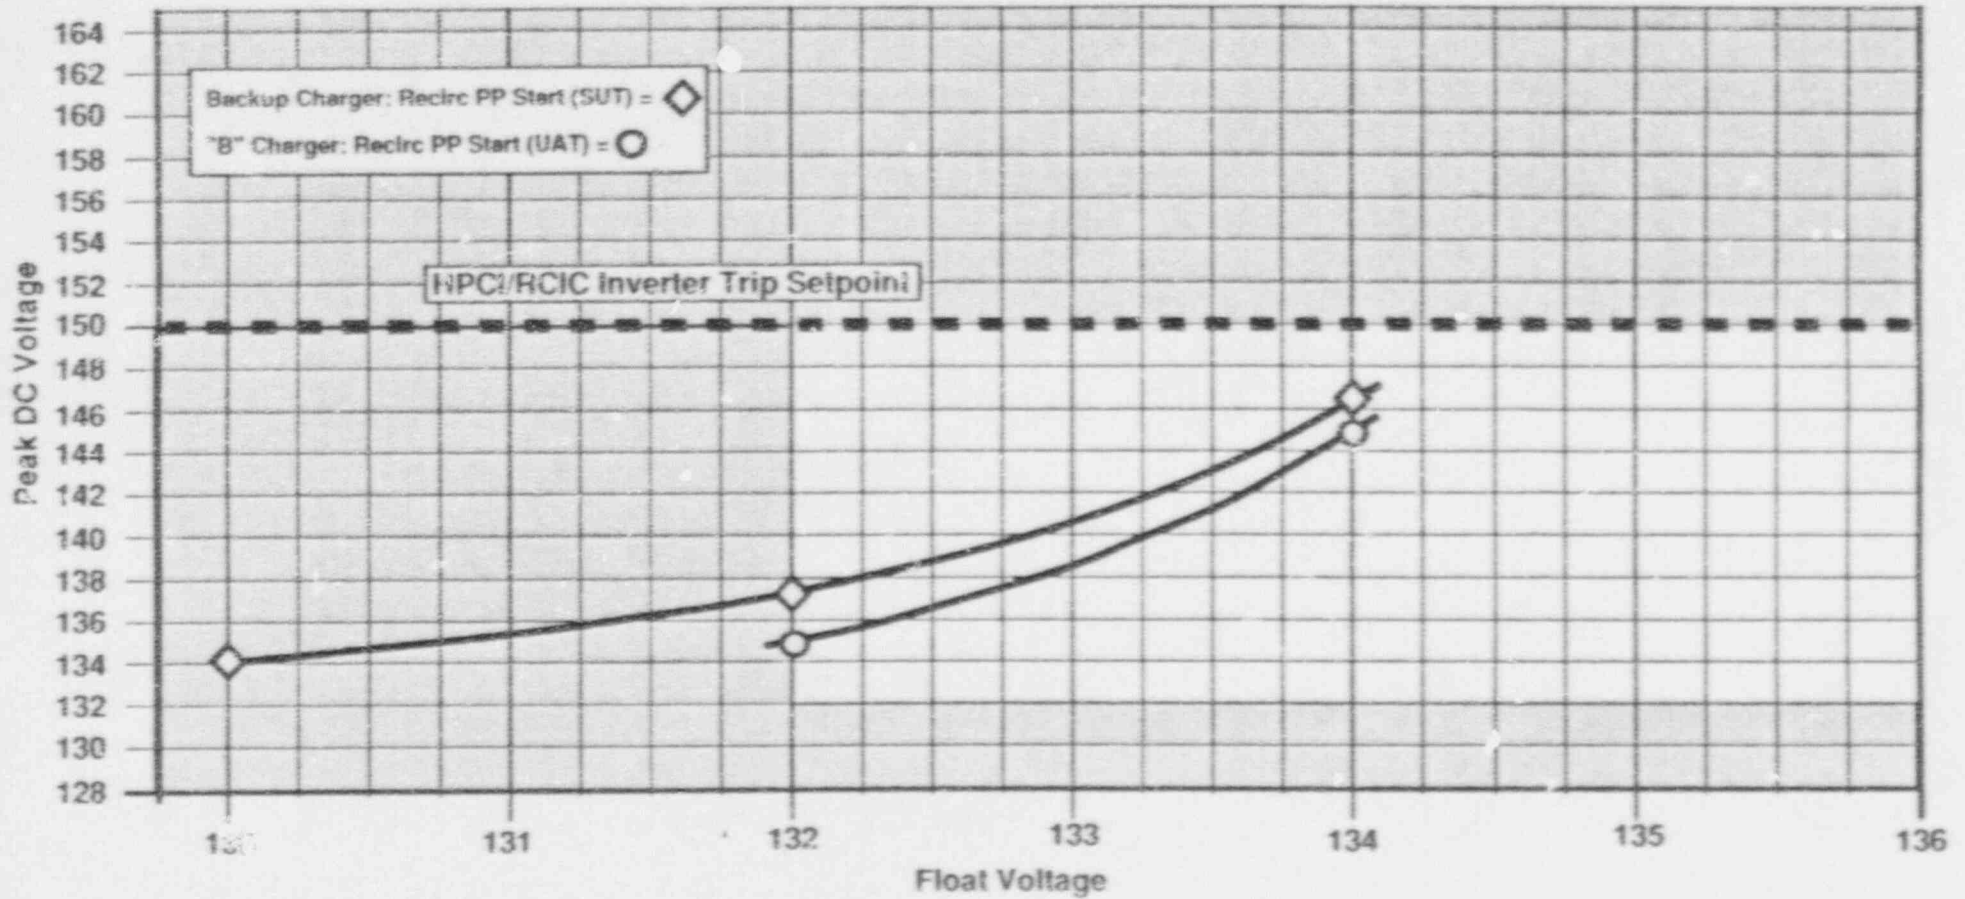
Battery Charger Response Profile for Float Voltage Change

Battery Charger Response to Float Voltage Similar by Test as Well as Vendor Review

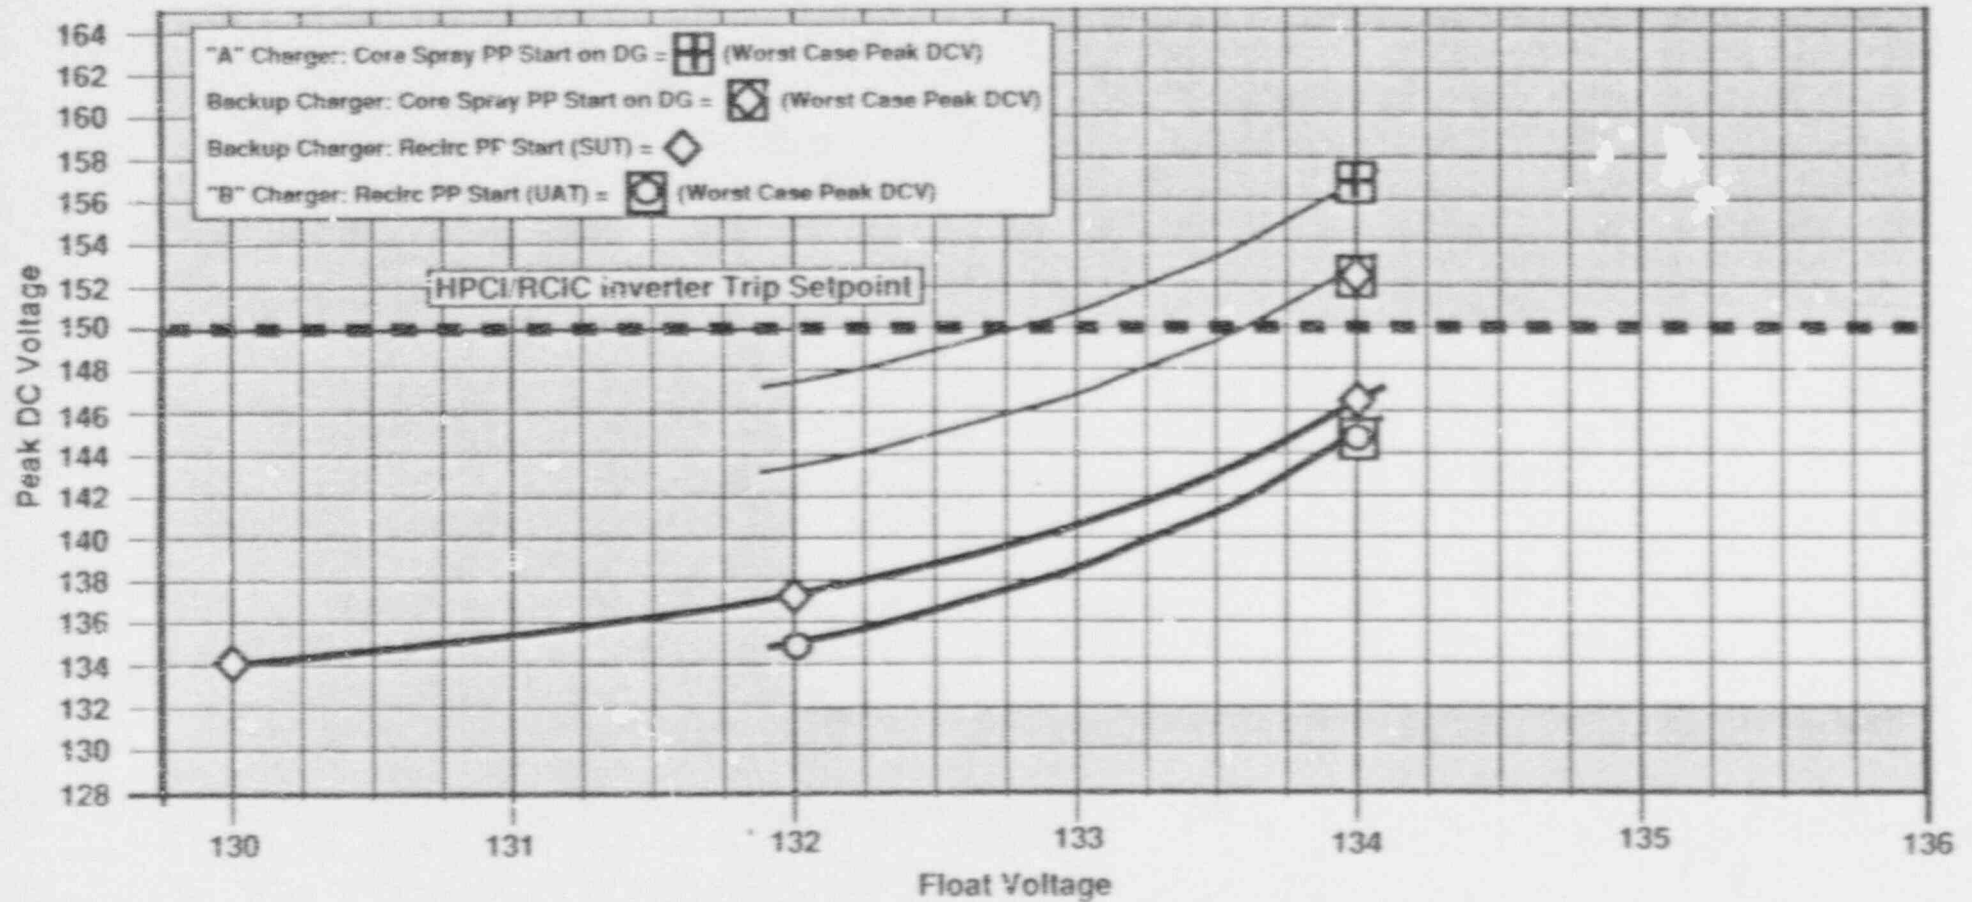
Peak Voltage vs Float Voltage

DC Float Voltage Satisfies Battery Charger Criteria And Inverter Trip Setpoint
