Midland Nuclear Power Plant, Units 1 and 2

Docket No. 50-329  
Docket No. 50-330

REPORT ON DESIGN AND CONSTRUCTION PROBLEMS FOR PERIOD FROM  
START OF CONSTRUCTION THROUGH JUNE 30, 1982

Report Requested by Advisory Committee on Reactor Safeguards

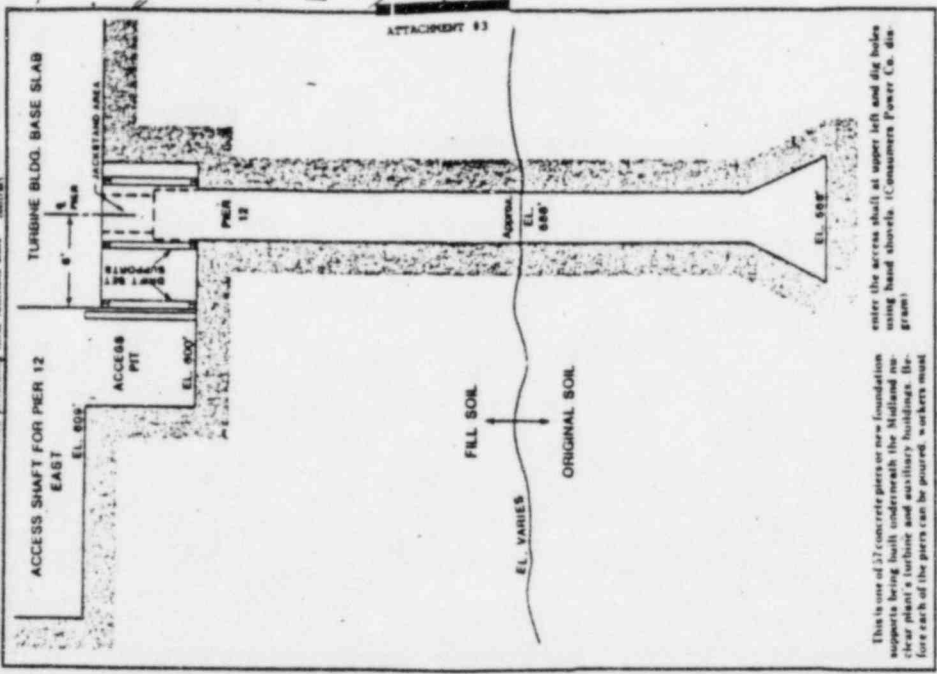
This is one of 37 concrete pieces on new foundation supports being built underneath the Middland nuclear plant's turbine and auxiliary buildings. Before each of the pieces can be poured, workers must enter the access shaft at upper left and dig holes using hand shovels. (Consumers Power Co. diagram)

As of February 11, 1983 the Stone & Webster - Parsons Brinckerhoff Assessment Team has observed the excavation, placing of reinforcement, and concreting of underpinning pier W12, and the excavation, and placing of reinforcement for underpinning pier E12. In addition, the Assessment Team has reviewed the drawings, procedures and other documents pertaining to the underpinning work and has observed the performance of the Quality Assurance and Quality Control Organizations during the progress of the work.

The project has been broken down into four phases of work which includes the installation of the East and West Access Shafts, 54 underpinning piers and six grillage beam support assemblies. The piers and grillage beam assemblies will temporarily support the Control Tower, EPA and Turbine Buildings until the permanent underpinning wall can be constructed and the building loads transferred to the wall.

After mass excavation is complete, the Contractor will construct a six foot wide, 35 feet high wall approximately 600 L.F. long, (4,287 cubic yards of concrete). This will serve as the new foundation for the building once the load has been transferred from the piers to the wall.
