U.S. NUCLEAR REGULATORY COMMISSION

Report Nos. 50-374/92004(DRSS)

Facility Name: LaSalle County Station, Units 2

Enforcement Conference on January 21, 1992 (Report No. 50-374/92004(DRSS))

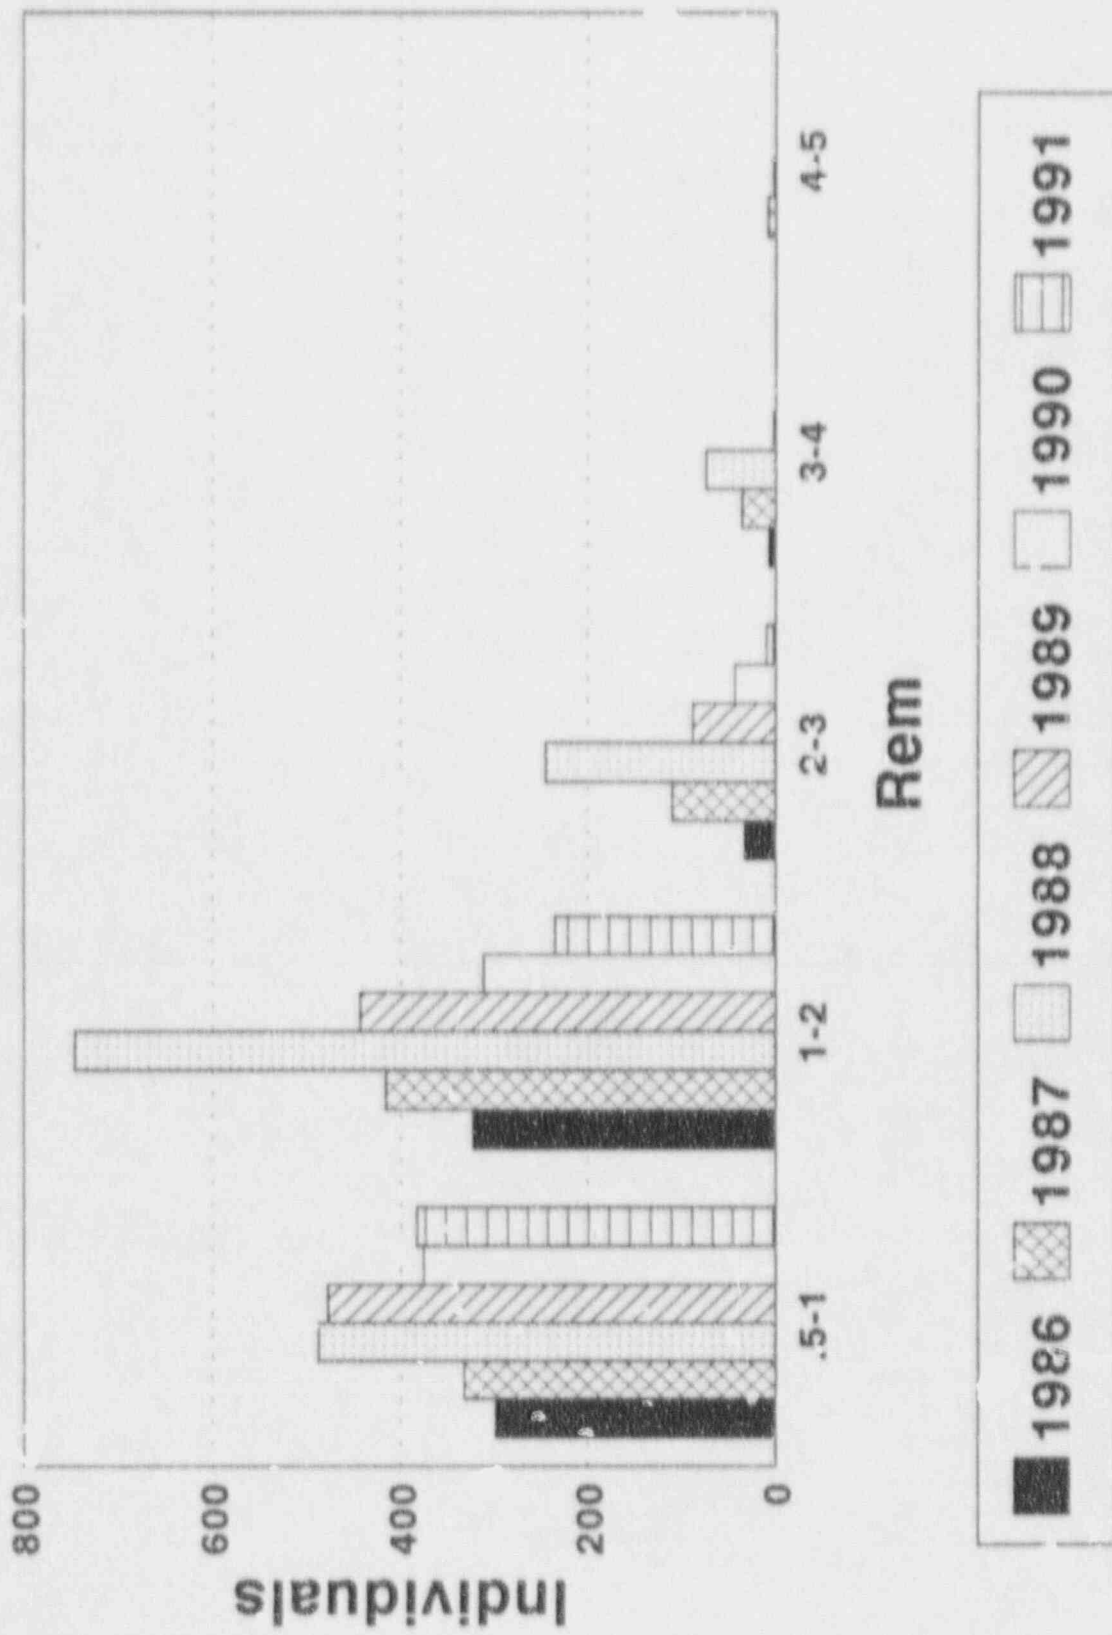
© LaSalle County Station Annual Whole Body External Exposure

- Chart 1 - LaSalle County Station Individual Personnel Exposure
- Chart 2 - LaSalle County Station Personnel Exposure
- Chart 3 - LaSalle Ccounty Station Personnel Contaminations

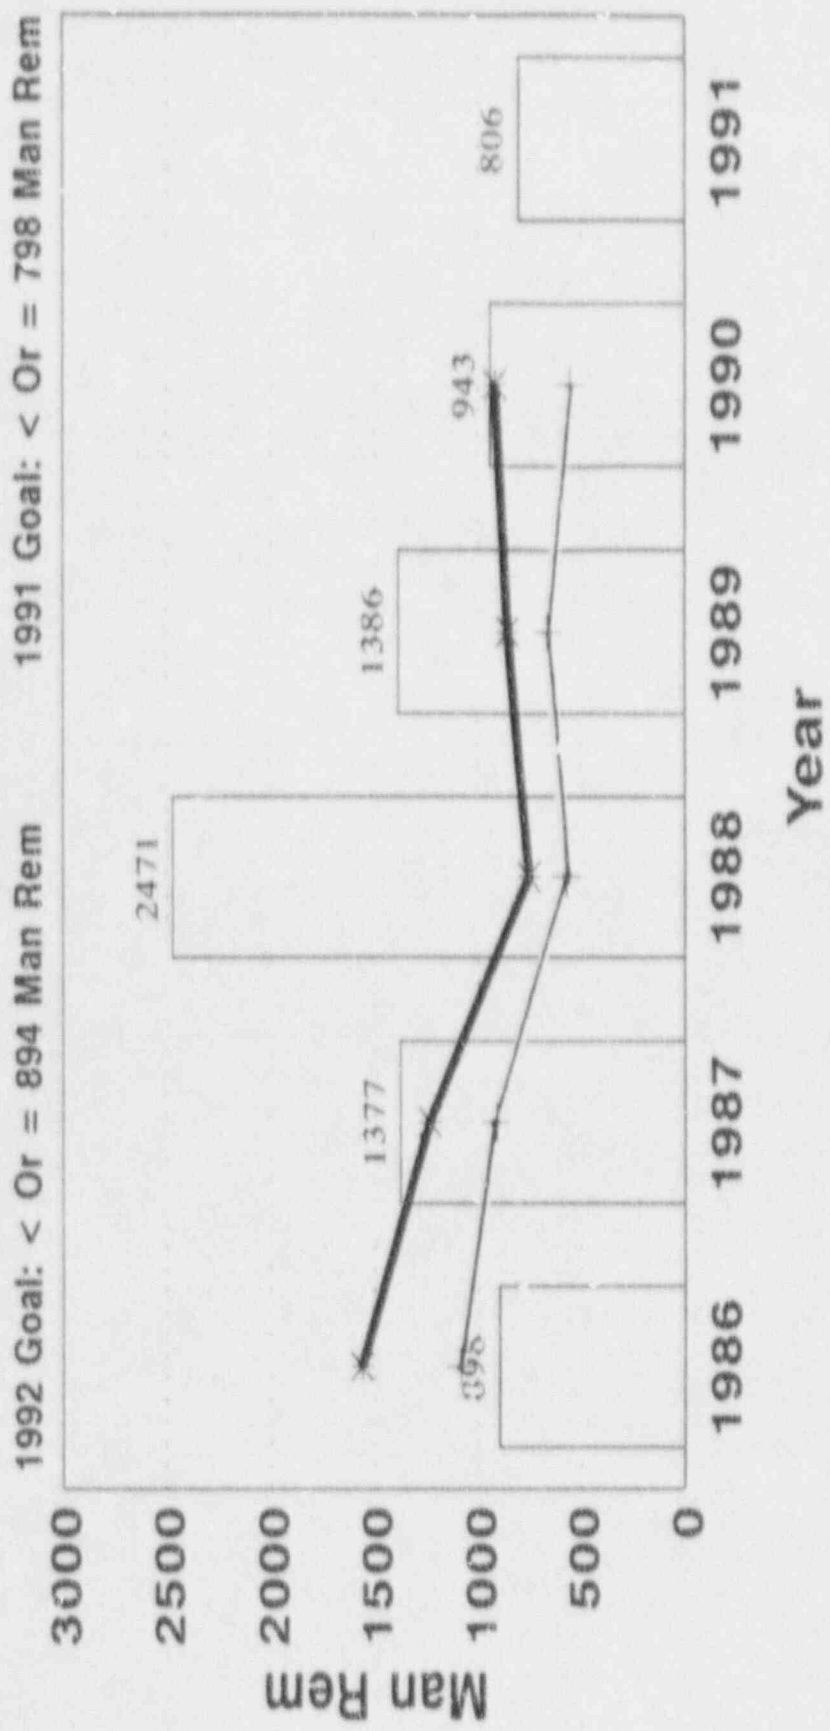
LaSalle County Station Personnel Exposure

Exposure
 + Industry Median
* Top Quartile

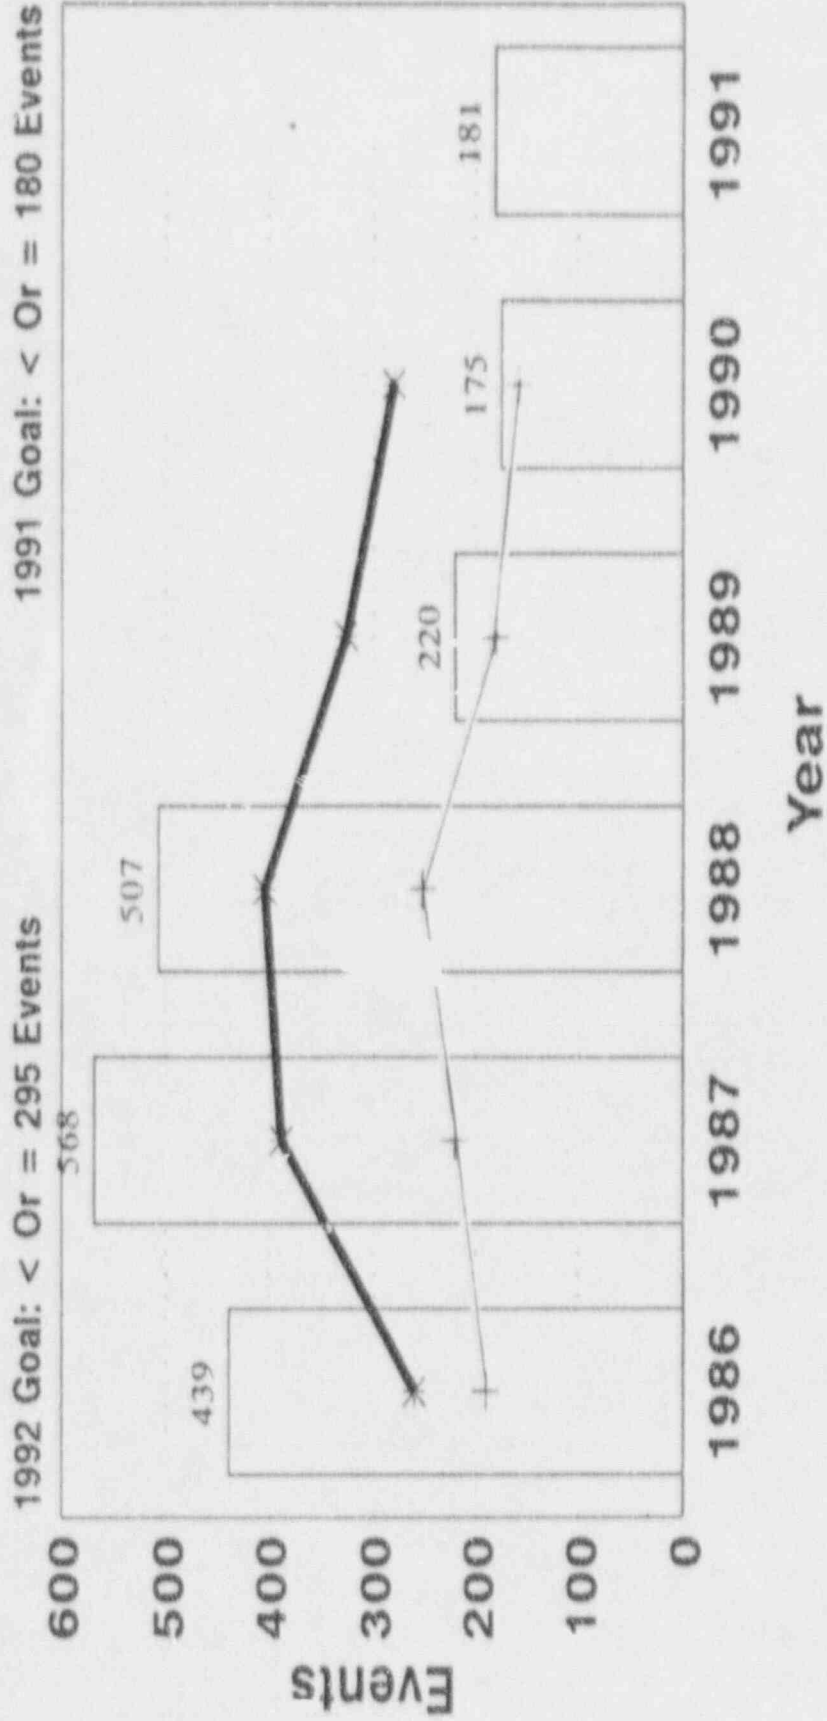
e LaSalle County Station Personnel Contaminations
