Vogtle Electric Generating Plant
 NUCLEAR OPERATIONS

Procedure No.
 17038-1
 Revision No.
 7
 Page No.
 1 of 97

ANNUNCIATOR RESPONSE PROCEDURES
FOR ALB 38 ON EAB PANEL

These procedures describe alarm conditions annunciated on Annunciator Light Board (ALB) 38 located on the Electrical Auxiliary Board. They apply to Unit 1 operation only, to provide guidance for specific operator responses to given alarms and may not be appropriate for all plant conditions.

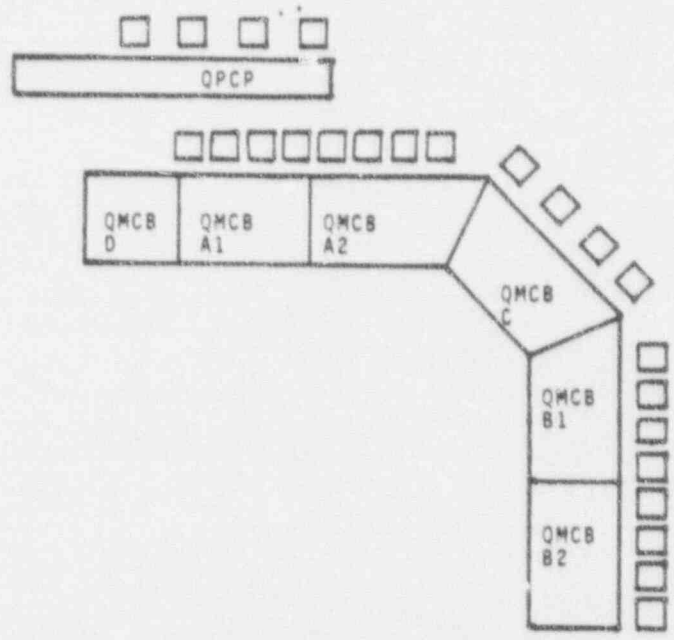
ALB 38

(1) (2) (3) (4) (5) (6) (7) (8) (9) (10)

A	DC18 LOW TEMP LUBE OIL-IN	DC18 LOW TEMP LUBE OIL-OUT	DC18 HI TEMP LUBE OIL-IN	DC18 HI TEMP LUBE OIL-OUT	DC18 TRIP HIGH TEMP LUBE OIL	DC18 LOW LEVEL LUBE OIL	DC18 TRIP HIGH TEMP ENGINE REC	DC18 TRIP HI CRANKCASE PRESS	DC18 VIBRATION TRIP	DC18 TRIP OVERSPEED
B	DC18 LOW PRESS LUBE OIL	DC18 TRIP LOW PRESS LUBE OIL	DC18 LOW PRESS TURBO OIL RIGHT	DC18 LOW PRESS TURBO OIL LEFT	DC18 TRIP LOW PRESS TURBO OIL	DC18 HI DIFF PRESS LUBE OIL FILTER	DC18 LOW OIL PRESS SENSOR MALFUNCTION	DC18 ENGINE CTRL POWER A FAILURE	DC18 ENGINE CTRL POWER B FAILURE	DC18 DISABLED GEN CONTROL PWR FAILURE
C	DC18 LOW TEMP JACKET WATER IN	DC18 LOW TEMP JACKET WATER OUT	DC18 HI TEMP JACKET WATER IN	DC18 HI TEMP JACKET WATER OUT	DC18 TRIP HI TEMP JACKET WATER	DC18 LOW PRESS JACKET WATER	DC18 TRIP LOW PRESS JACKET WATER	DC18 HI LEVEL JACKET WATER	DC18 HI JACKET WATER TEMP SENSOR MALF	DC18 DISABLED MOWBSET OF EMERGENCY TRIP
D	DC18 LOW PRESS FUEL OIL	DC18 HI DIFF PRESS FUEL OIL FILTER	DC18 FUEL OIL INJECTION LINE BREAK	DC18 HIGH LEVEL MAIN TANK	DC18 LOW LEVEL MAIN TANK	DC18 GEN USED FREQ	DC18 HIGH OR LOW LEVEL DAY TANK			DC18 DISABLED DC C&T BRKR IMOPERABLE

E	DC18 GENERATOR TROUBLE	DC18 LOW VOLTAGE	DC18 HIGH TEMP GEN CTRL PNL	DC18 LOW EXCITATION	DC18 DISABLED ENGINE CONTROL IN LOCAL	DC18 TRIP GENERATOR FAULT	DC18 TRIP GEN DIFF	DC18 HIGH TEMP GEN BEARINGS	DC18 LOCAL ANB PNL PWR FAILURE	DC18 DISABLED MAINTENANCE LOCK OUT
F	DC18 LOW PRESS CONTROL AIR	DC18 LOW PRESS STARTING AIR	DC18 HIGH PRESS STARTING AIR	DC18 DISABLED DC START POWER FAILURE	DC18 FAILED TO START	DC18 SWITCH NOT IN AUTO	DC18 RAISING DEVICE ENGAGED	DC18 PANFL INTRUSION	DC18 HI TEMP PANEL	DC18 EMERGENCY START

The twelve annunciators denoted by an asterisk (*) are wired to provide a "First Alert" function at the local engine control panel PDG4 annunciators. The "First Alert" feature makes it possible to determine which of the twelve annunciators actuated first, should multiple alarm actuation occur. The first annunciator to actuate flashes fast and all subsequent annunciators flash slow.
