ENCLOSURE 1

NOTICE OF VIOLATION

Tennessee Valley Authority Sequoyah Nuclear Plant Unit 1 Docket No. 50-327 License No. DPR-77 EA 92-006

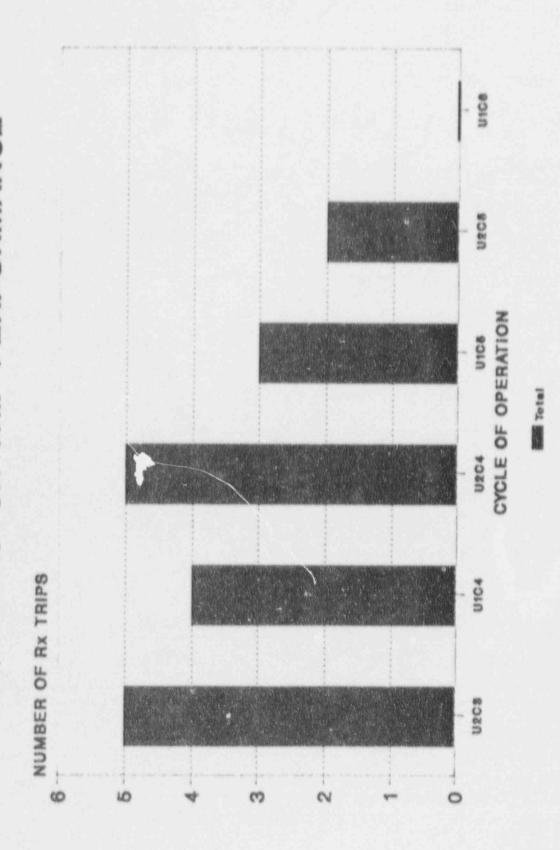
SON REACTOR TRIP PERFORMANCE

- Reduction In Reactor Trips And Reactivity Mismanagement Events
- Reduction In Reportable Events Related to Performance
- Improved Operations Performance
- Overall Personnel Performance Improvements
