REGION IV  
DIVISION OF REACTOR PROJECTS  
QUARTERLY PLANT PERFORMANCE REVIEW

SOUTH TEXAS PROJECT  
ELECTRIC GENERATING STATION

DATE: October 19, 1993

QUARTER: Third Quarter (July-September 1993)

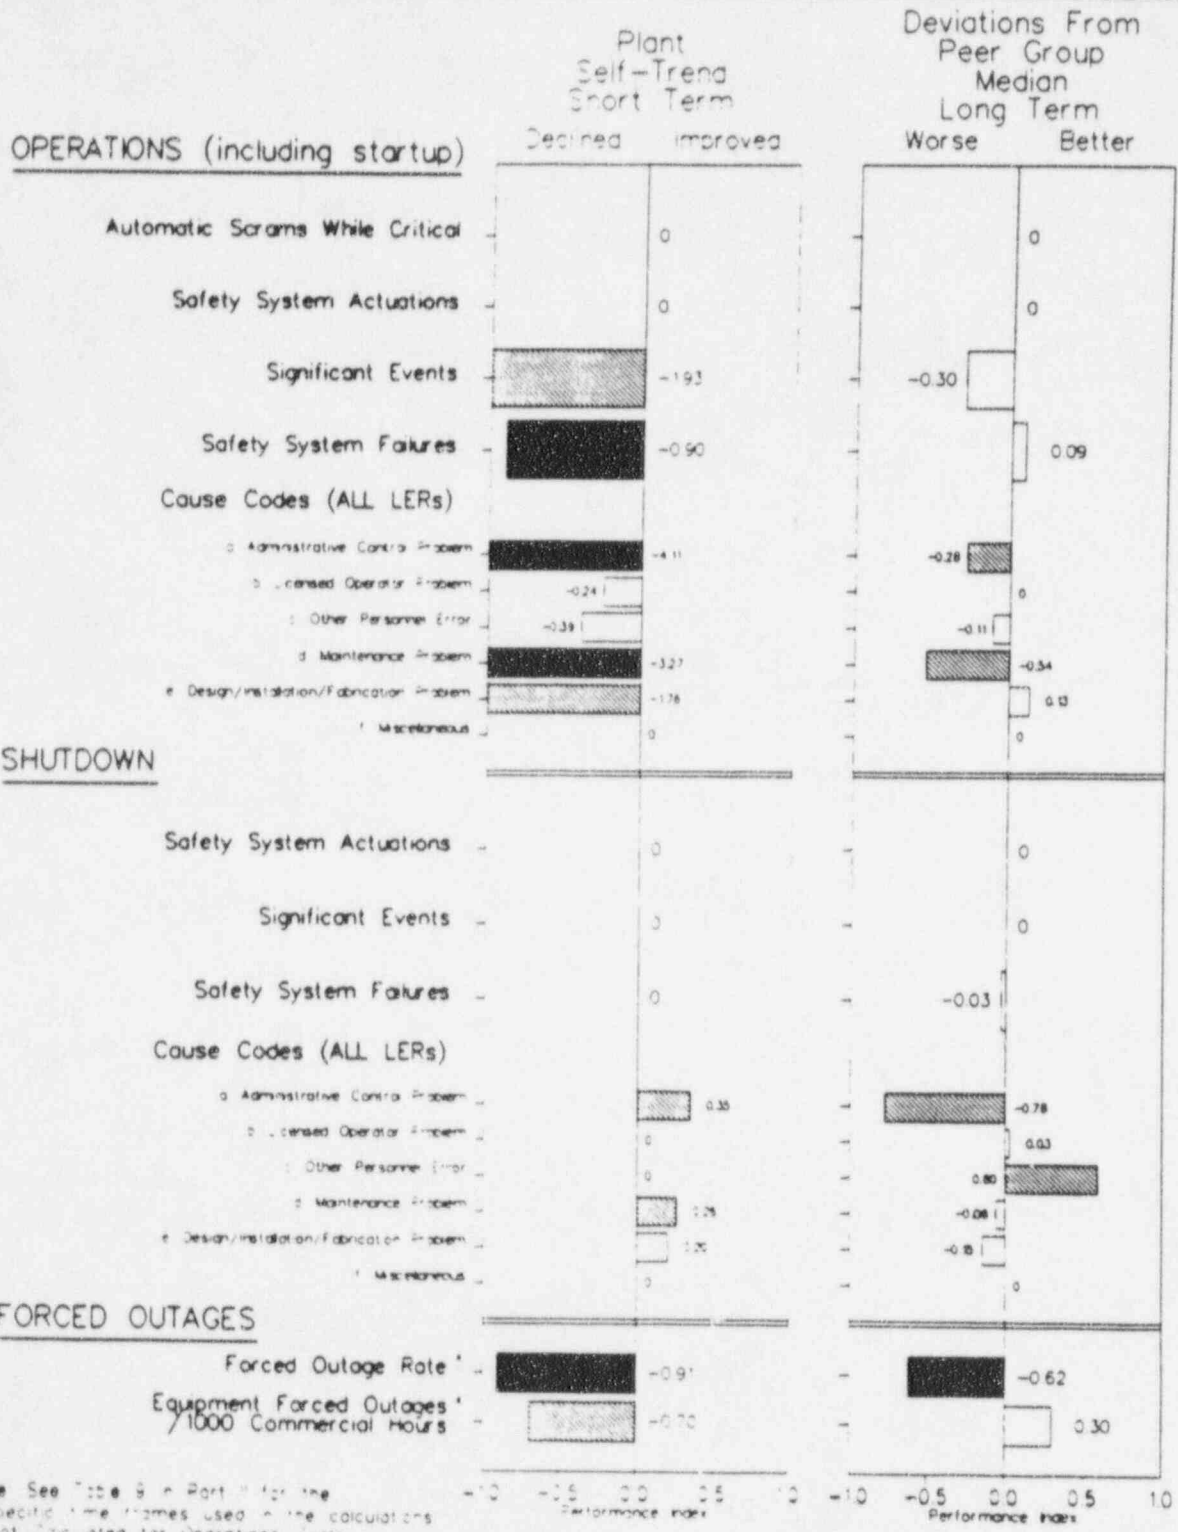
FIGURE 7.89b

Peer Group Westinghouse New 3 and 4-Loop  
90-2 to 93-1 Trends and Deviations

Legend Statistical Significance

Note: See Table 8 in Part II for the specific time frames used in the calculations.  
\* Not Calculated for Operations Cycle
