REGION IV
DIVISION OF REACTOR PROJECTS
QUARTERLY PLANT PERFORMANCE REVIEW

SOUTH TEXAS PROJECT
ELECTRIC GENERATING STATION

DATE: January 19, 1993

QUARTER: Fourth Quarter (October-December 1993)

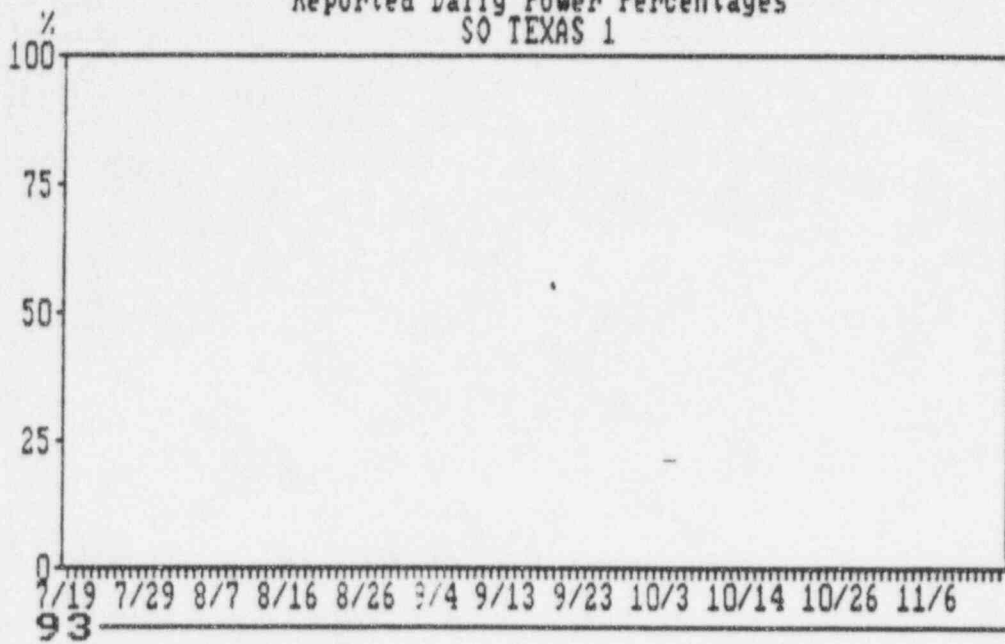
Reported Daily Power Percentages
SO TEXAS 1

Pct Power (Reported to OPS Center)

Following 120 day period

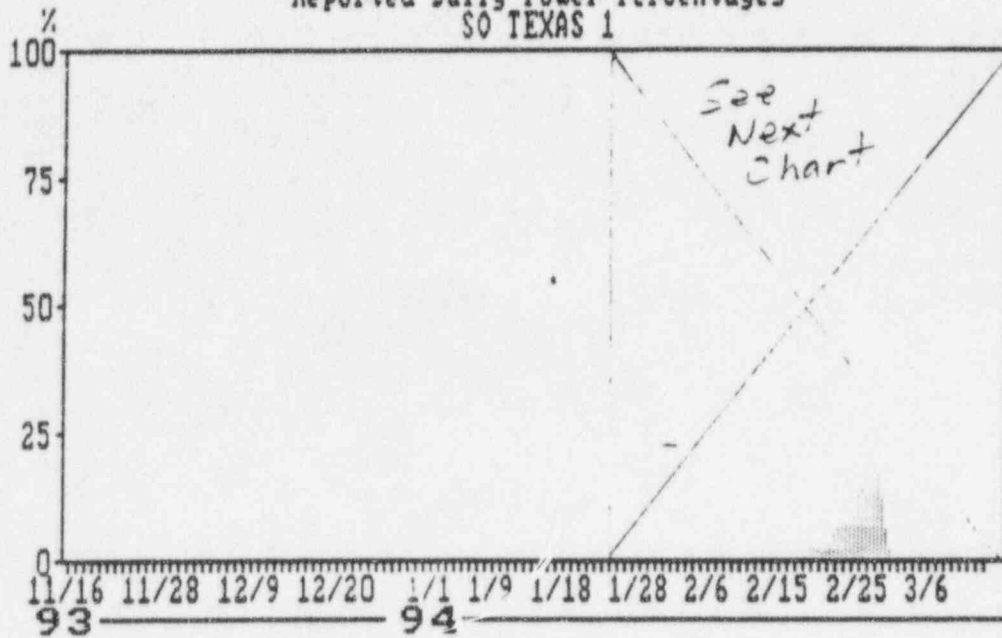
Reported Daily Power Percentages
SO TEXAS 1

■ Pct Power (Reported to OPS Center)

▨ Prior 120 day period

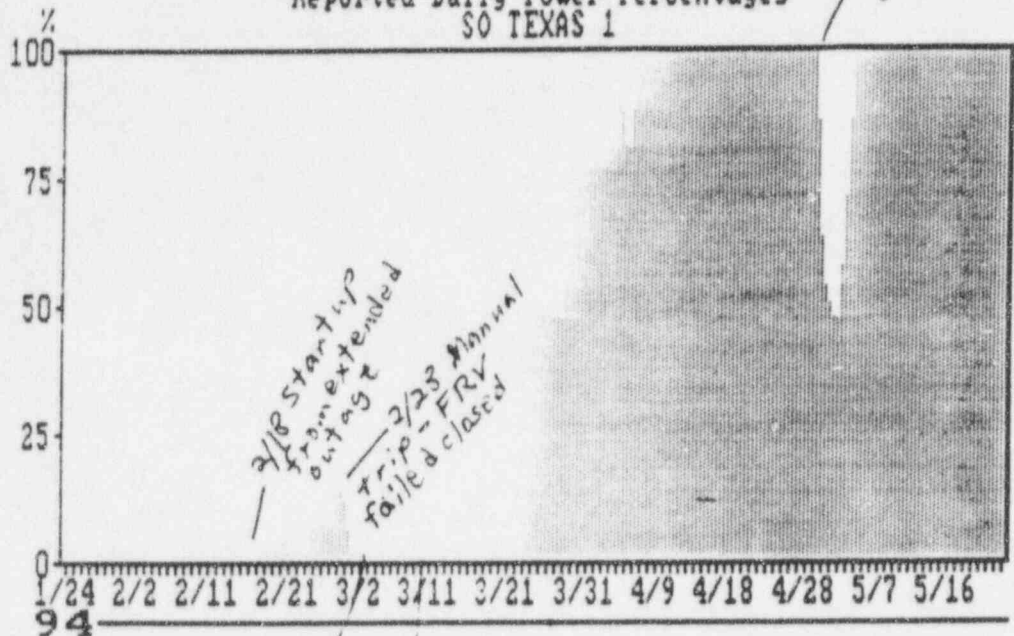
Reported Daily Power Percentages
SO TEXAS 1

MFP lube oil cooler cleaning

Pct Power (Reported to OPS Center)

Following 120 day period

SG leak identified

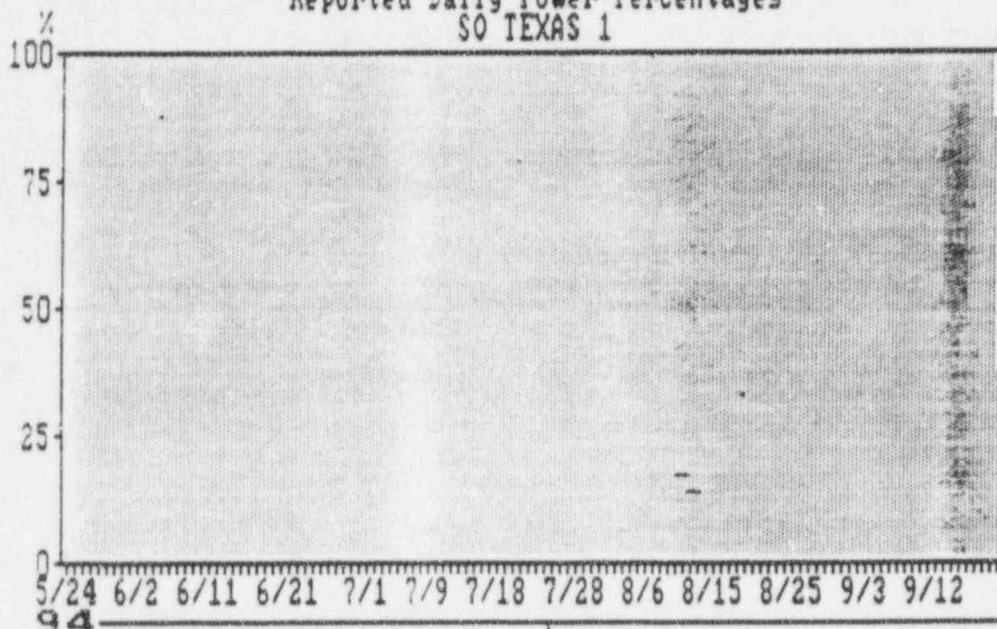
Reported Daily Power Percentages
SO TEXAS 1

920 Trif on
- Loss of MFP

Pct Power (Reported to OPS Center)

◆ Prior 120 day period

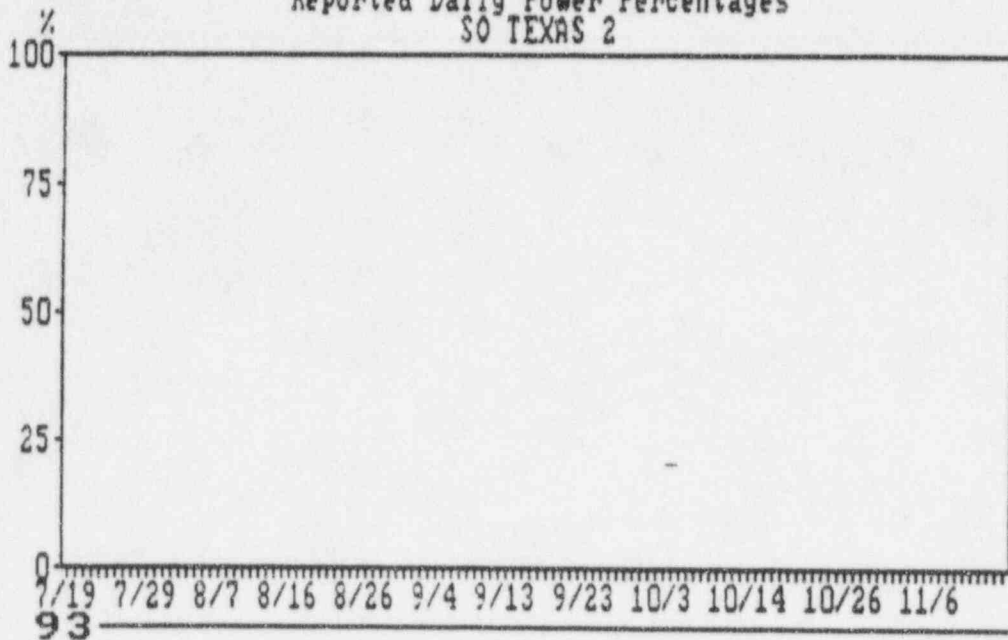
Reported Daily Power Percentages
SO TEXAS 2

■ Pct Power (Reported to OPS Center)

■ Following 120 day period

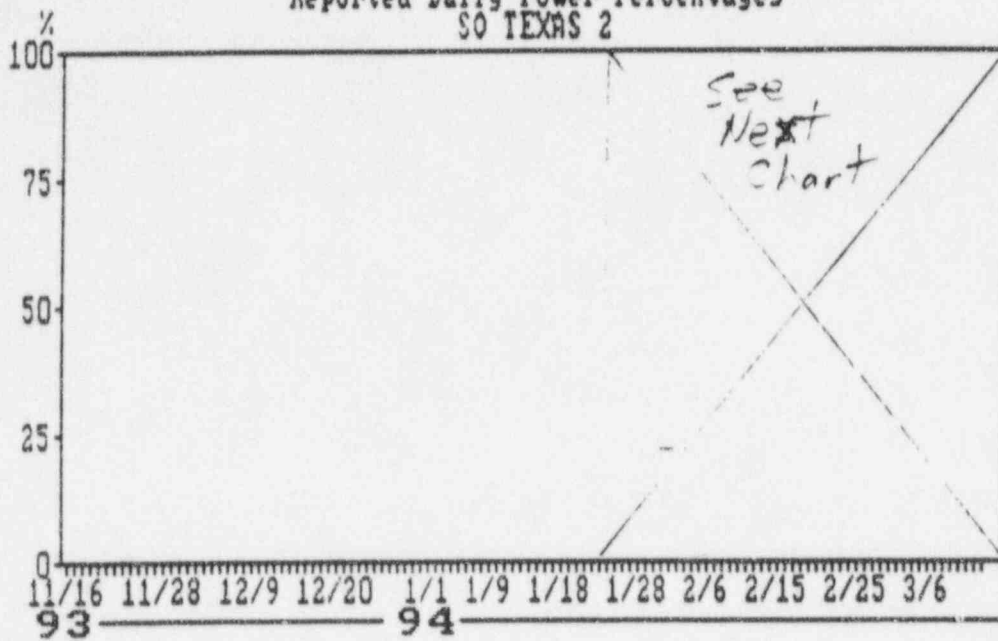
Reported Daily Power Percentages
SO TEXAS 2

Pct Power (Reported to OPS Center)

Prior 120 day period

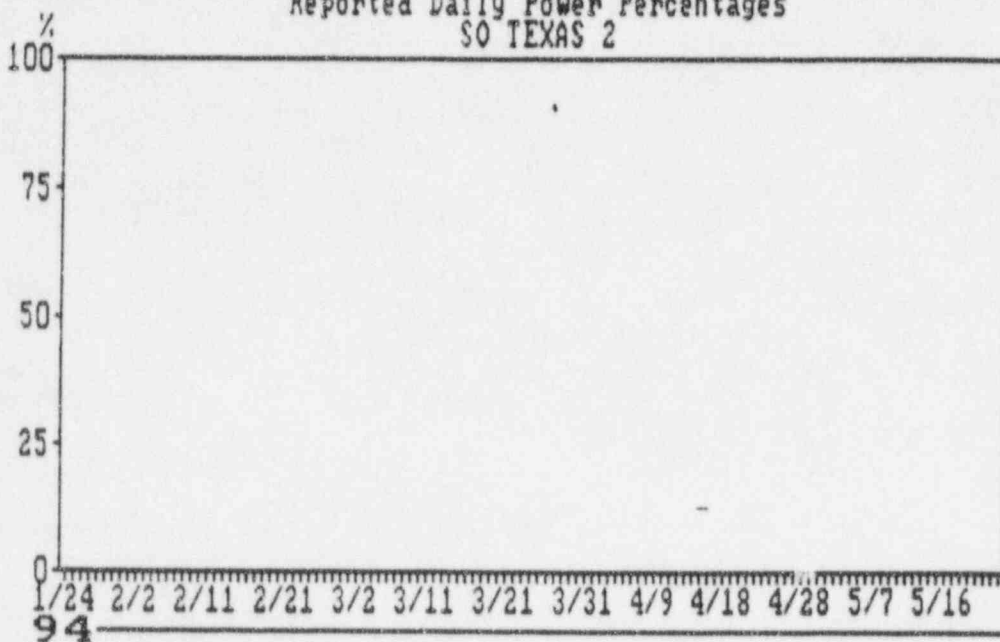
Reported Daily Power Percentages
SO TEXAS 2

Pct Power (Reported to OPS Center)

following 120 day period
