U. S. NUCLEAR REGULATORY COMMISSION
REGION I

Report/License No.: 95-18/DRP-35

Facility Name: Pilgrim Nuclear Power Station

Inspection Conducted: August 28-31, 1995

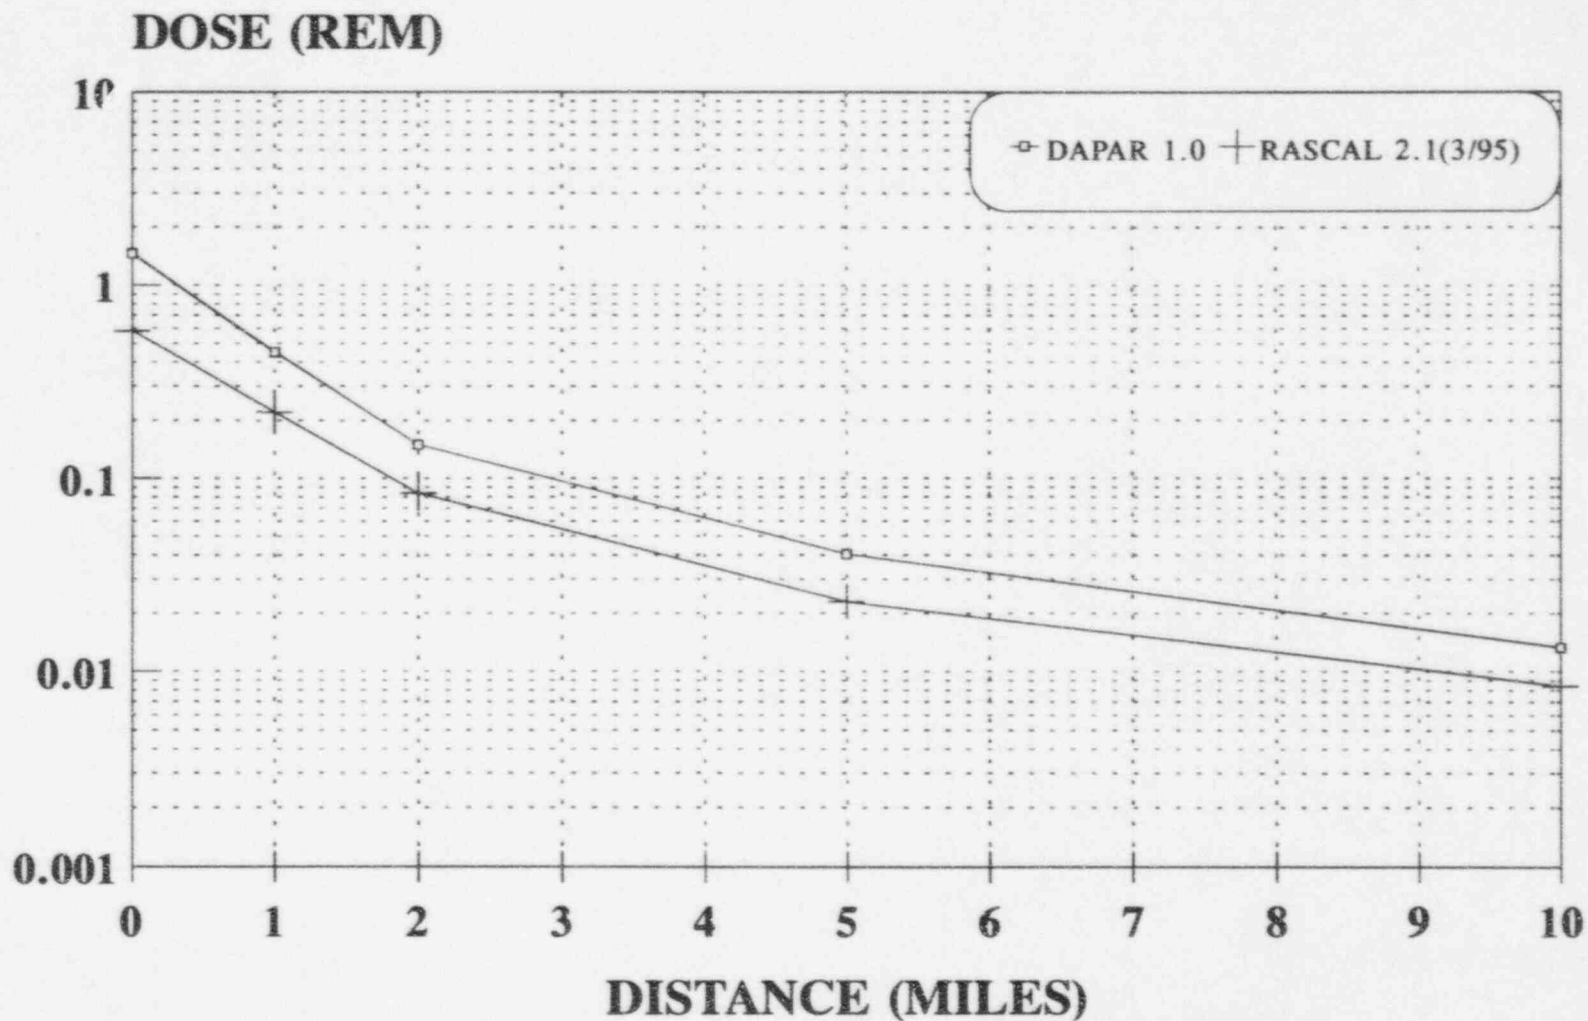
PROJECTED DOSE COMPARISON

PIL Drywell Leakage 0.5% per day Based on Plant Conditions

Case A: 4 miles/hr and Stability class D (TEDE)

During the inspection, comparisons between the licensee's computer code "Dose Assessment and Protective Action Recommendation (DAPAR)" Version 1, and the NRC's "Radiologic Assessment System for Consequence Analysis (RASCAL)" Version 2.1, March 1995, were made. The results of nine cases examined indicated very good agreement. Of the nine cases, the differences were within a factor of two - 51% of the time, a factor of four - 76% of the time, and within a factor of eight - 95% of the time. Graphs of the comparisons are contained in Attachment 2.

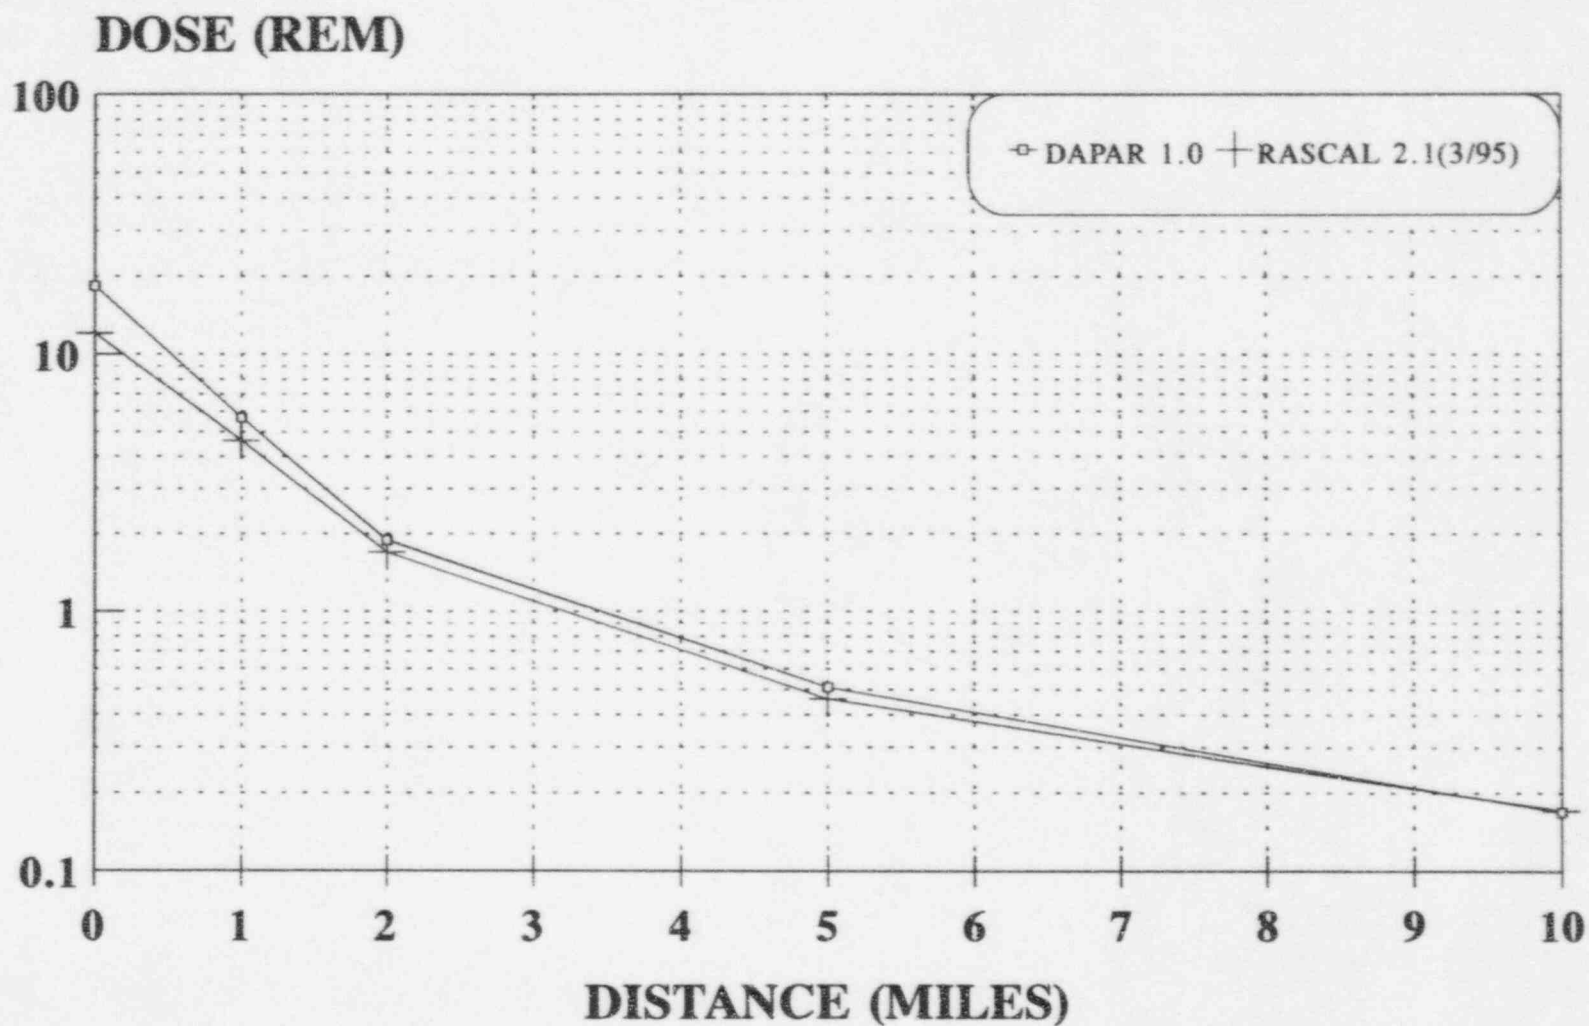
PROJECTED DOSE COMPARISON

PIL Drywell Leakage 0.5% per day Based on Plant Conditions

Case B: 4 miles/hr and Stability class D (Thyroid)

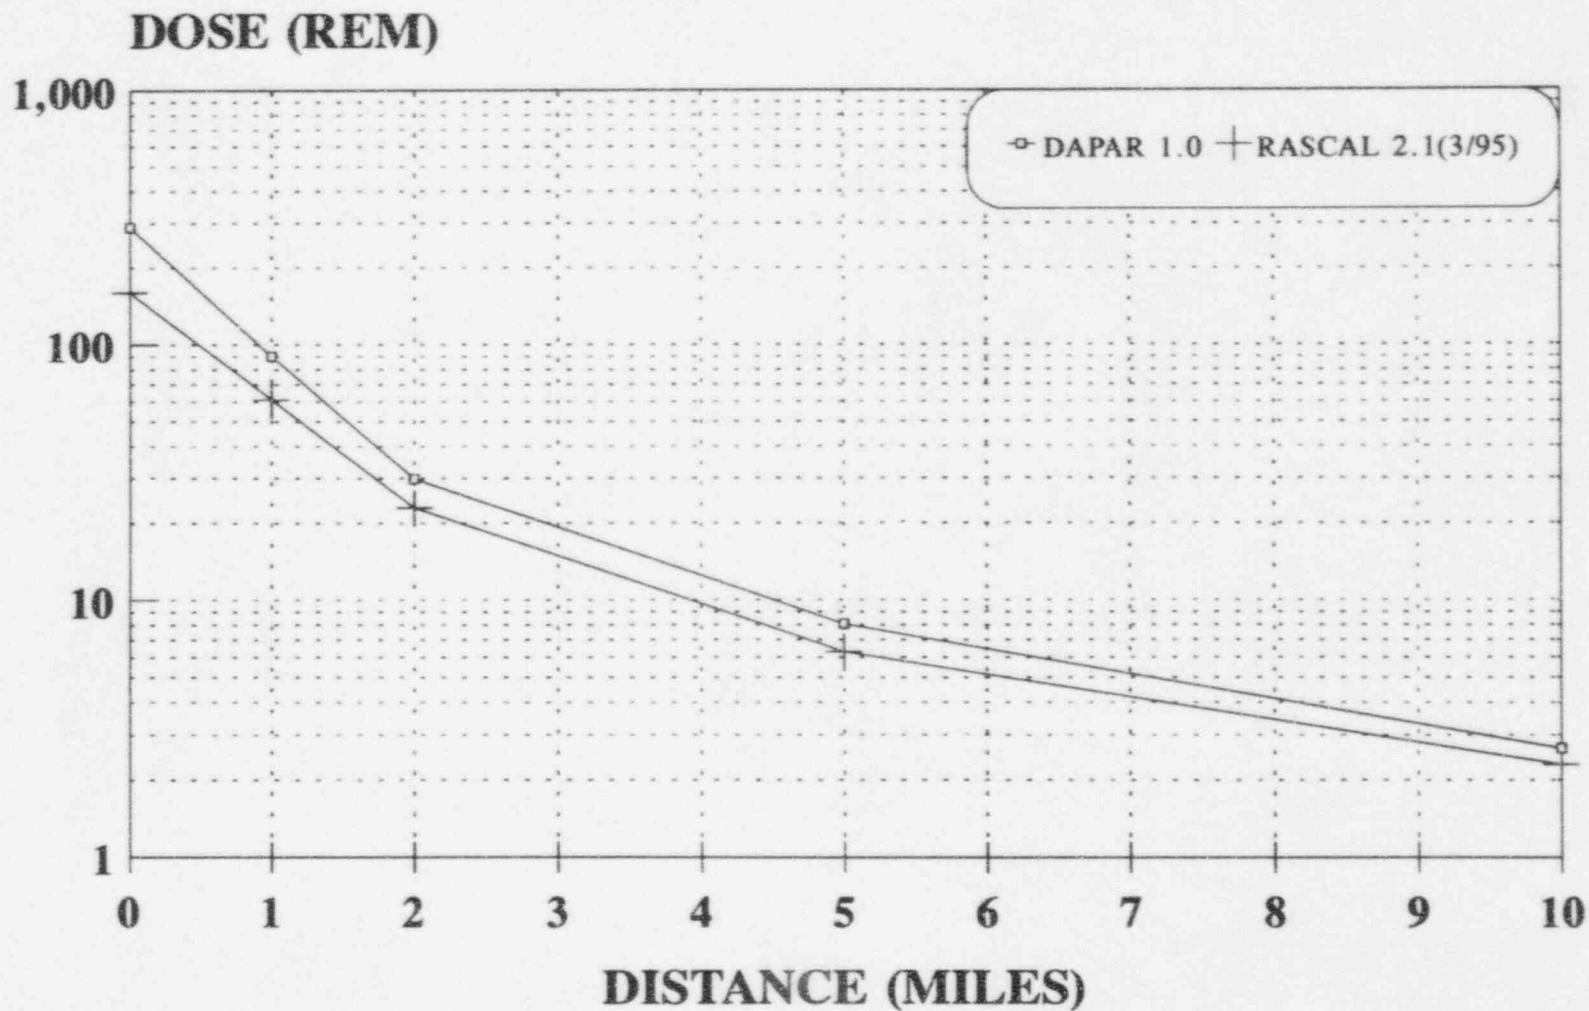
PROJECTED DOSE COMPARISON

PIL 100% Gap; Ground Level Release, Failure to Isolate

Case C: 4 miles/hr and Stability class D (TEDE)

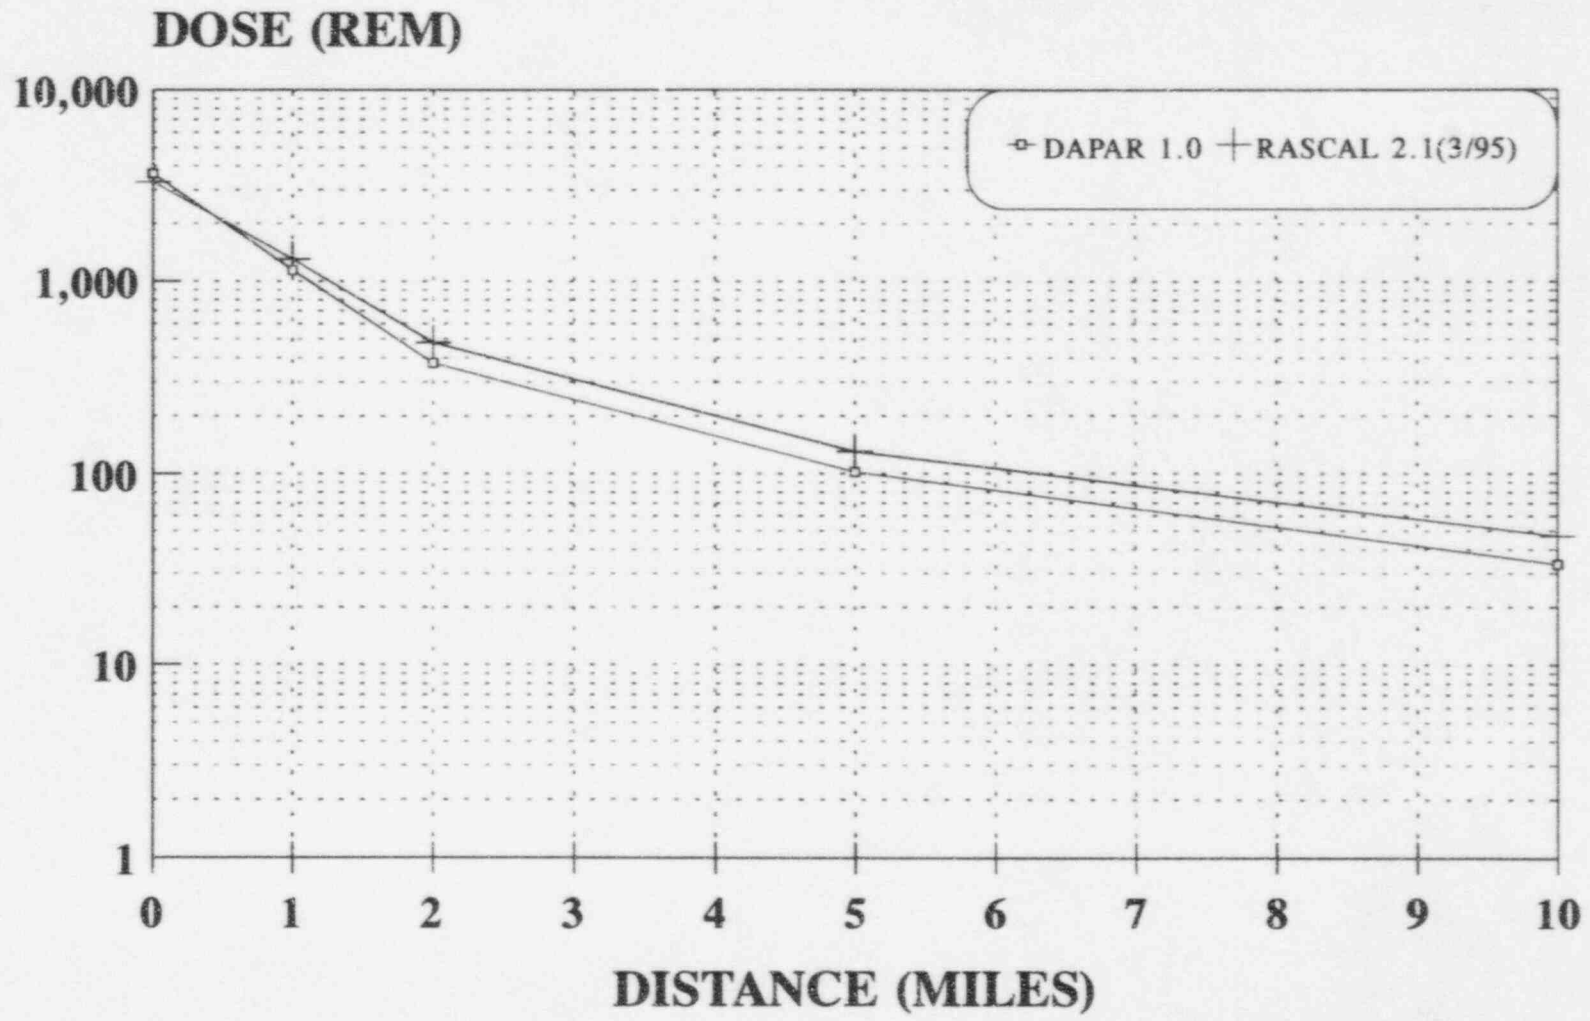
PROJECTED DOSE COMPARISON

PIL 100% Gap; Ground Level Release, Failure to Isolate

Case D: 4 miles/hr and Stability class D (Thyroid)

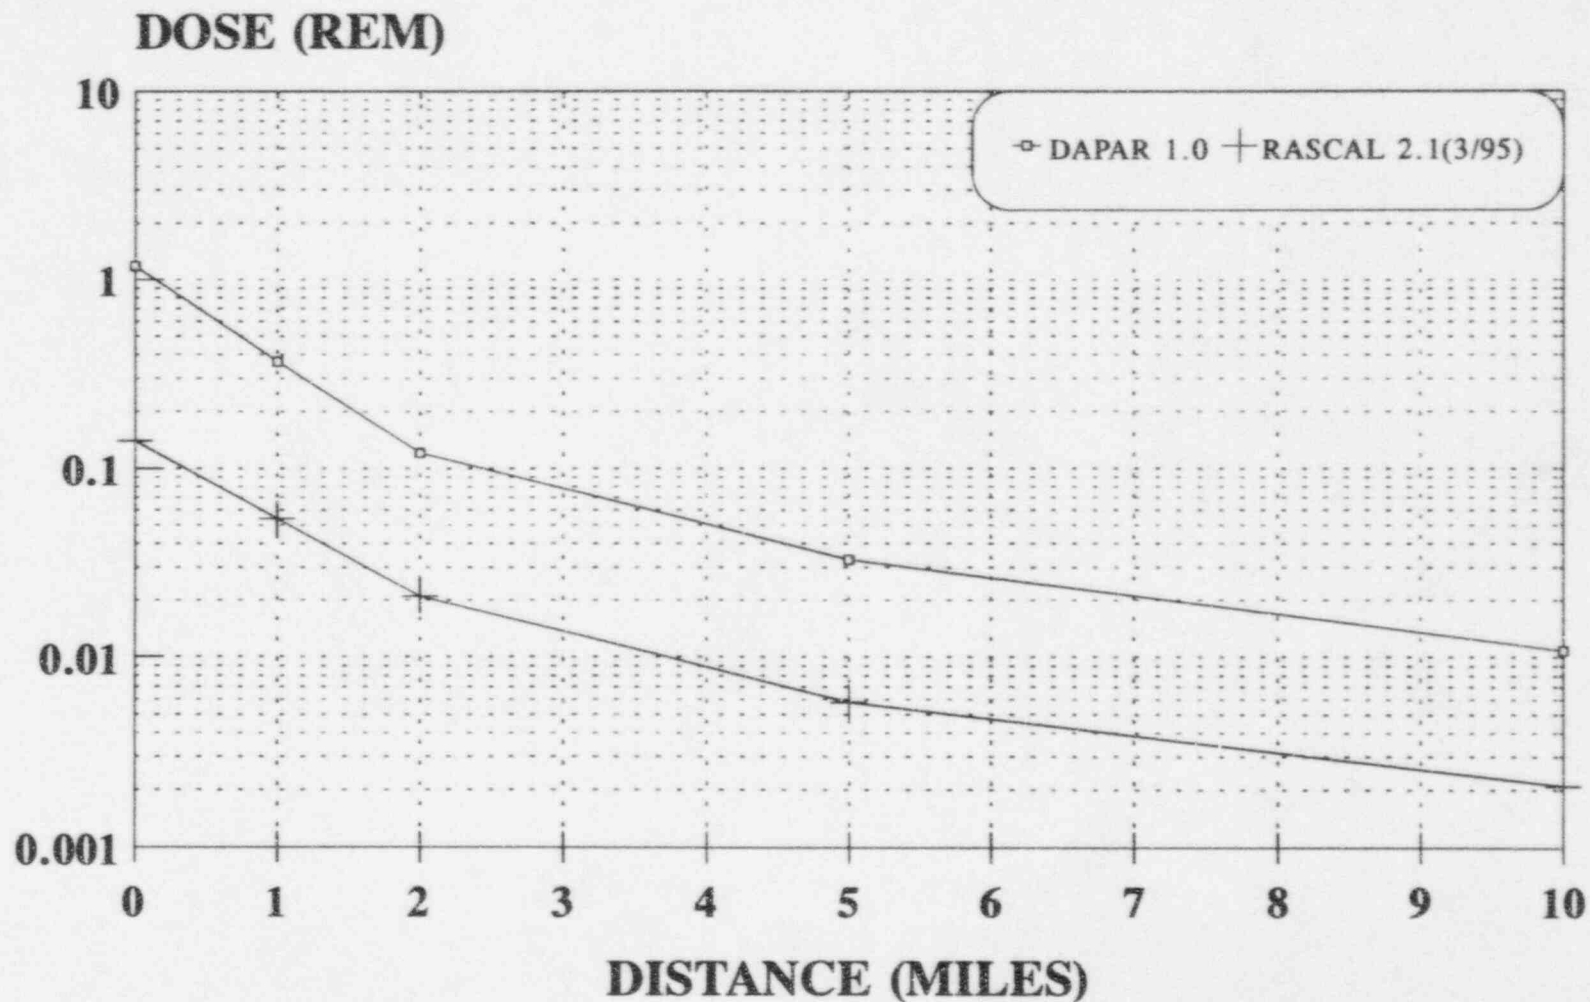
PROJECTED DOSE COMPARISON

PIL 100% Gap; Ground Release

Case E: 4 miles/hr and Stability class D (TEDE)

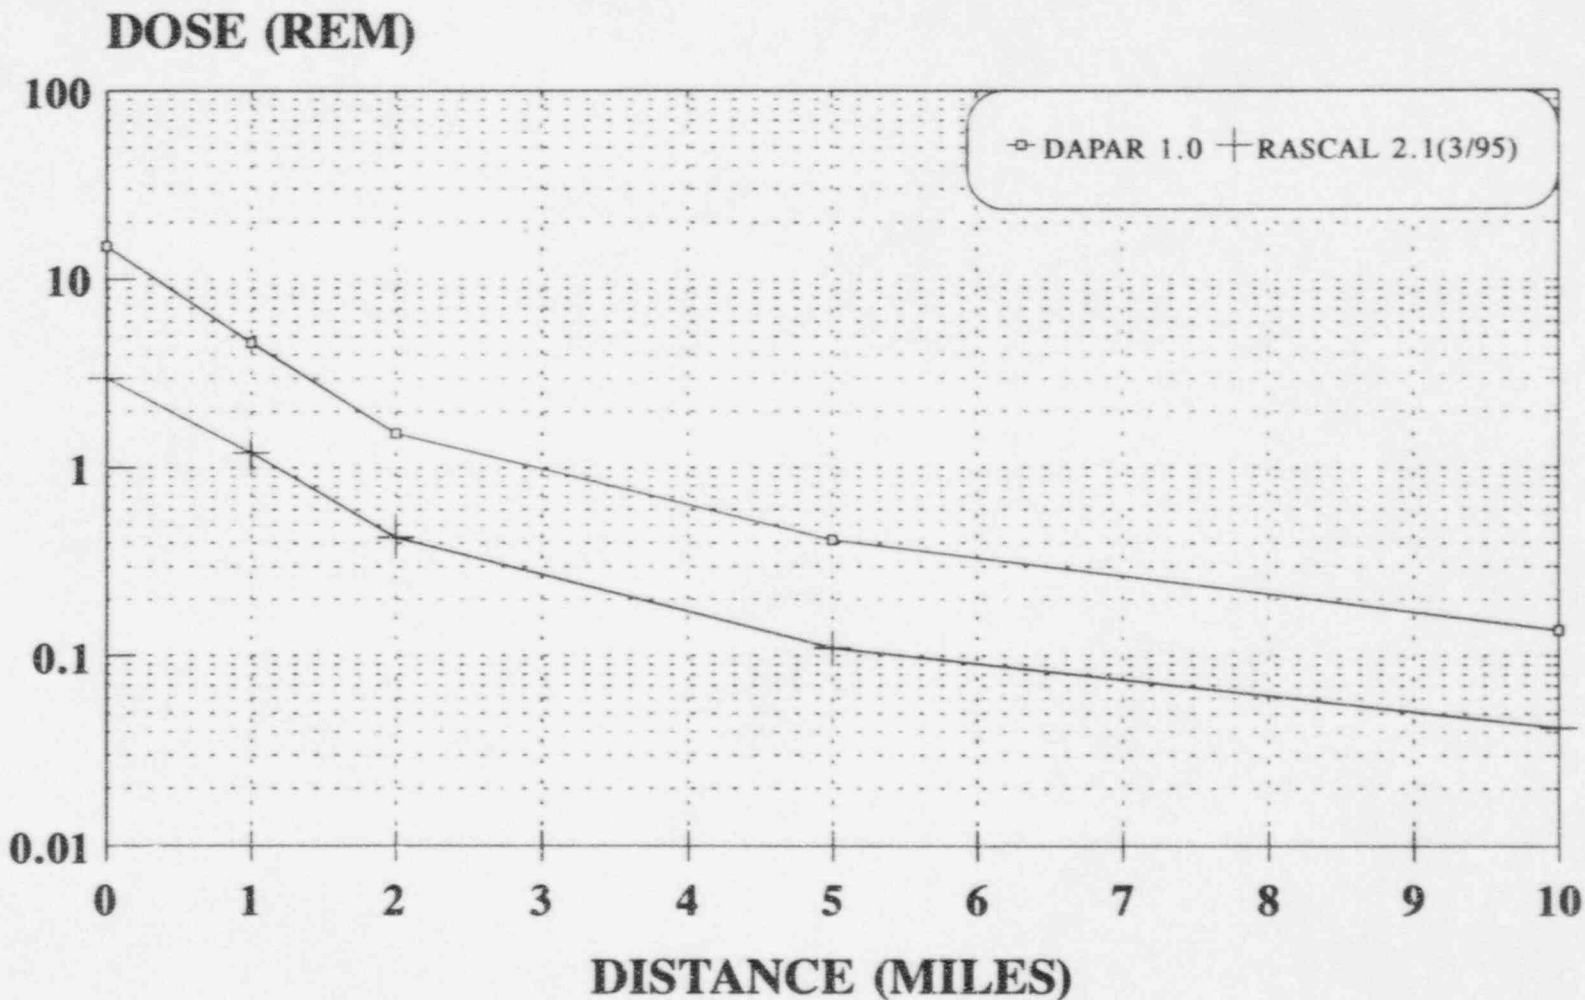
PROJECTED DOSE COMPARISON

PIL 100% Gap; Ground Release

Case F: 4 miles/hr and Stability class D (Thyroid)

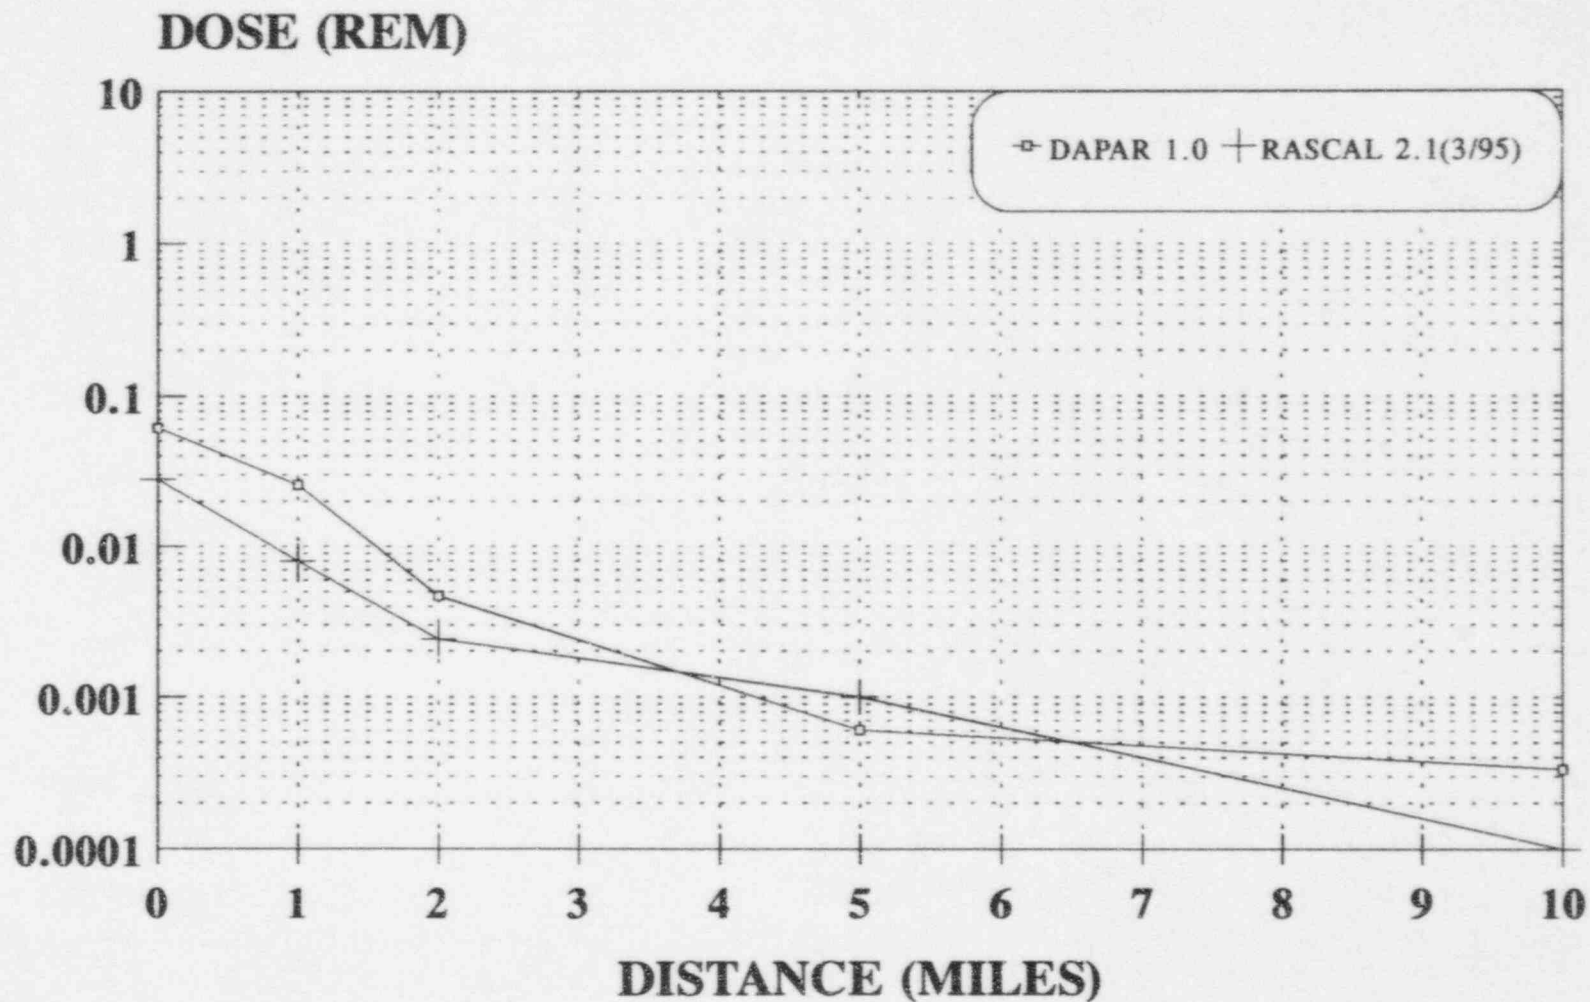
PROJECTED DOSE COMPARISON

PIL 100% Gap; Elevated Release Height

Case G: 4 miles/hr and Stability class B (TEDE)

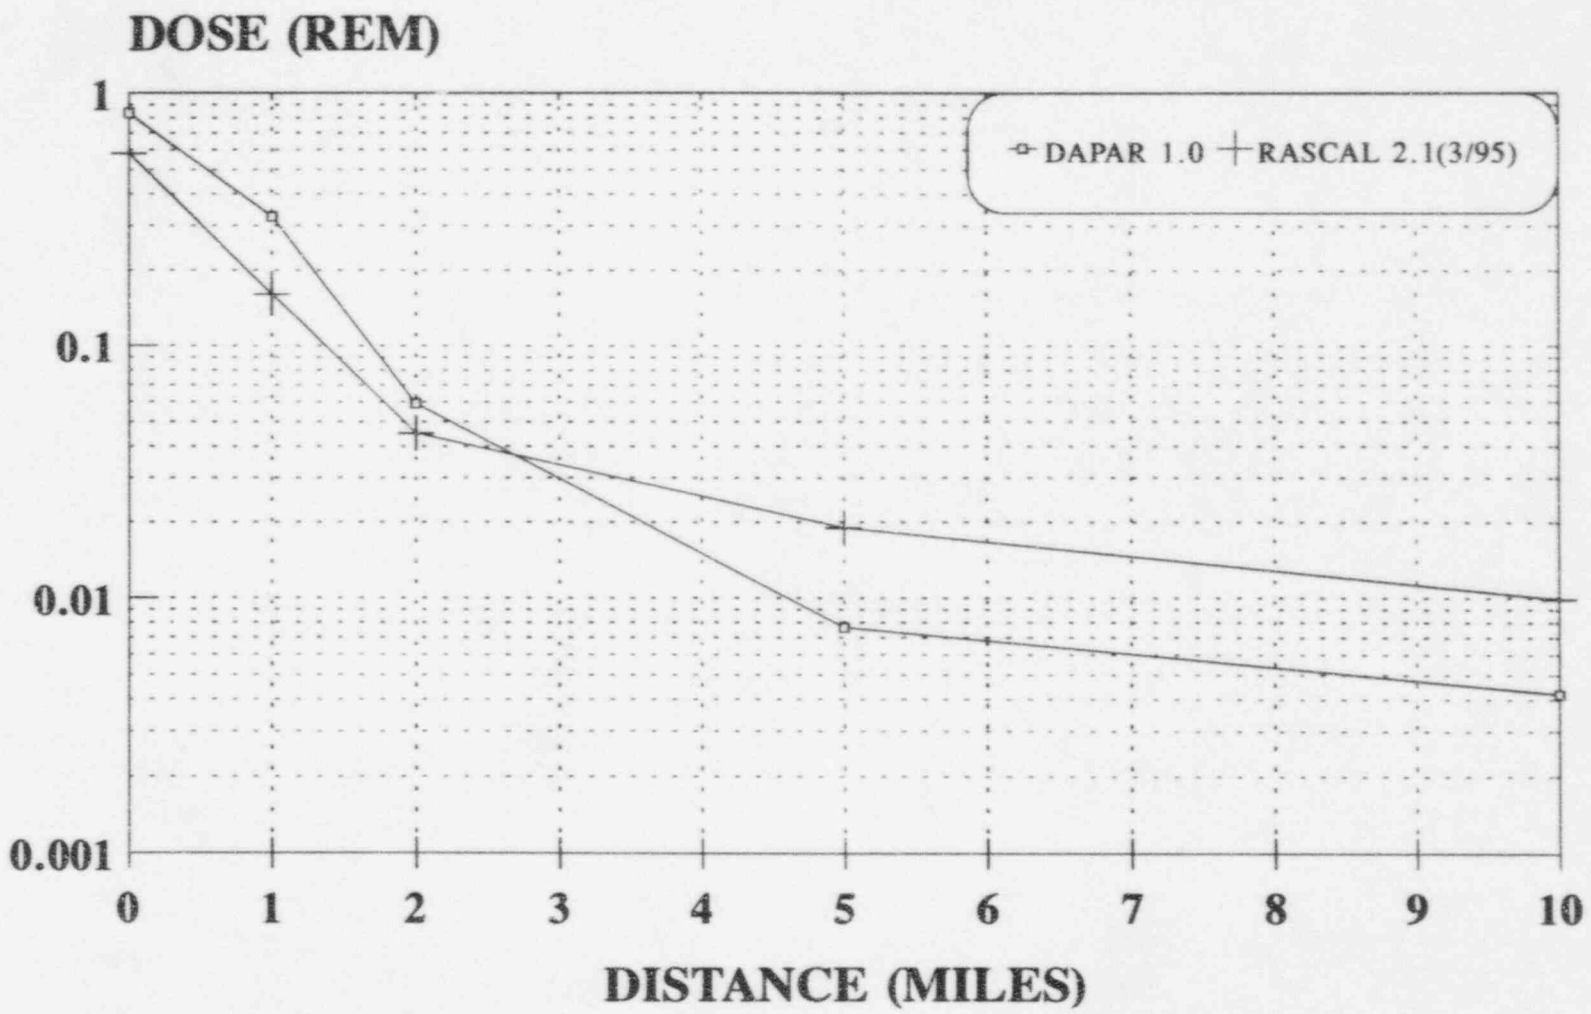
PROJECTED DOSE COMPARISON

PIL 100% Gap; Elevated Release Height

Case H: 4 miles/hr and Stability class B (Thyroid)

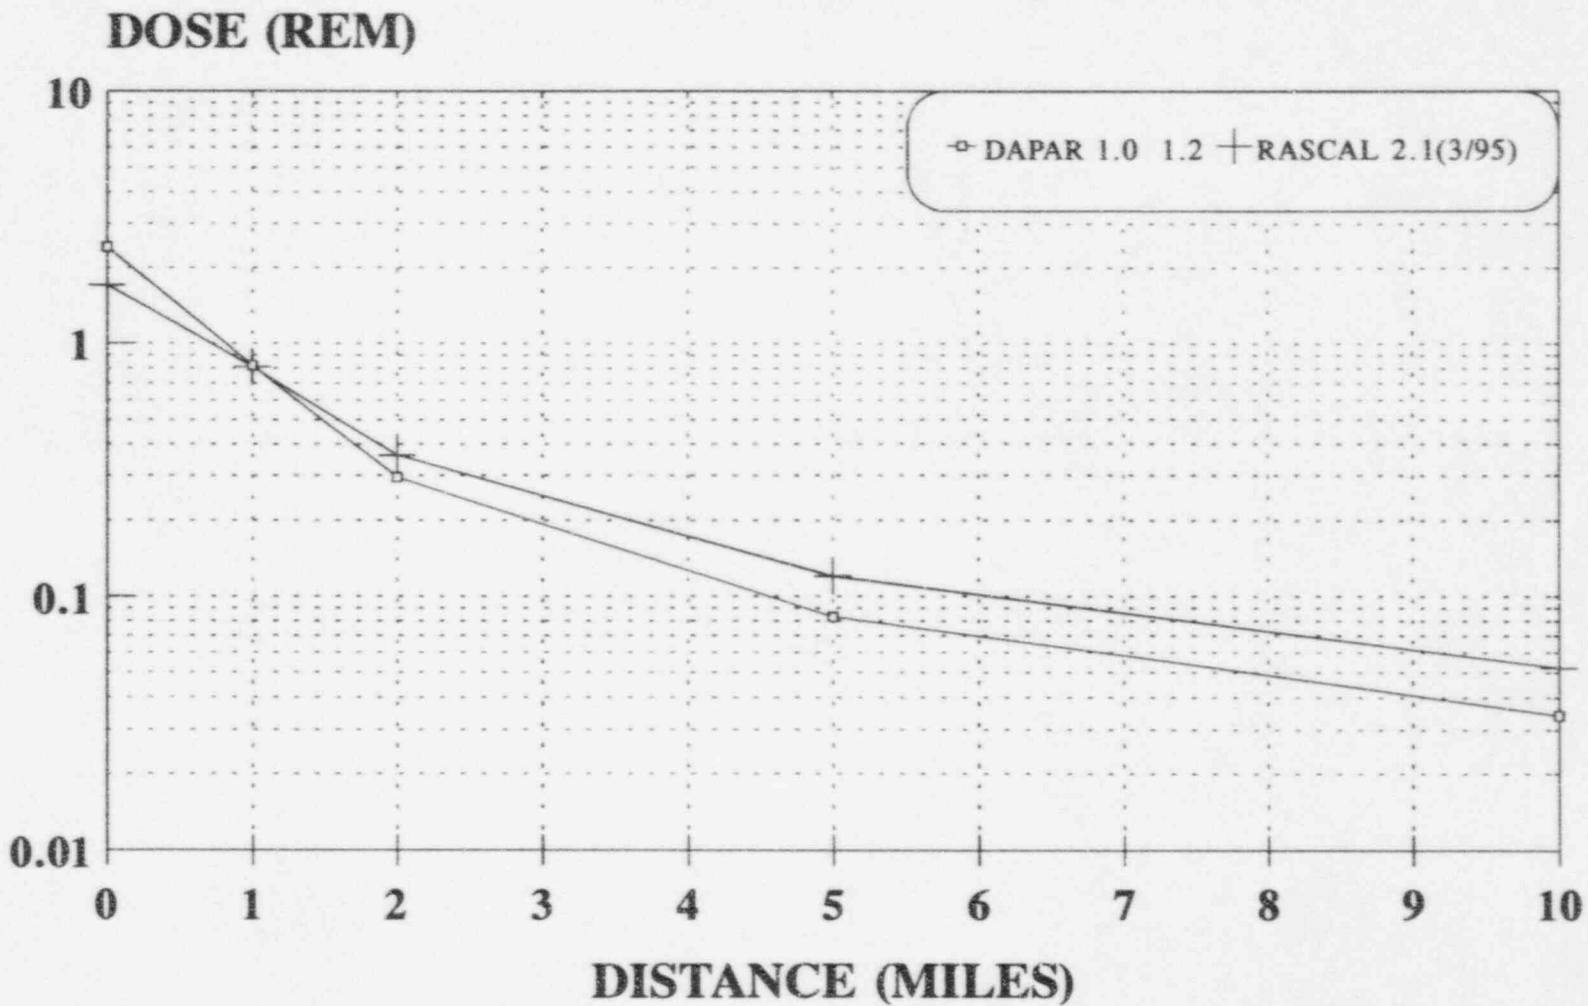
PROJECTED DOSE COMPARISON

PIL 100% Gap; Ground Level Release

Case I: 10 miles/hr and Stability class F (TEDE)

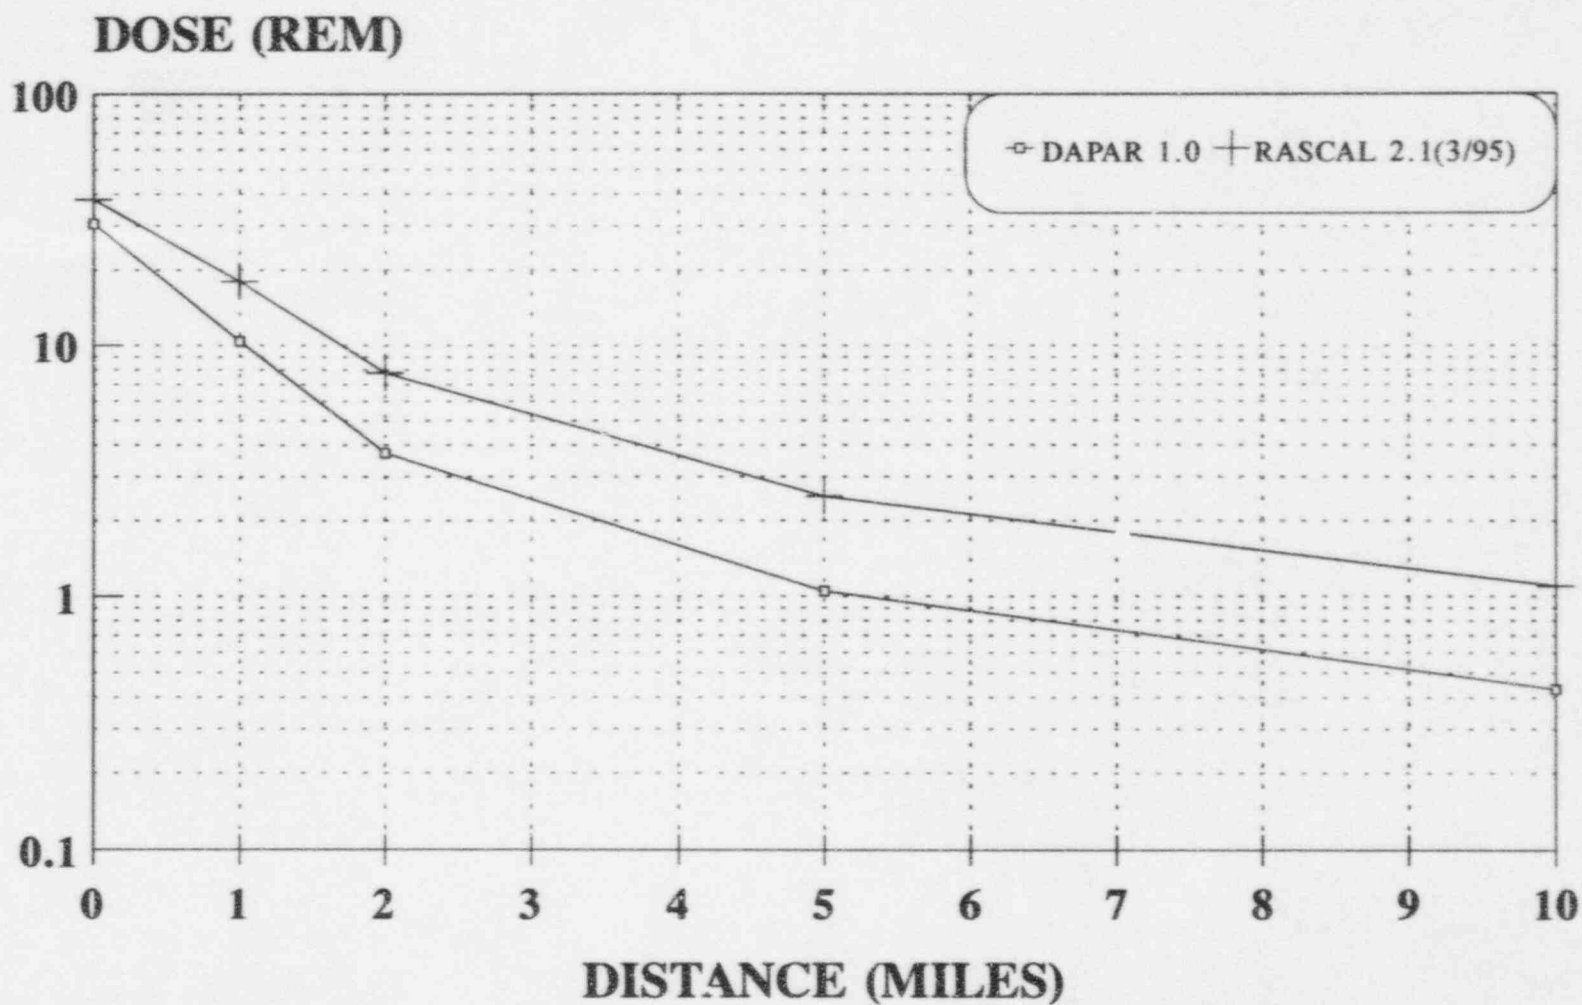
PROJECTED DOSE COMPARISON

PIL 100% Gap; Ground Level Release

Case J: 10 miles/hr and Stability class F (Thyroid)

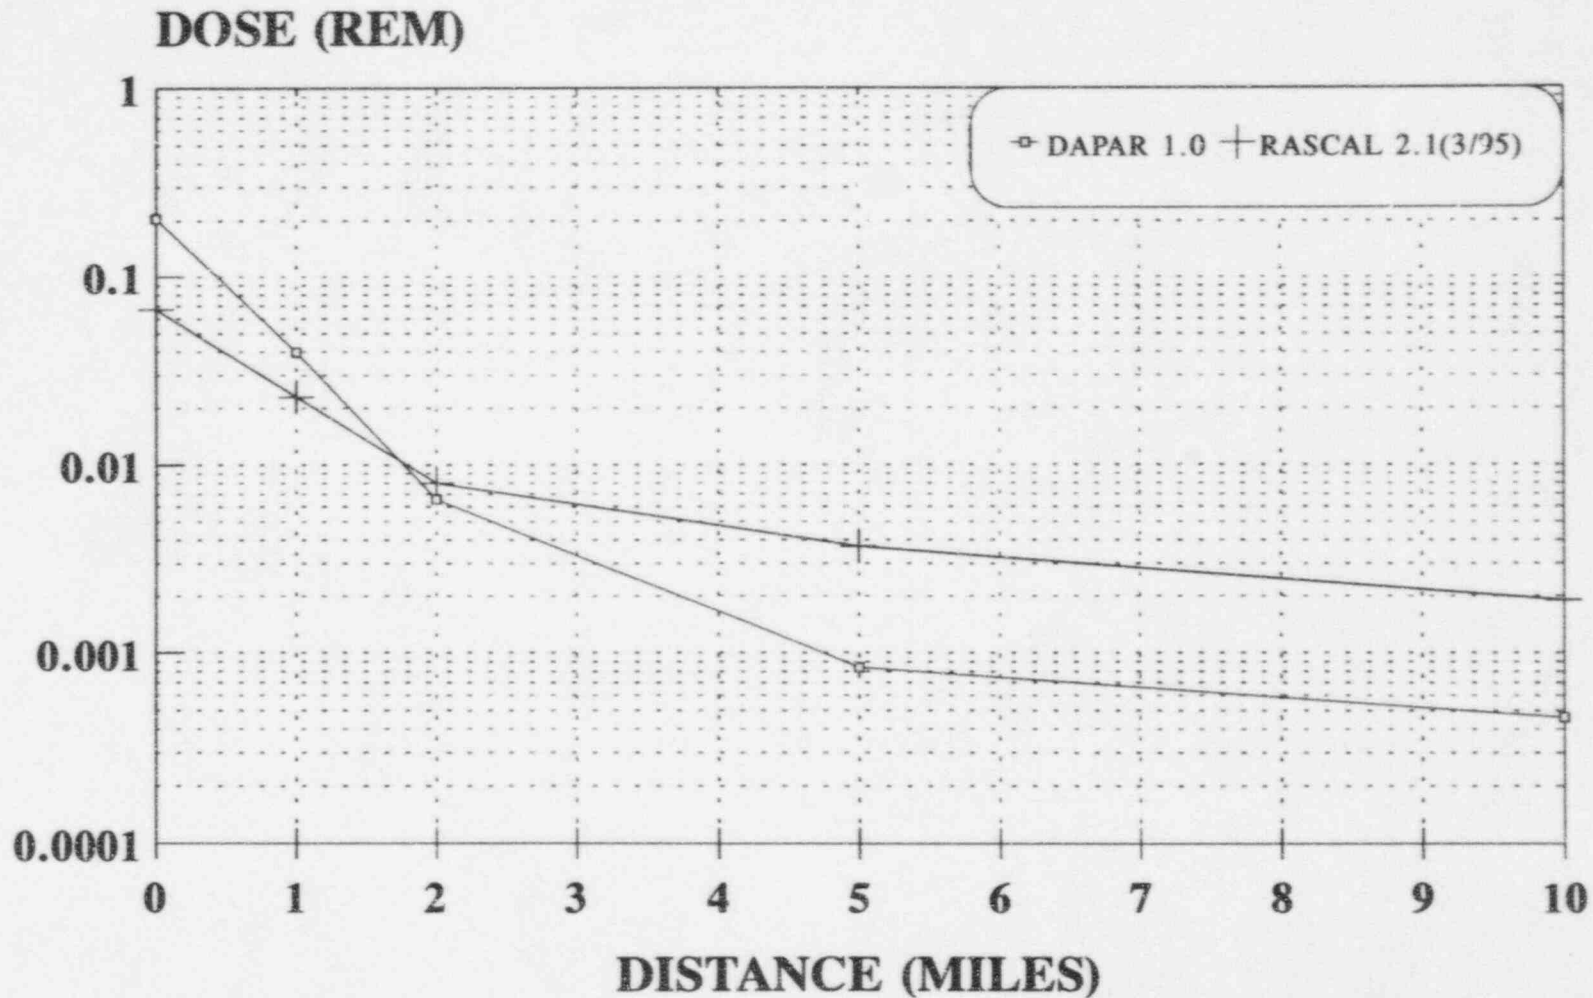
PROJECTED DOSE COMPARISON

PIL Kr-88 Isotopic; Ground Level Release

Case K: 10 miles/hr and Stability class B (TEDE)

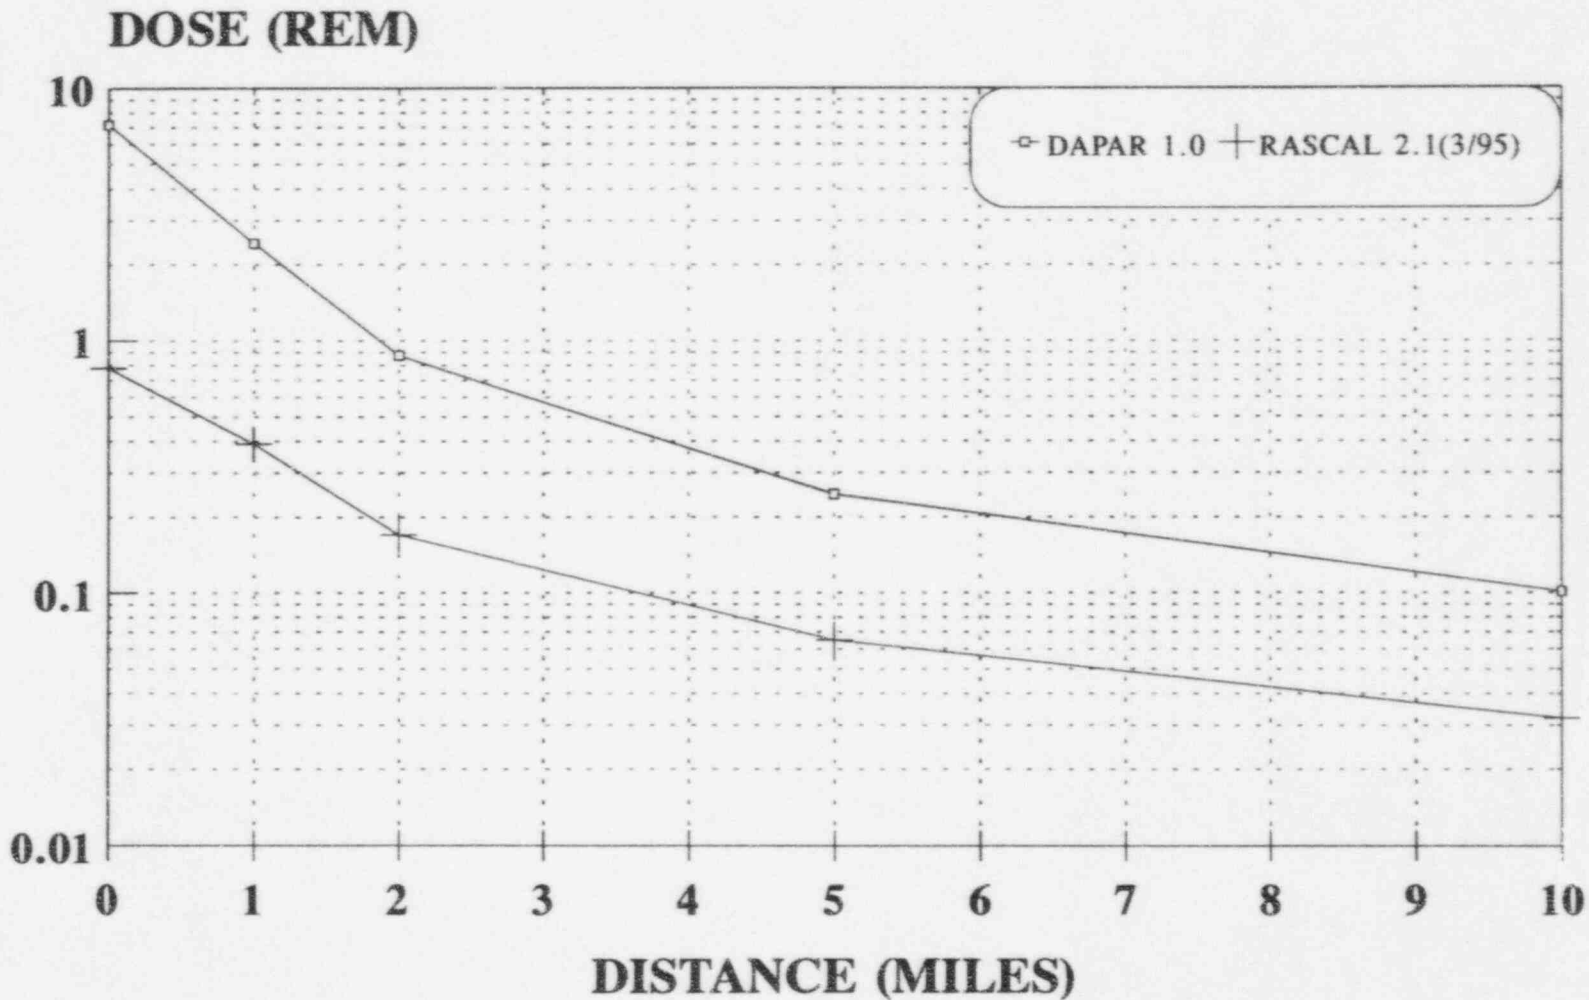
PROJECTED DOSE COMPARISON

PIL Kr-88 Isotopic; Ground Level Release

Case L: 10 miles/hr and Stability class F (TEDE)

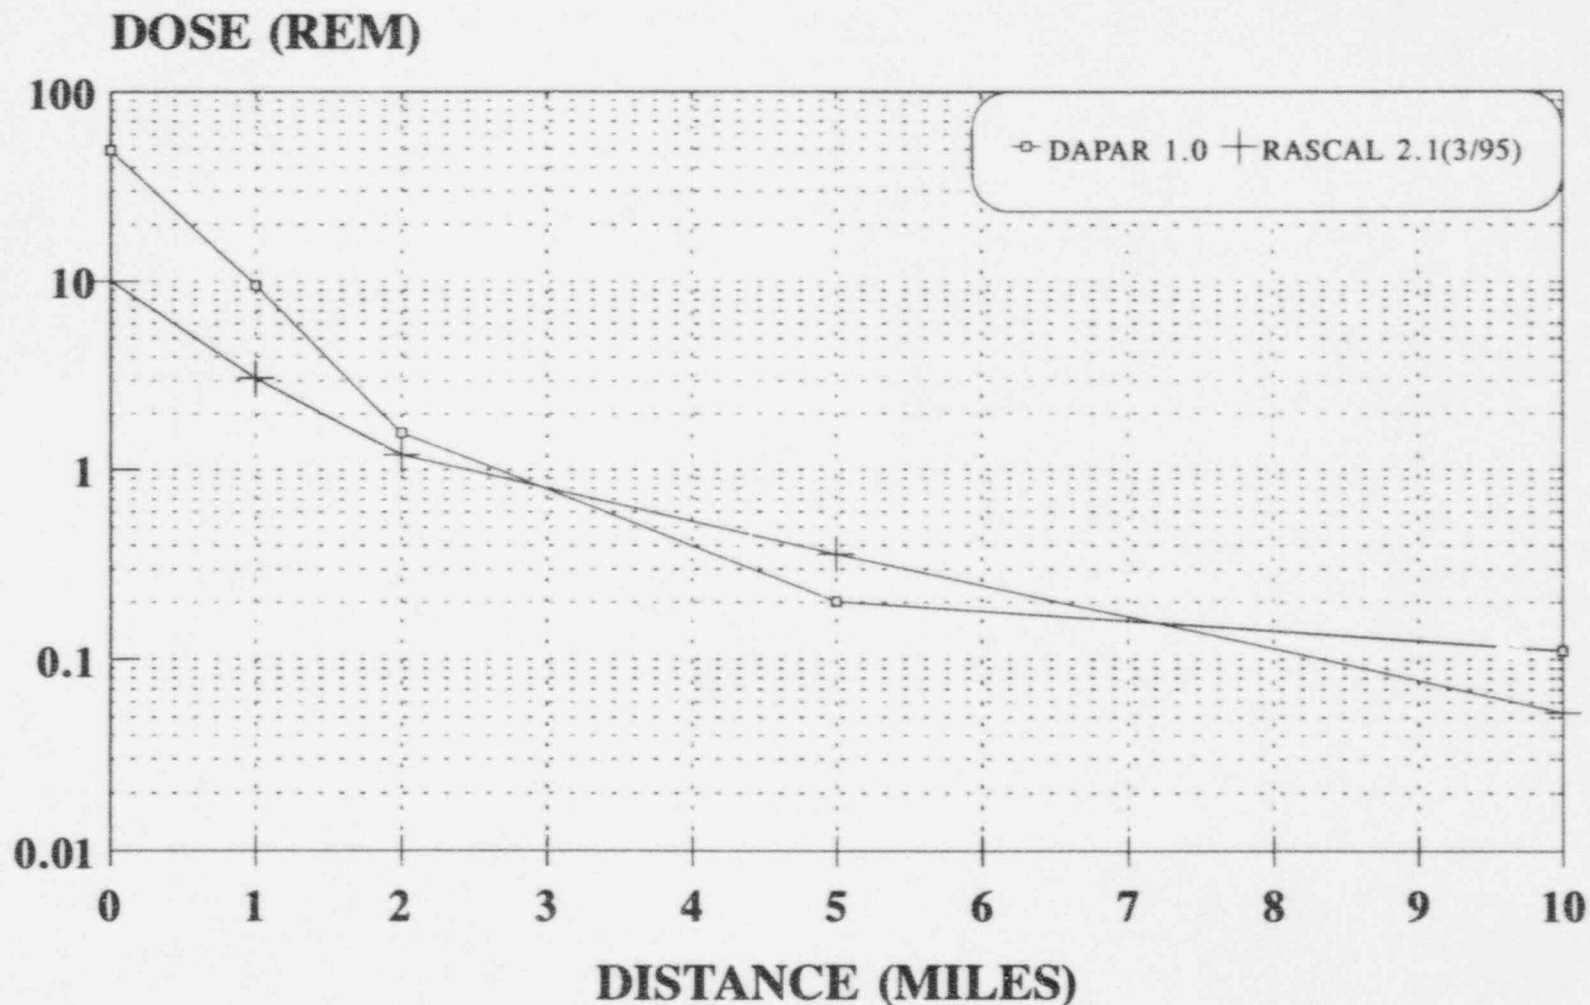
PROJECTED DOSE COMPARISONS

PIL Xe-133 Isotopic; Ground Level Release

Case M: 10 miles/hr and Stability class B (TEDE)

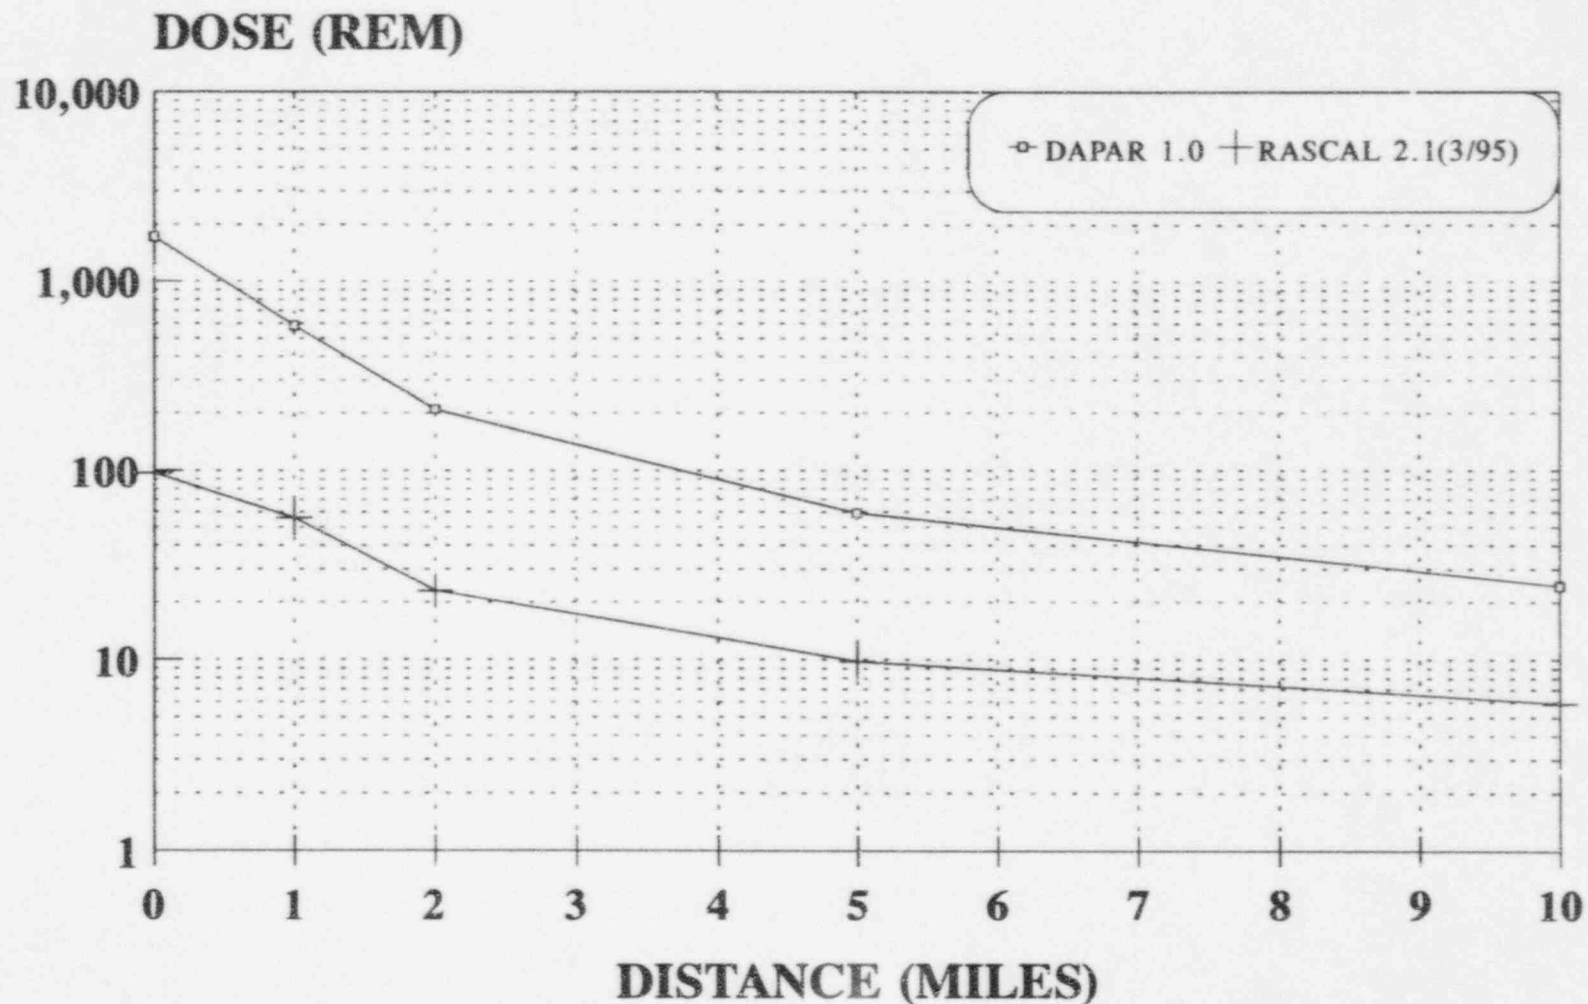
PROJECTED DOSE COMPARISON

PIL Xe-133 Isotopic; Ground Level Release

Case N: 10 miles/hr and Stability class F (TEDE)
