UNITED STATES OF AMERICA  
NUCLEAR REGULATORY COMMISSION

BEFORE THE ATOMIC SAFETY & LICENSING BOARD

-----x  
 :  
 In the matter of: :  
 :  
 COMMONWEALTH EDISON COMPANY : Docket Nos. 50-454  
 : 50-455  
 (Byron Nuclear Power Station, :  
 Units 1 and 2) :  
 :  
 -----x

Deposition of RAY S. LOVE, called for examination  
by counsel for Applicant, beginning at 9:50 a.m., pursuant  
to agreement, before Ann Riley, a Notary Public in and for  
the State of Maryland.

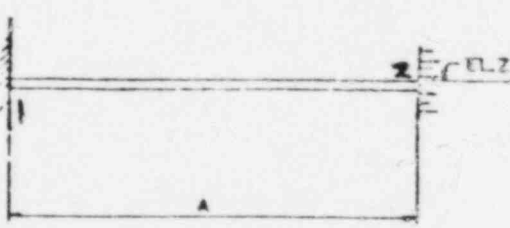
Hanger Configuration			Hanger Data					
Standard <u>0-3260</u> Type <u>8HV</u>			HO/HL Drawing <u>0-3097 H01</u> Rev. <u>B</u>

<p>DETAIL 8HV</p>			CONNECTION		DIMENSION			
			ID	SPECIFIED	ACTUAL	ID	SPECIFIED	ACTUAL
			1	DV67	✓	A	18 1/4	✓
			2	DV67	✓	B		
			3			C		
			4			D		
			5			E	7	6
			6			F	12	12 1/2
			7			G	8	7 1/2
			8			H	12	12 1/2
			9			I	4 1/2	4
			10			J	24	24 1/2
						INSTRUCTION
