NORTHEAST UTILITIES

October 5, 1984

Millstone Nuclear Power Station, Unit No. 3
Probabilistic Safety Study (PSS)

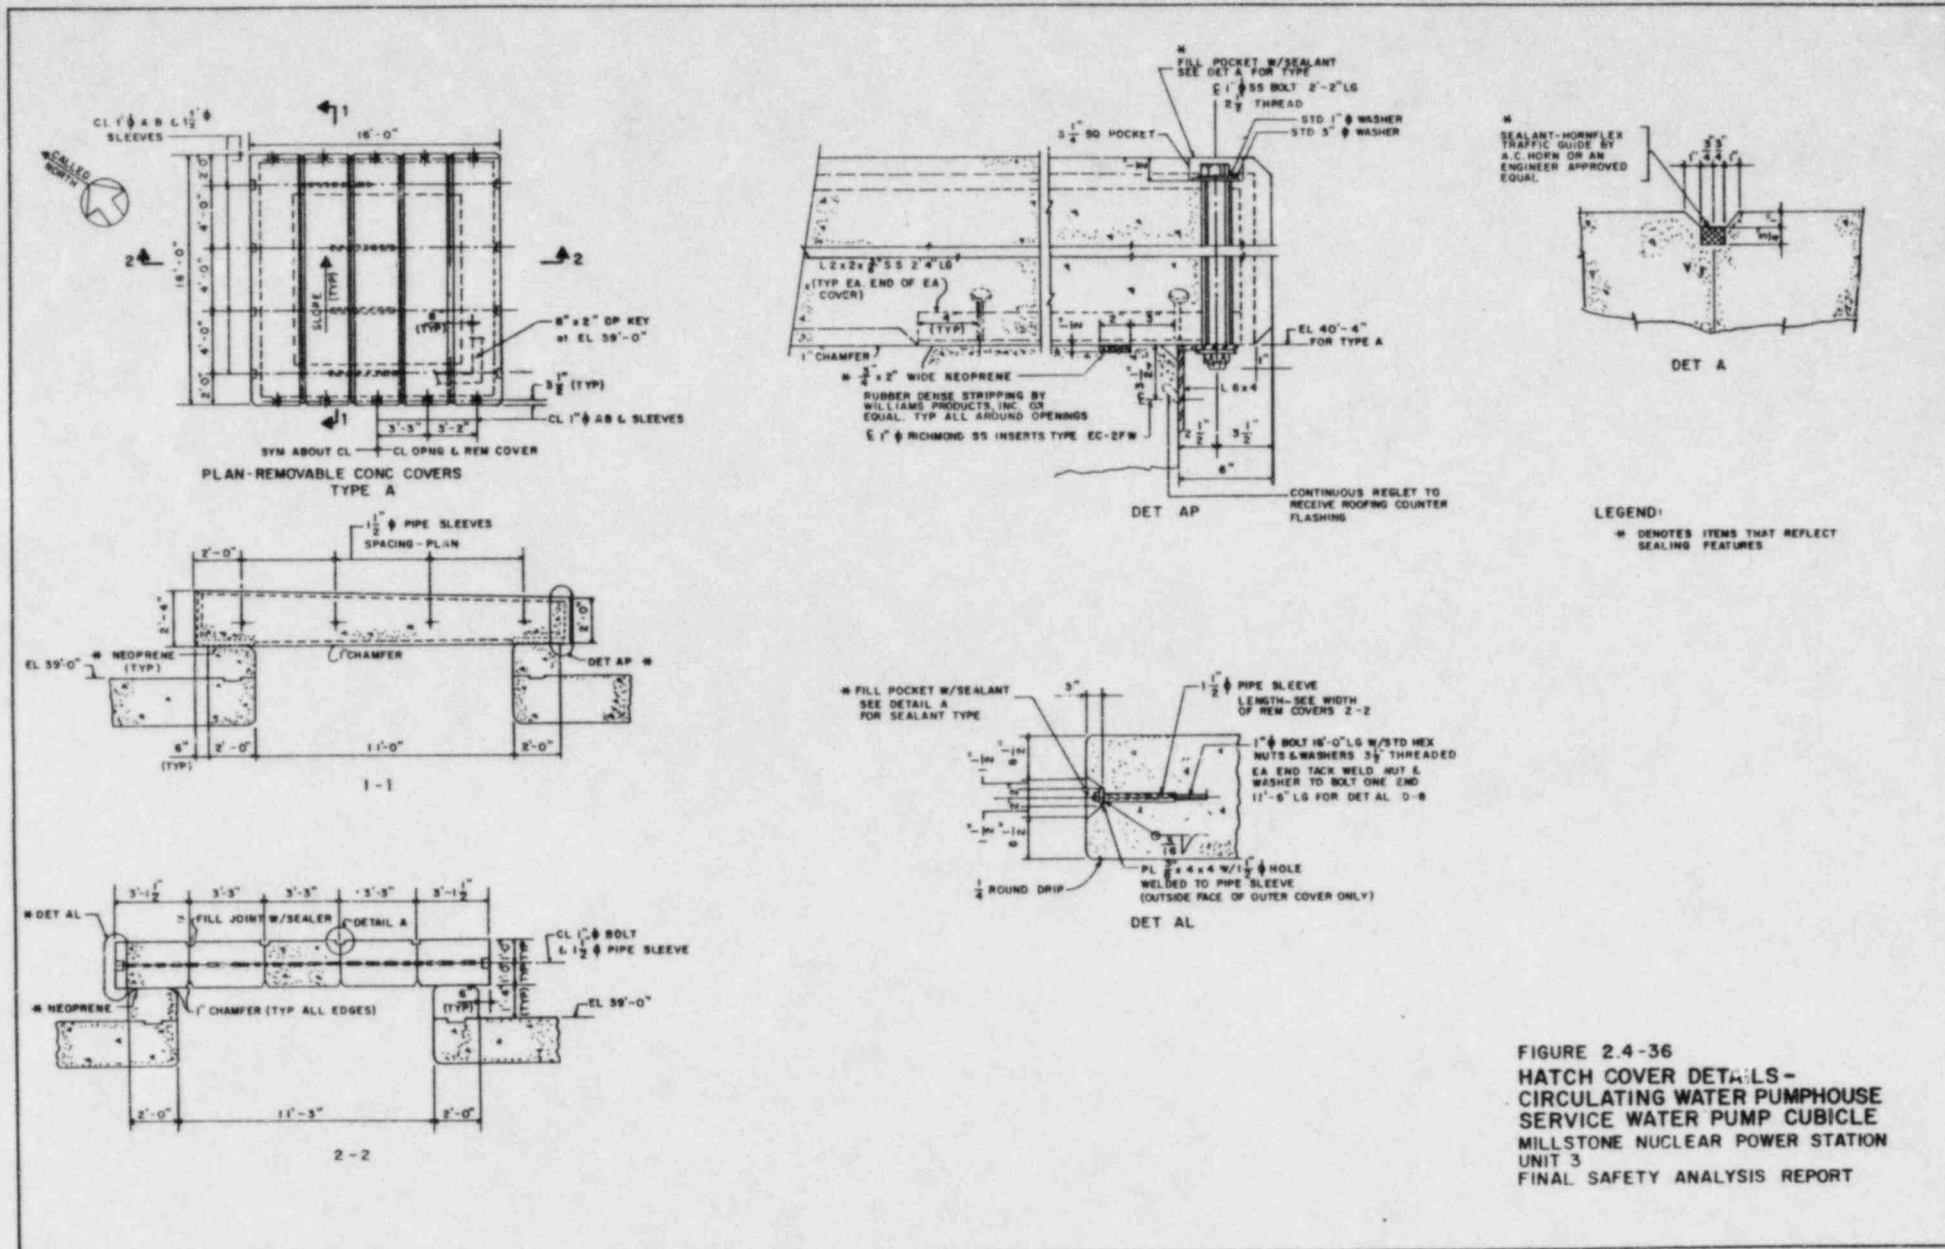
FIGURE 2.4-36
 HATCH COVER DETAILS -
 CIRCULATING WATER PUMPHOUSE
 SERVICE WATER PUMP CUBICLE
 MILLSTONE NUCLEAR POWER STATION
 UNIT 3
 FINAL SAFETY ANALYSIS REPORT

- (a) Attached is Figure 2.4-36 from the FSAR depicting the hatch covers over the service water pumps. The covers consist of pre-cast concrete sections which weigh approximately 76,800 lbs. and rest on neoprene gaskets to produce a very effective sealing mechanism.

The impact on the S.W. pumps of this 0.5 in. of water against the hatch cover for the five minute duration was evaluated as follows. As shown in Figure 2.4-36 the neoprene seals consists of continuous strips of dense neoprene, 2-in. wide by 3/4 in. thick, set in a 2 in. x 1/2 in. groove in the concrete. The probability of failure for this neoprene seal arrangement was assessed to be negligible, and any localized failure would not result in an infiltration of water which would endanger the service water pump cubicles. A postulated condition of no neoprene seal was considered to ascertain the impact on in-leakage. Due to the low head, 0.5 inches, and the resistance to flow that would be encountered along the concrete/concrete interface, in-leakage would be minimal using these conservative assumptions. Therefore, based upon a highly conservative analysis (the evaluation using the PMP event) the probability of in-leakage through the hatch seals is extremely small and need not be considered.

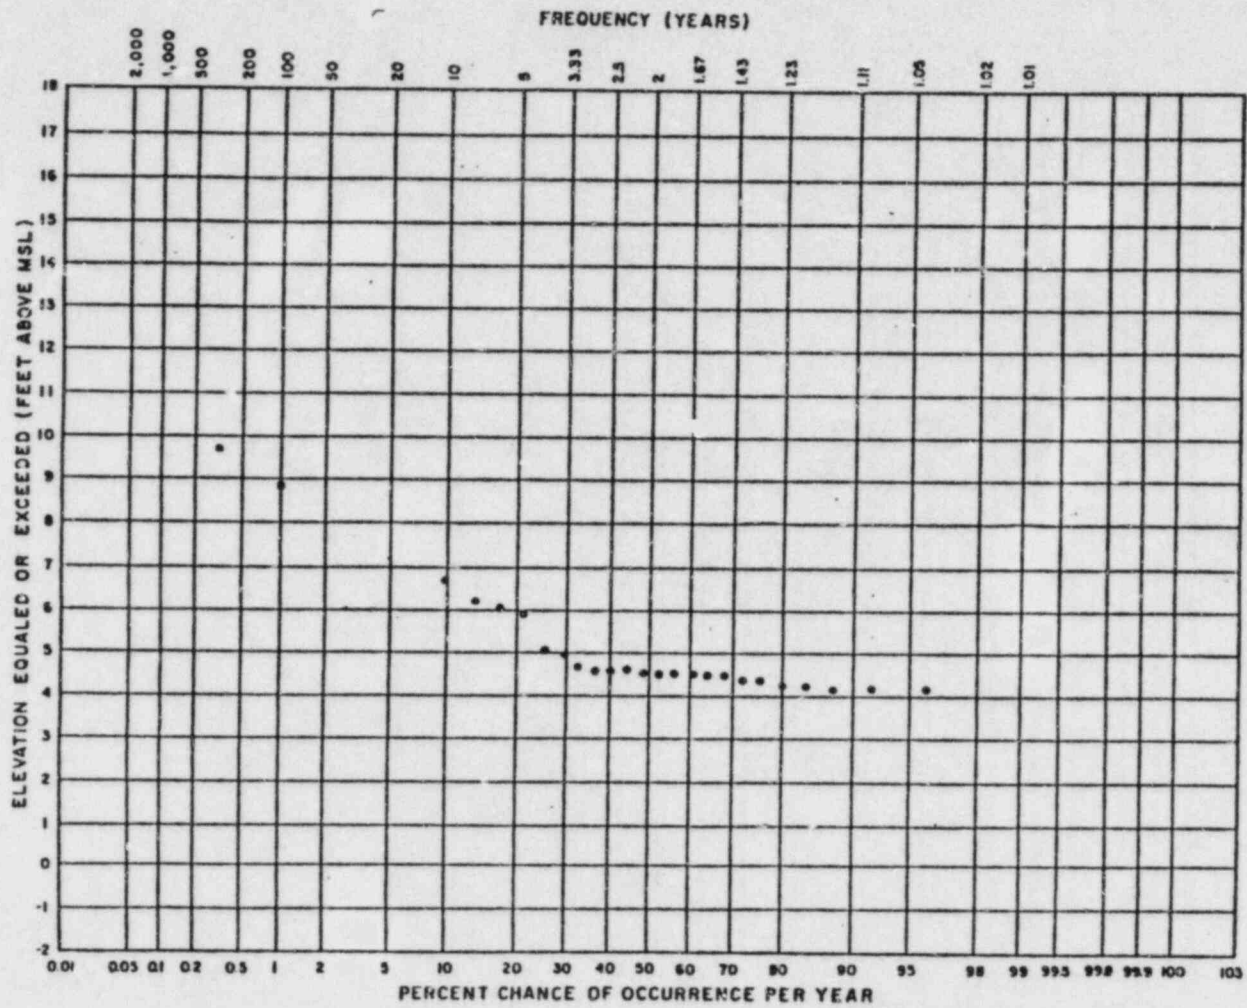
FIGURE 2.4-6
 FREQUENCY OF TIDAL FLOODING
 AT NEW LONDON, CONNECTICUT
 MILLSTONE NUCLEAR POWER STATION
 UNIT 3
 FINAL SAFETY ANALYSIS REPORT

- (a) The elevation of the threshold to the water-tight doors is 14.75 feet. Attached is Figure 2.4-6 from the FSAR entitled "Frequency of Tidal Flooding at New London, Connecticut." This figure is based upon historical data in the vicinity of Millstone and includes the occurrence of the 1938 Hurricane. Extrapolation of this data indicates that the recurrence interval for tidal flooding above elevation 14.75 is greater than 2000 years. This would equate to best estimate frequency of occurrence of $5 \times 10^{-4}/\text{yr}$.
