Crystal River Unit 3

Subject: Technical Specification Change Request No. 204, Revision 0

DESCRIPTION OF STEPS REQUIRED FOR RCP MOTOR DISASSEMBLY TO PROVIDE ACCESS
FOR FLYWHEEL SURFACE EXAM AND COST ESTIMATE

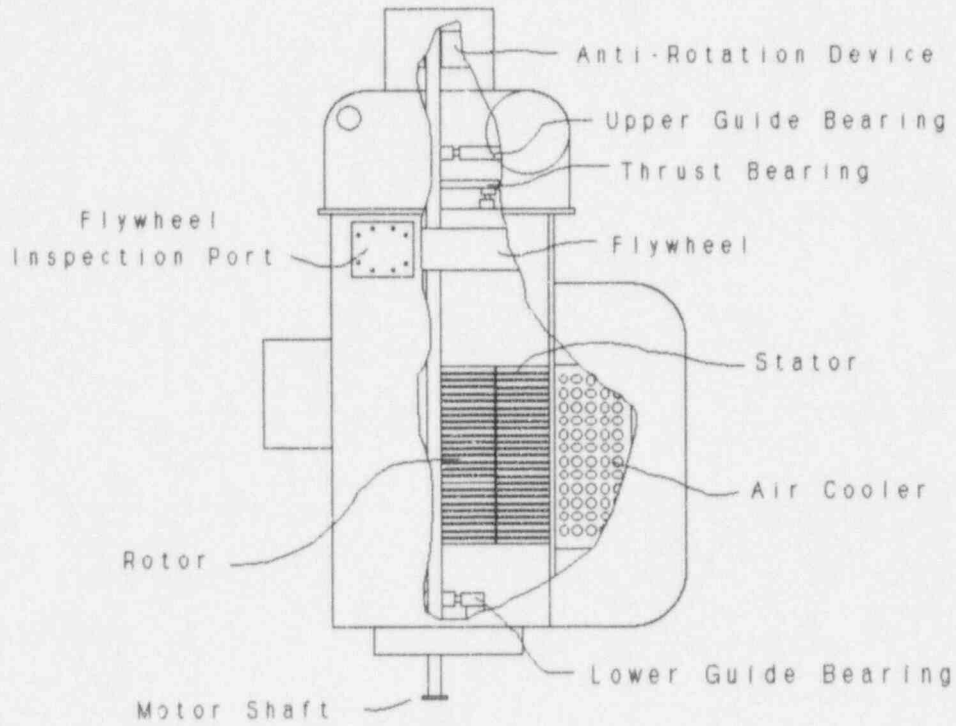
1. Decouple pump from seal in order to build a bridge at the pump to support the rotating assembly.
2. Remove constant load support, platforms, grating, and structural steel interferences.
3. Disassemble upper end of motor:
 - Oil collection system
 - Oil cooling system and associated piping
 - Anti-rotation device
 - All upper bearings (radial and thrust bearings)
 - Remove upper end shield
4. Disassemble stator cooling ductwork (RCP flywheel is under ductwork).
5. Remove rotor from stator to provide access to both sides of flywheel.
