SUBJECT: REVIEW OF SALP III DRAFT FOR MIDLAND

Midland Project

This refers to our scheduled meeting on _____, 1983, at _____ to discuss the NRC's Systematic Assessment of Licensee Performance (SALP) for the Midland Nuclear Plant, Units 1 and 2, for the period July 1, 1981 through March 31, 1983.

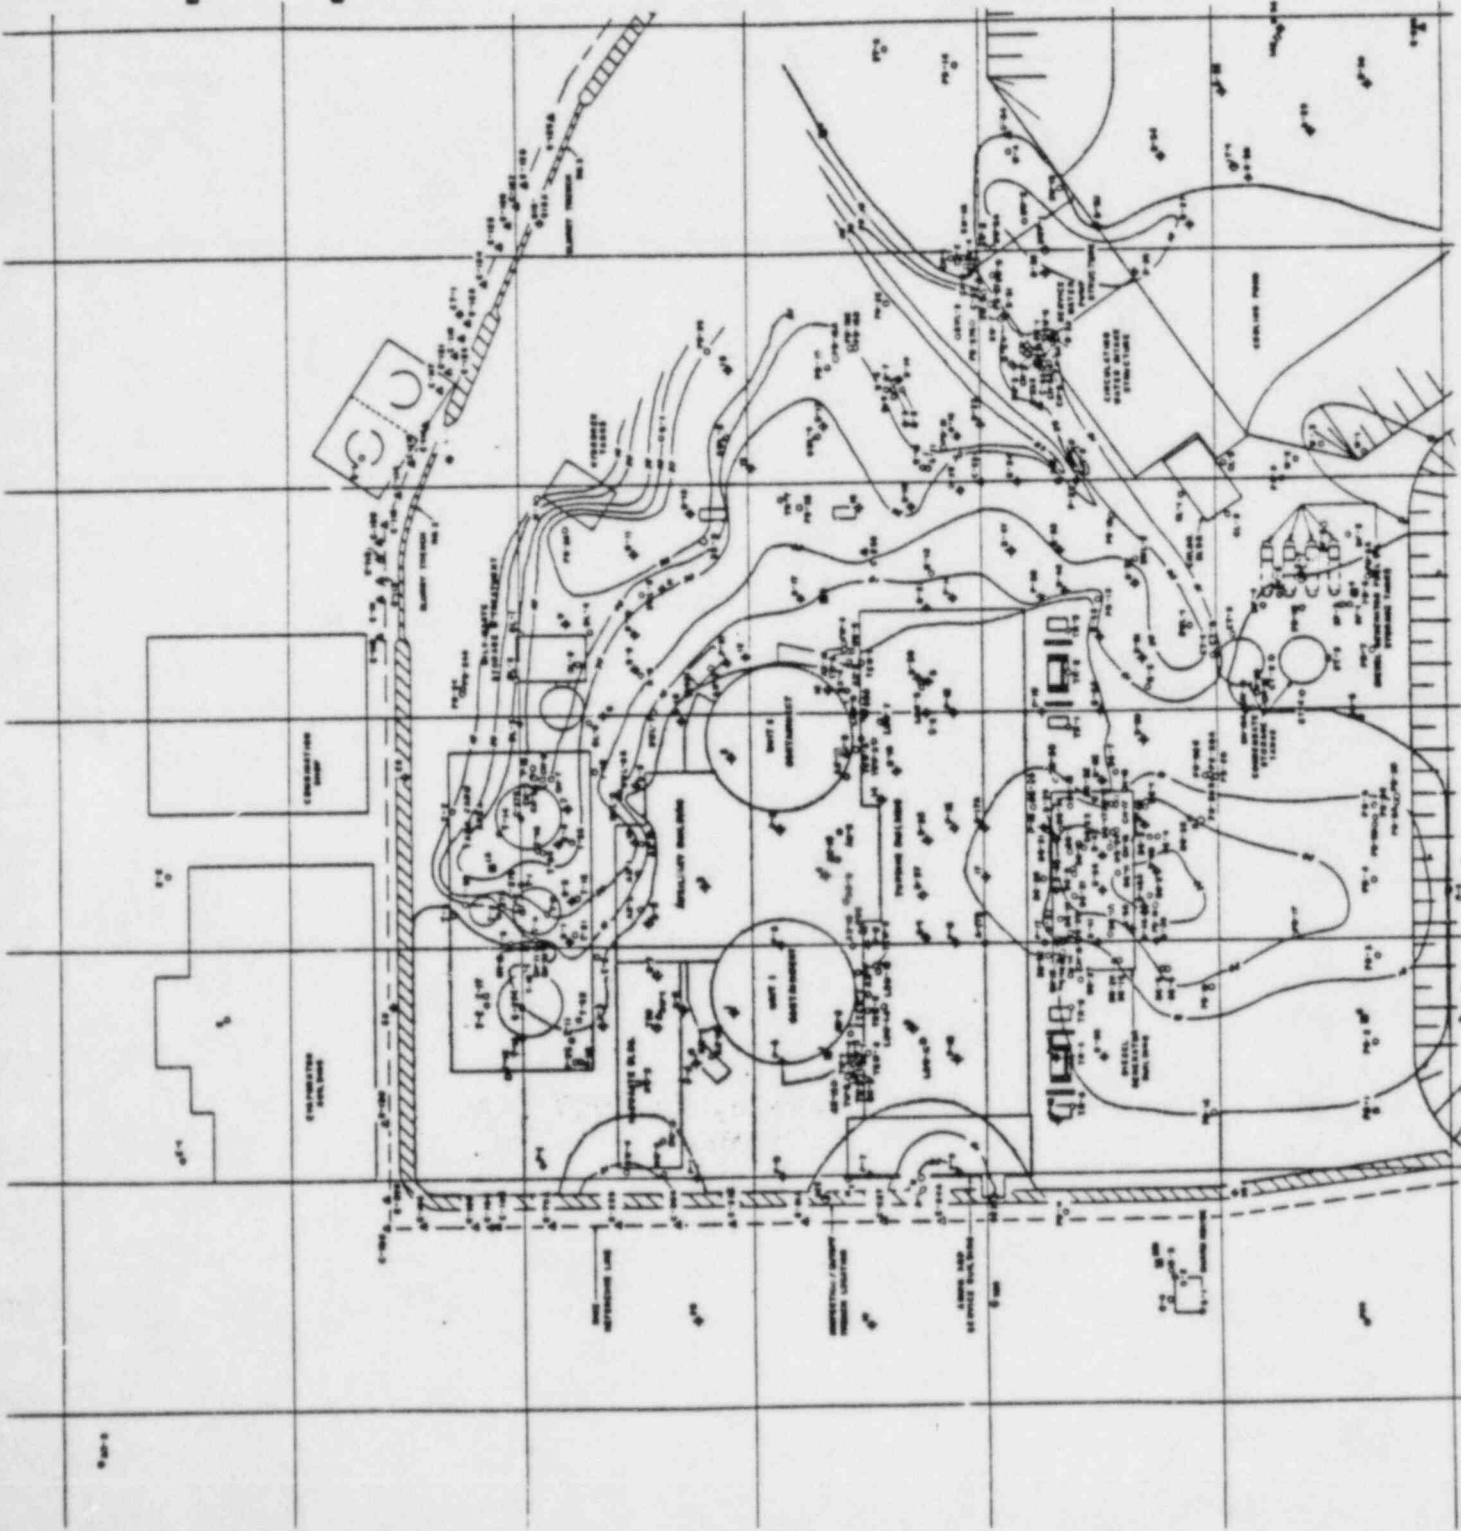
- AREAS ABSENT OF NATURAL SAND
- CONTOURS REPRESENT THICKNESS OF BACKFILL SANDS, NATURAL SANDS OR COMBINATIONS OF THE TWO WHERE IN DIRECT CONTACT WITH EACH OTHER

- 1 Distribution of backfill and natural sands based on interpretation of boring logs and construction records
- 2 Contours are controlled by the placement of backfill sands and location of building foundations

BECHTEL <small>AN IRVING COMPANY</small>	
MIDLAND POWER PLANT	
ISOPACH MAP OF BACKFILL AND NATURAL SANDS	
DRAWING NO. 7220	FIGURE 15
REV.	A

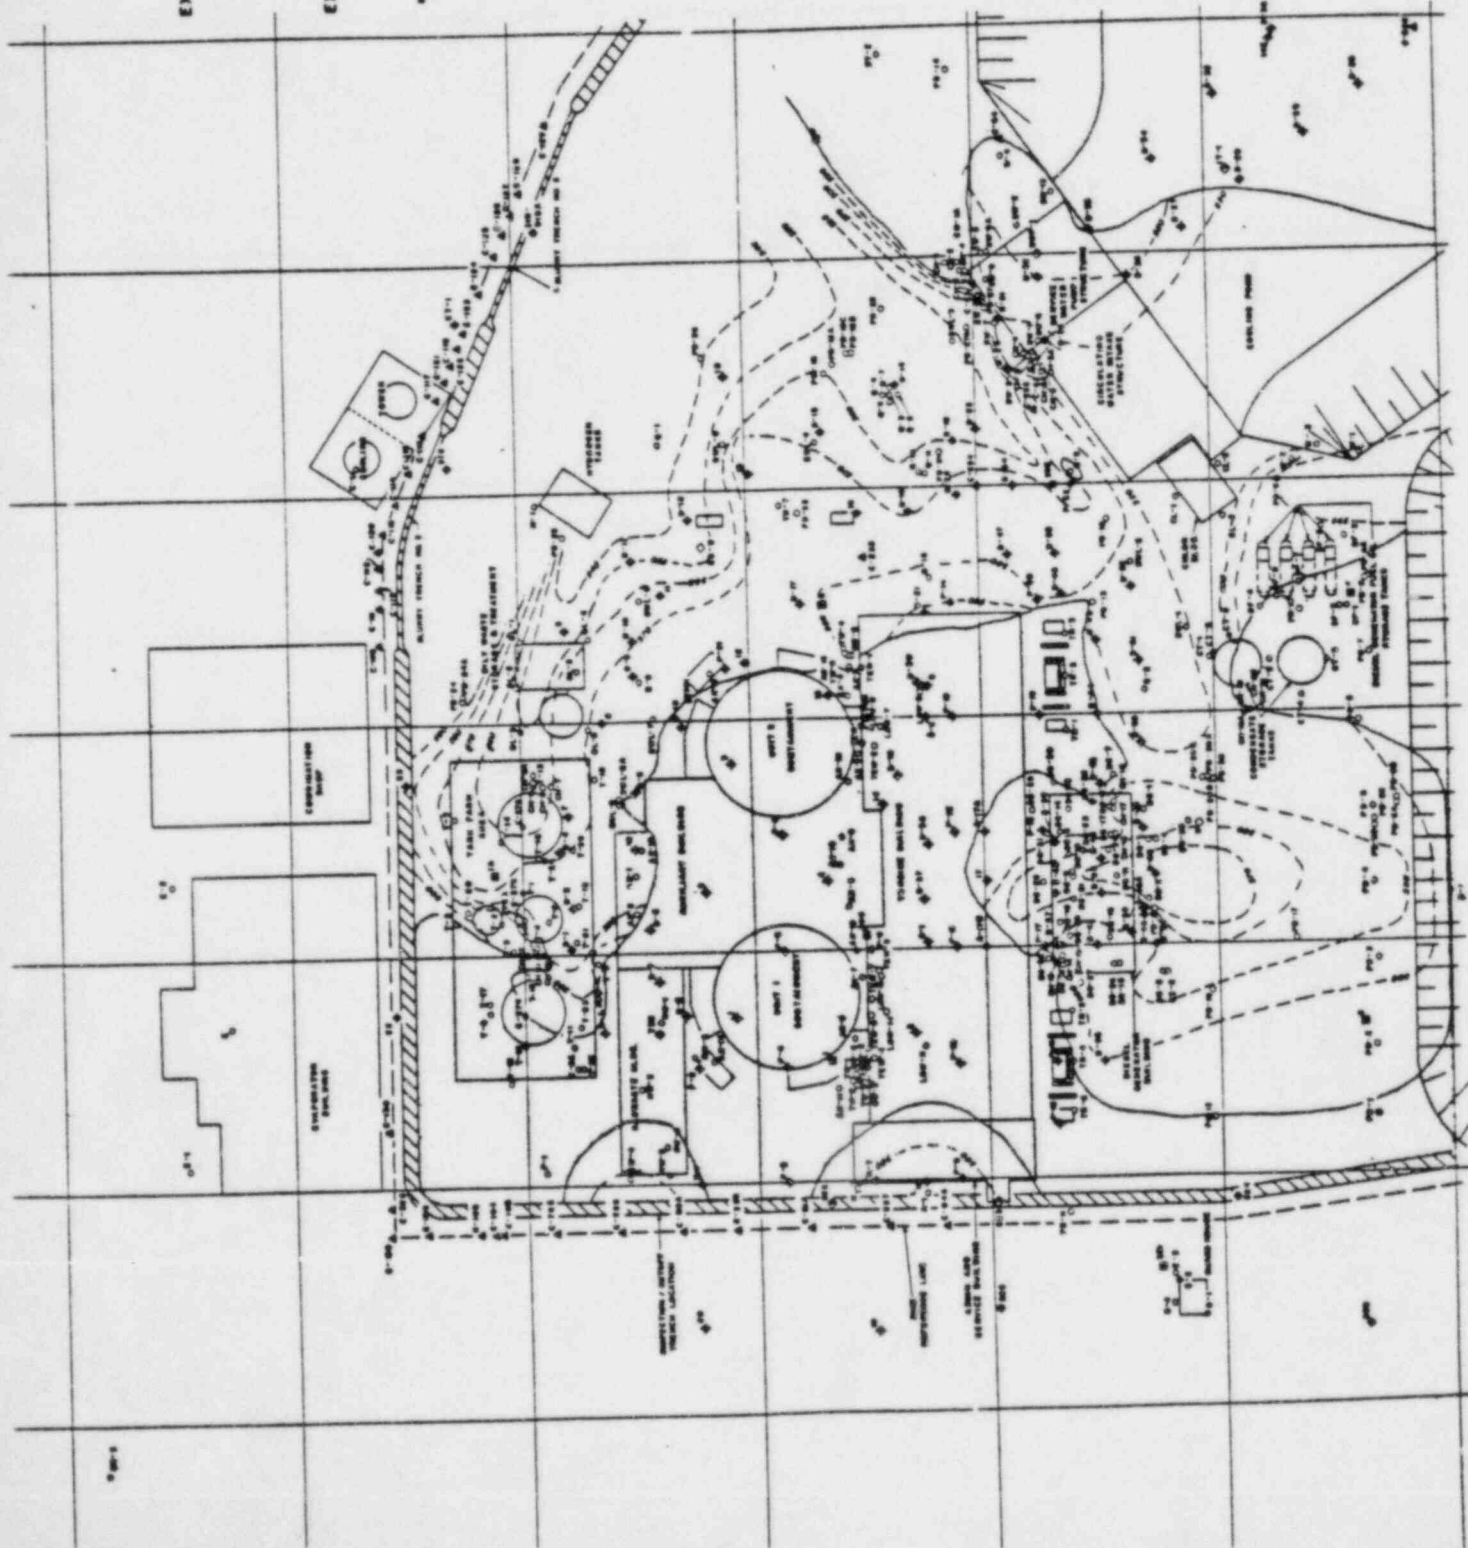
EXPLANATION
 ○ LOCATION OF OBSERVATION WELLS
 ● LOCATION OF PUMPING WELLS

BECHTEL	
MIDLAND POWER PLANT	
PUMPING TEST LOCATION PLAN	
7220	FIGURE 17 A

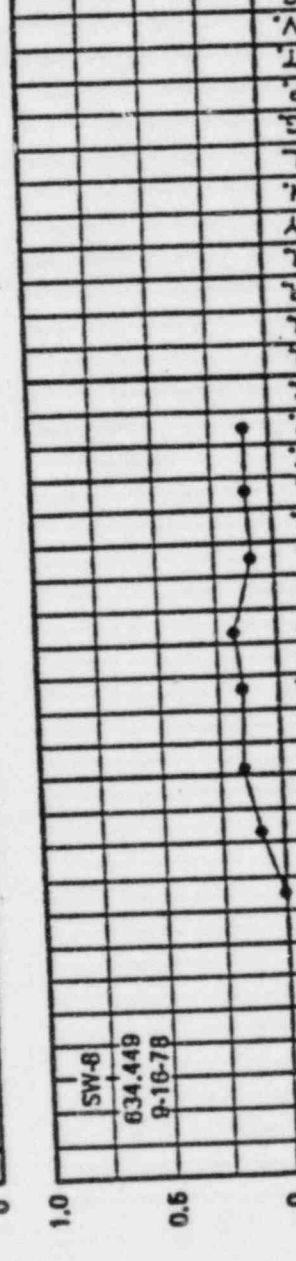
SETTLEMENT (INCHES)

- SW-5 — SETTLEMENT MARKER
- 635.317 — INITIAL ELEVATION
- 9-16-78 — DATE OF INITIAL READING

BECHTEL	
ANN ARBOR	
MIDLAND POWER PLANT	
RETAINING WALL (EAST)	
RATE OF SETTLEMENT	
JOB NO.	DRAWING NO.
7000	FIGURE 74
