Docket No. 50-346  
License No. NPF-3  
Serial No. 1-1067  
August 14, 1984  
Page 2

## SAFETY EVALUATION

This Safety Evaluation is written to justify that adequate cooling capacity exists for the Emergency Core Cooling System (ECCS) pump room, decay heat cooler from and H<sub>2</sub> dilution system blowers with the valves SW-86, SW-94, SW-102, SW-108, SW-116, SW-371 and SW-381 locked closed (see Fig. 9.1.-1 attached).

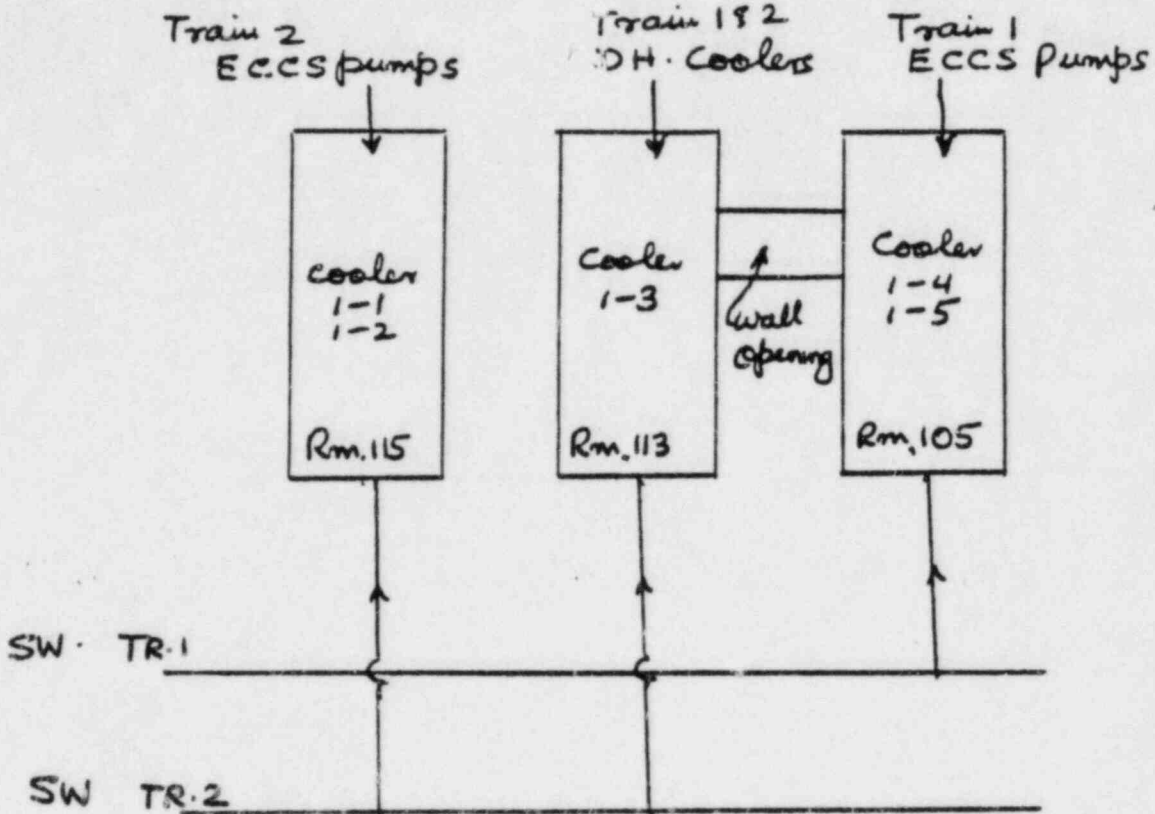
FIG. 1

ECCS pump room coolers 1-1 and 1-2 are located in room 115 (ECCS pump room 2), coolers 1-4 and 1-5 are in room 105 (ECCS pump room 1) and the cooler 1-3 is located in room 113 (DH cooler room) (see Fig. 1 attached). There are at present two trains of service water that supply water to each of the above coolers. However, only one train of service water is required to serve each of these coolers.

If train 1 of service water which provides flow to ECCS pump room coolers 1-4 and 1-5 in room 105 fails, the redundant train 2 will provide flow to the ECCS pump room coolers 1-1 and 1-2 in room 115 and the decay heat cooler room cooler 1-3 in room 113. The operable train 2 of SW will provide adequate cooling capacity in ECCS pump room 115 and decay heat cooler room 113, and, as a result, train 2 ECCS pumps will remain operable.

If train 2 of service water which provides flow to the ECCS pump room coolers 1-1 and 1-2 in room 115 and decay heat cooler 1-3 in room 113 fails, the redundant train 1 will provide flow to ECCS pump room coolers 1-4 and 1-5 in room 105. We have calculated that two coolers in ECCS pump room 105 will have adequate capacity to remove the heat loads in rooms 105 and 113, and will maintain these room design temperatures equal to or less than 122°F in accident condition. Therefore, the operable train 1 of SW will provide adequate cooling capacity in ECCS pump room 105 and decay heat cooler room 113, and, as a result, train 1 ECCS pumps will remain operable.
