# Duquesne Light

SUBJECT: Beaver Valley Power Station - Unit No. 2  
Docket No. 50-412  
Response to Draft SER Open Item No. 173

This letter forwards the attached response to the NRC Geotechnical Engineering Section's Draft SER Open Item No. 173.

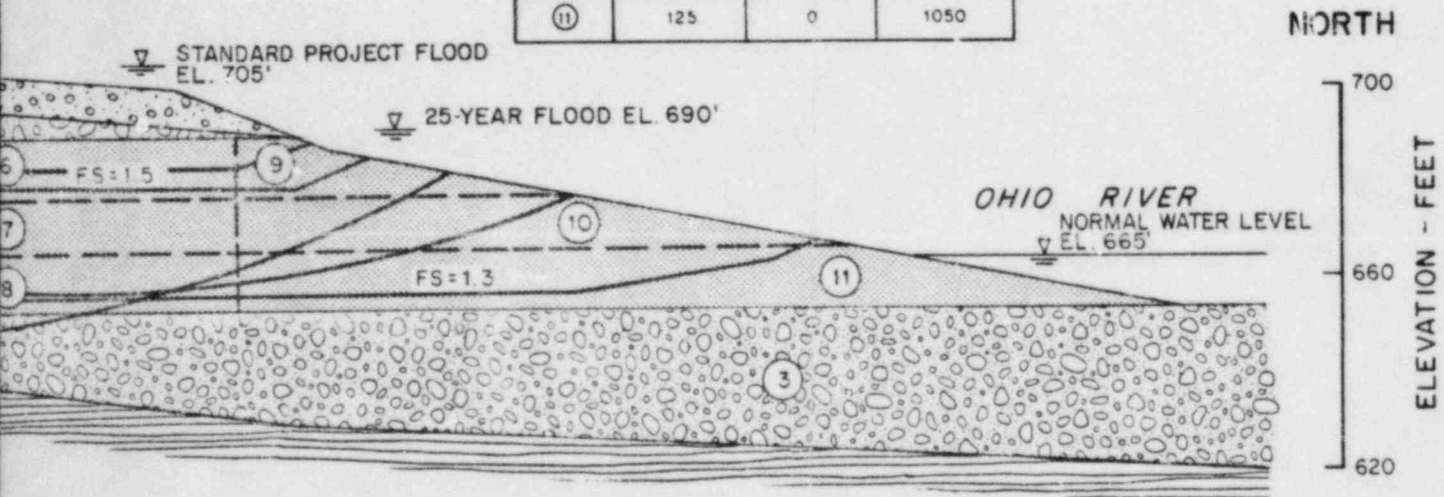
SOUTH

ELEVATION - FEET  
780  
740  
700  
660  
620

ENGINEERING SOIL PROPERTIES			
SOIL UNIT	TOTAL UNIT WEIGHT $\gamma$ -lb/ft <sup>3</sup>	FRICTION ANGLE $\phi$ -DEGREES	COHESION C-lb/ft <sup>2</sup>
①	136	36	0
②	120	30	0
③	125	30	0
④	125	0	1900
⑤	125	0	2500
⑥	125	0	900
⑦	125	0	1500
⑧	125	0	1950
⑨	125	0	200
⑩	125	0	650
⑪	125	0	1050

LEVEL.  
CES FOR OBE ARE 1/2 THE SSE FORCES.  
SAFETY ARE DUE TO SSE LOADING  
OTHERWISE NOTED.

Fig. 173-1 presents the results of the stability analysis of the EOS riverward slope. This section corresponds to Fig. 6-5 of the SWEC report entitled, "Stability of Slopes at the Emergency Outfall Structure," June 1983. The OBE + standard project flood condition was not previously analyzed. Since the cohesionless material above the clay layer will be partially saturated during the standard project flood, the stability of the upper slope may be affected. Therefore, an additional analysis was performed for the OBE + standard project flood condition, as shown on Fig. 173-1, resulting in a minimum factor of safety of 1.3, which is satisfactory.

The stability of failure surfaces passing through the clay layer will not change by raising the water level from normal water conditions to the 25-year flood level. As stated in the 1983 SWEC report, the short-lived flood conditions will not reduce the strength properties of the clay nor will it affect the sand and gravel above the clay layer. A failure surface below the clay layer through the sand and gravel was analyzed for the SSE + 25-year flood condition and the factor of safety resulting from this analysis was also found to be satisfactory.
