Millstone Nuclear Power Station, Unit No. 3
Transmittal of a response to the SER Open Item (2)

Enclosed is Northeast Nuclear Energy Company's (NNECO) response to the SER open item (2) concerning the adequacy of the tornado-missile protection for the emergency diesel generator stacks. This response should fully resolve the staff's concern regarding the open item.

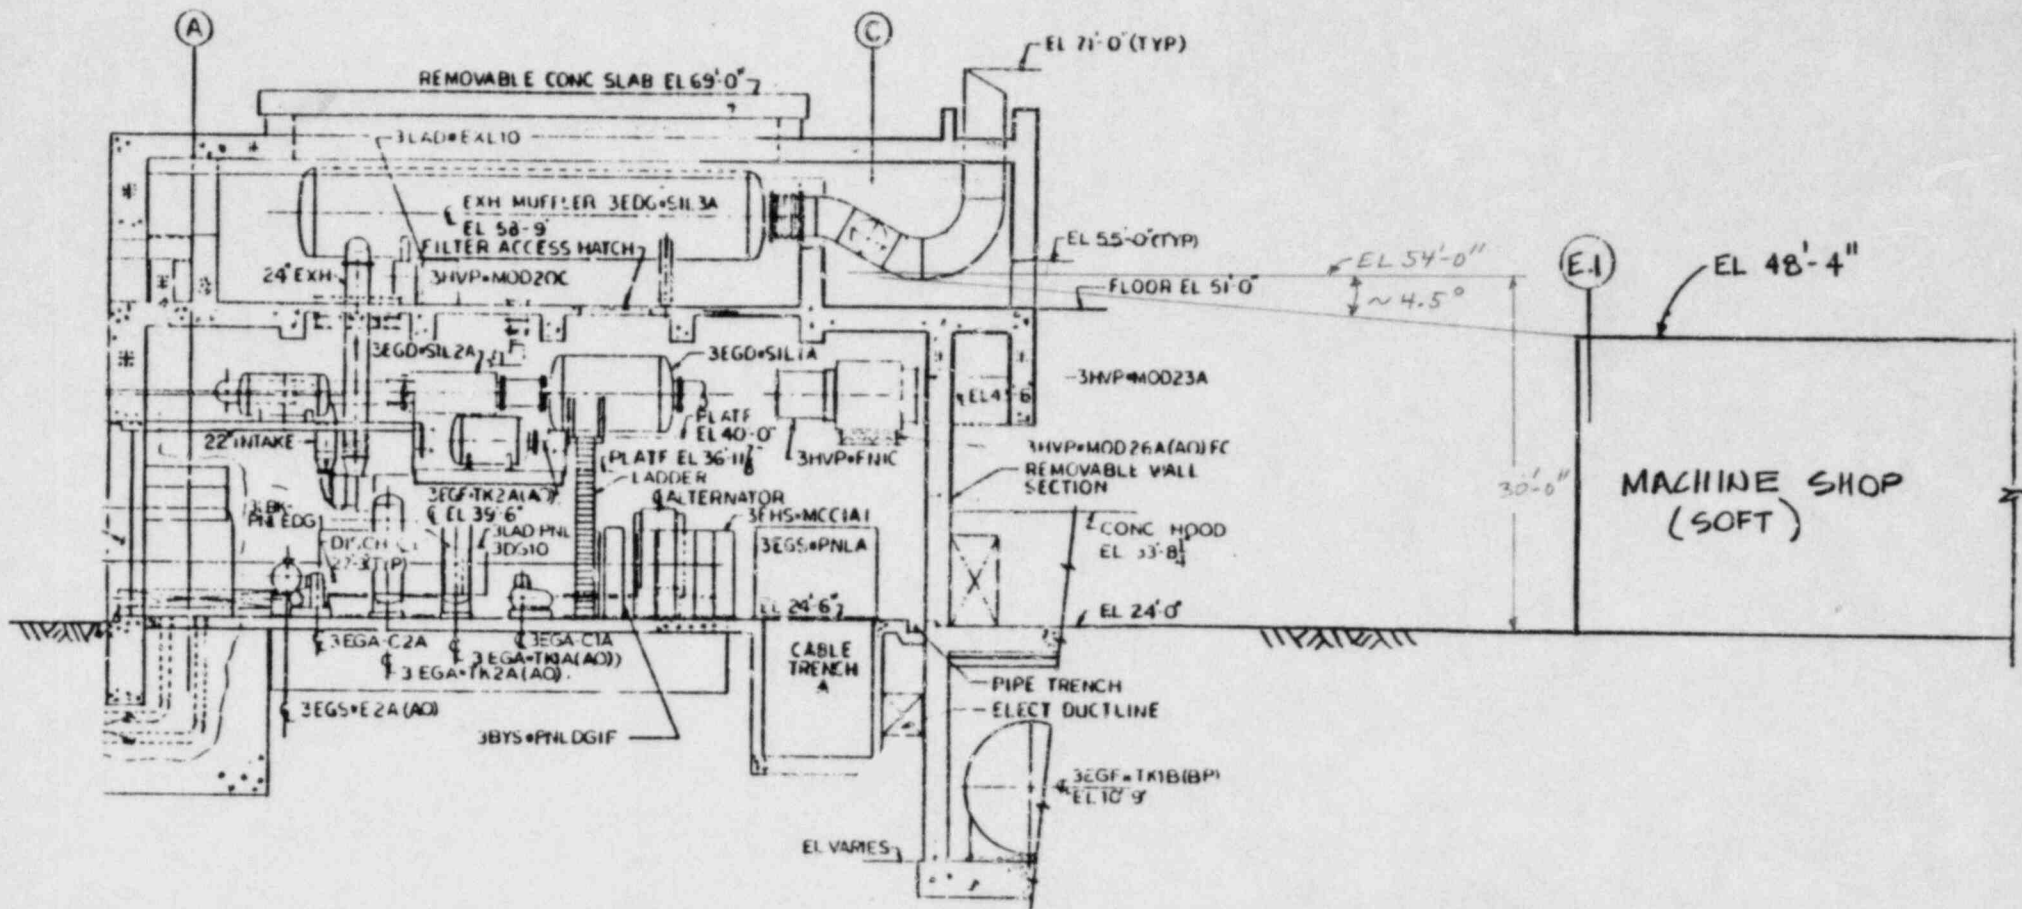
FIG. 430.134-1

ELEVATION LOOKING NORTH

- a. Damage to the access hatch from tornado missiles is not credible. Figures 430.134-1 and 430.134-2 show that no viable missile trajectory targets the access hatch. Once the access hatch is open, exposed portions of the exhaust ductwork are not required. Damage to these exposed parts will not degrade the exhaust.

The plenum openings are arranged in a manner which precludes the targeting of missiles on the exhaust duct access hatch. The exhaust duct is a 40 inch diameter pipe with a 3/8 inch wall thickness. It is seismically supported to withstand the high forces and accelerations experienced during a seismic event. The required missile trajectories necessary to cause damage to the exhaust stack coincident with the elevations required for missile damage are not credible. The proximity of adjacent buildings shields the engine's stack and further decreases the existence of a credible missile path.
