U. S. NUCLEAR REGULATORY COMMISSION
REGION I

Docket/Report No.: 50-443/92-05

Facility: Seabrook Station, Seabrook, New Hampshire

Dates: March 3 - April 6, 1992

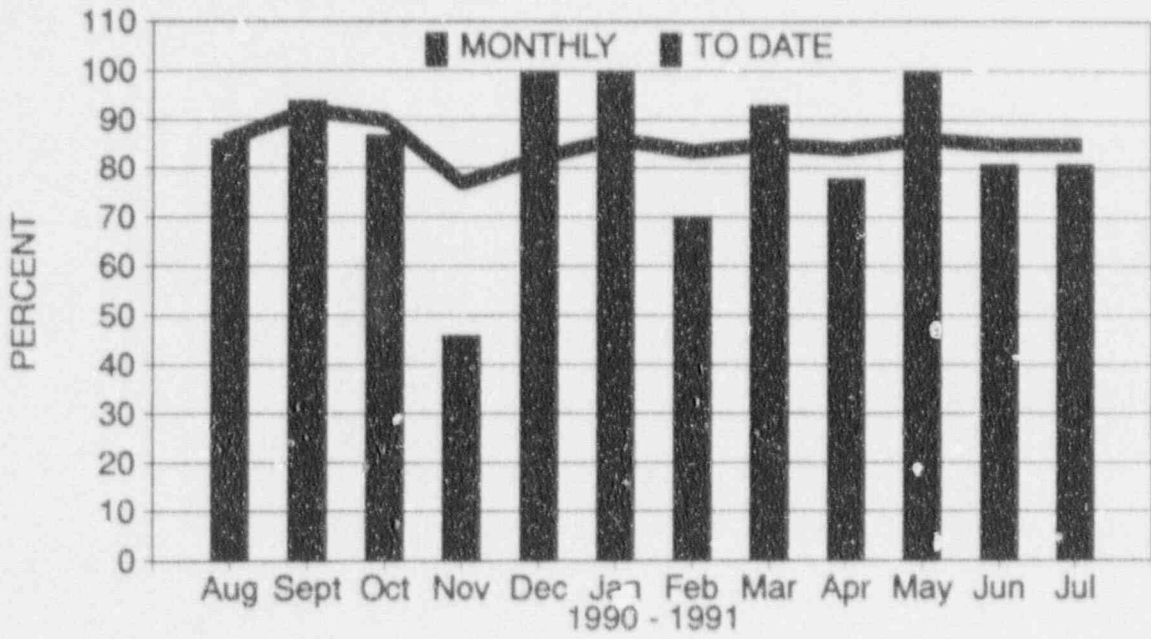
Seabrook Station CAPACITY FACTOR

- 84.8% CAPACITY FACTOR (EXCLUDING REFUELING OUTAGE)
- 68.2% CAPACITY FACTOR (INCLUDING REFUELING OUTAGE)
- NET GENERATION 8,998,574 MWhr
- FIVE UNPLANNED REACTOR TRIPS

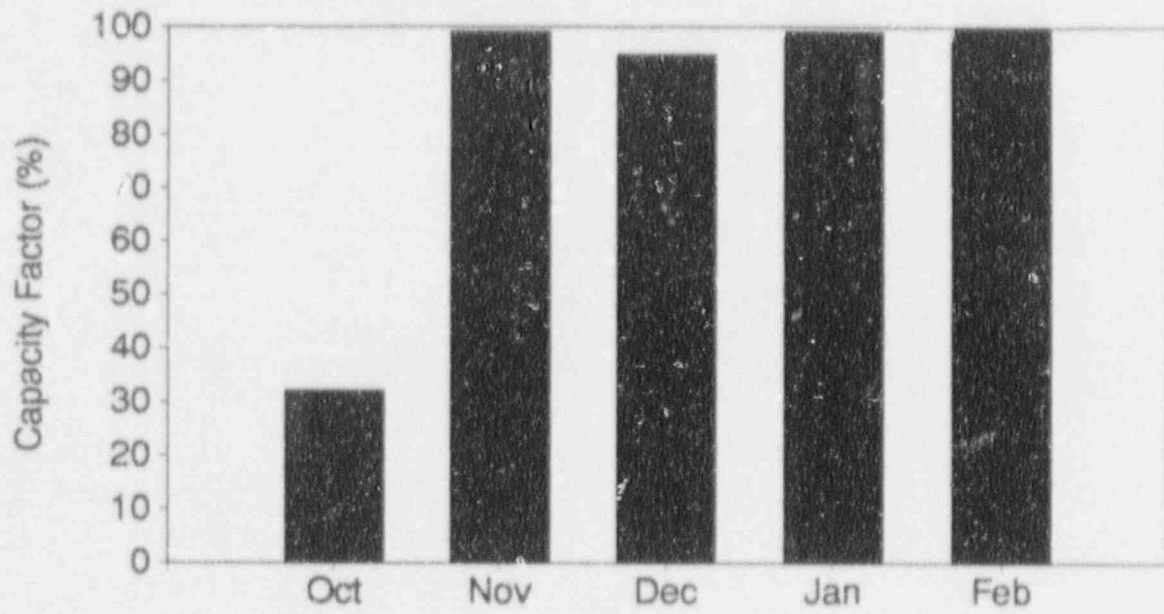
Seabrook Station CAPACITY FACTOR BY MONTH

- 95.4% CAPACITY FACTOR FROM END OF REFUELING OUTAGE TO MARCH 18, 1992
- 152 CONSECUTIVE DAYS AS OF MARCH 18, 1992
- NO UNPLANNED OUTAGES OR TRIPS
- NO MAJOR EQUIPMENT PROBLEMS

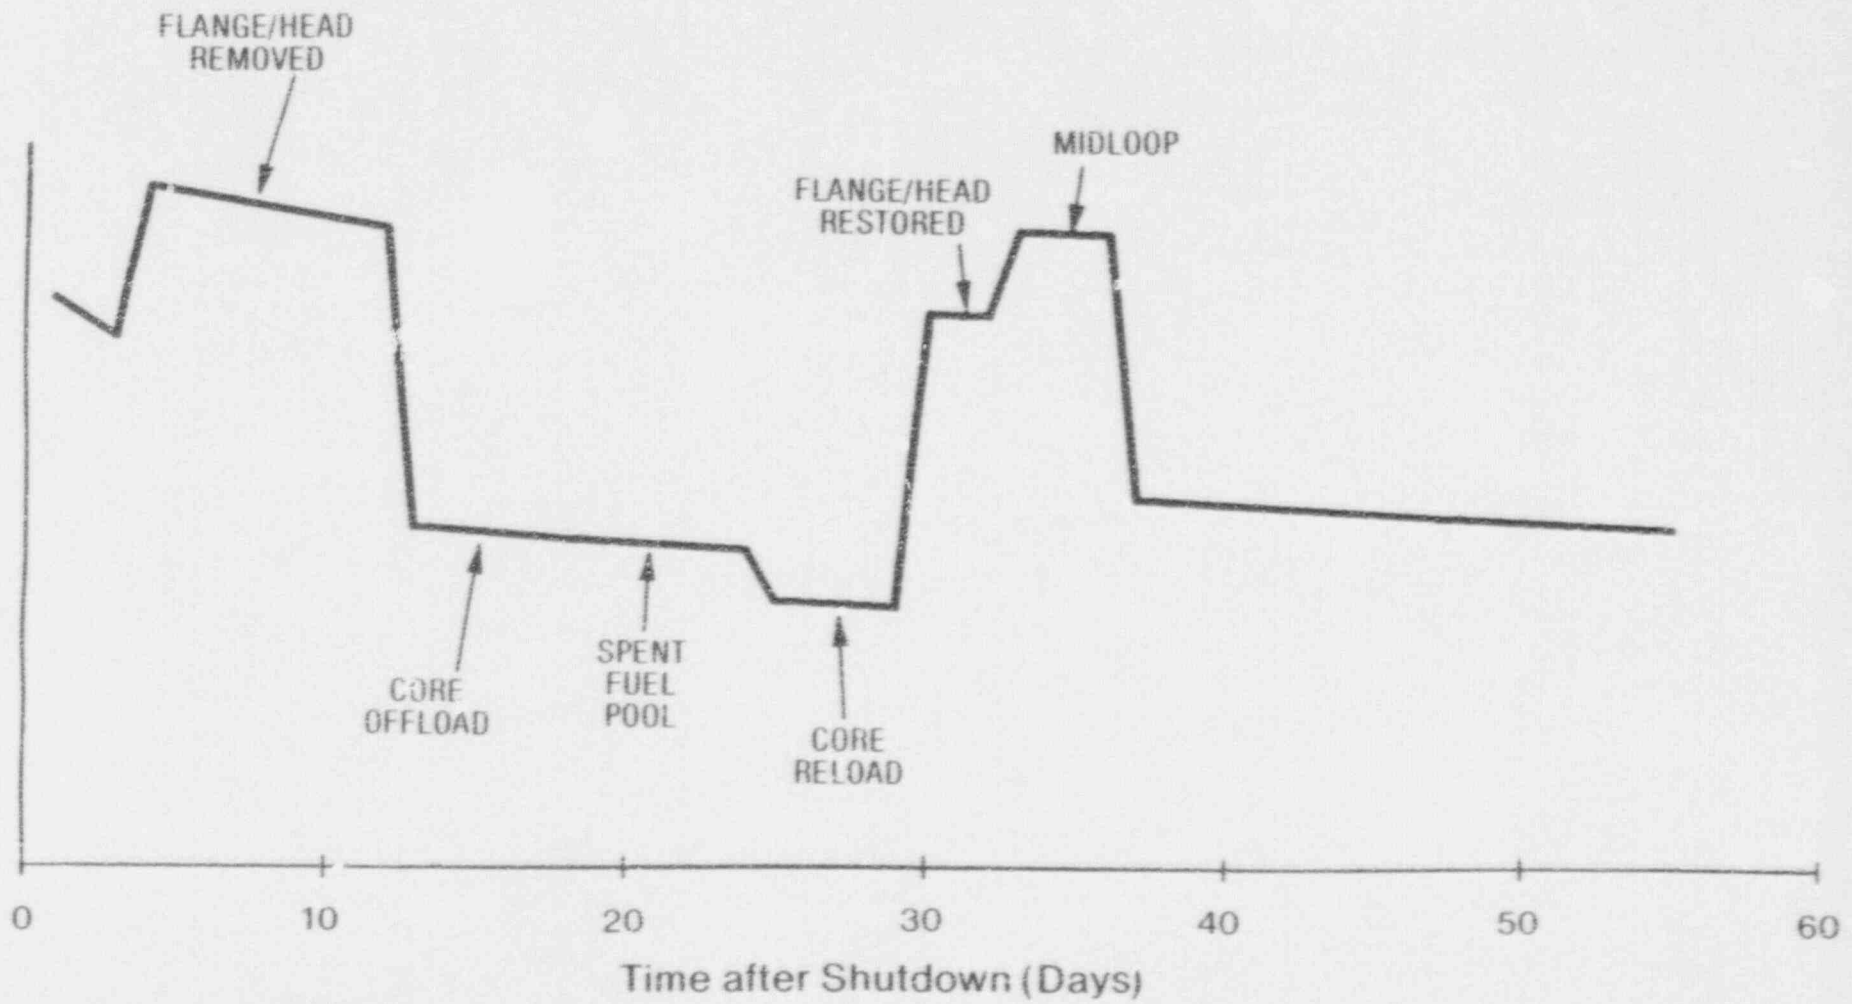
RISK CURVE for OR02*

- IPE Evaluation received from NRC Staff
- IPEEE Fire and Seismic PRA Updates complete
- IPEEE on schedule for 10/2/92 submitted to NRC
- Outage 2 Risk Assessment in progress

* Risk based on time to core uncover after loss of RHF
