SALP BOARD REPORT

U.S. NUCLEAR REGULATORY COMMISSION
REGION III

SYSTEMATIC ASSESSMENT OF LICENSEE PERFORMANCE

LASALLE COUNTY NUCLEAR POWER STATION

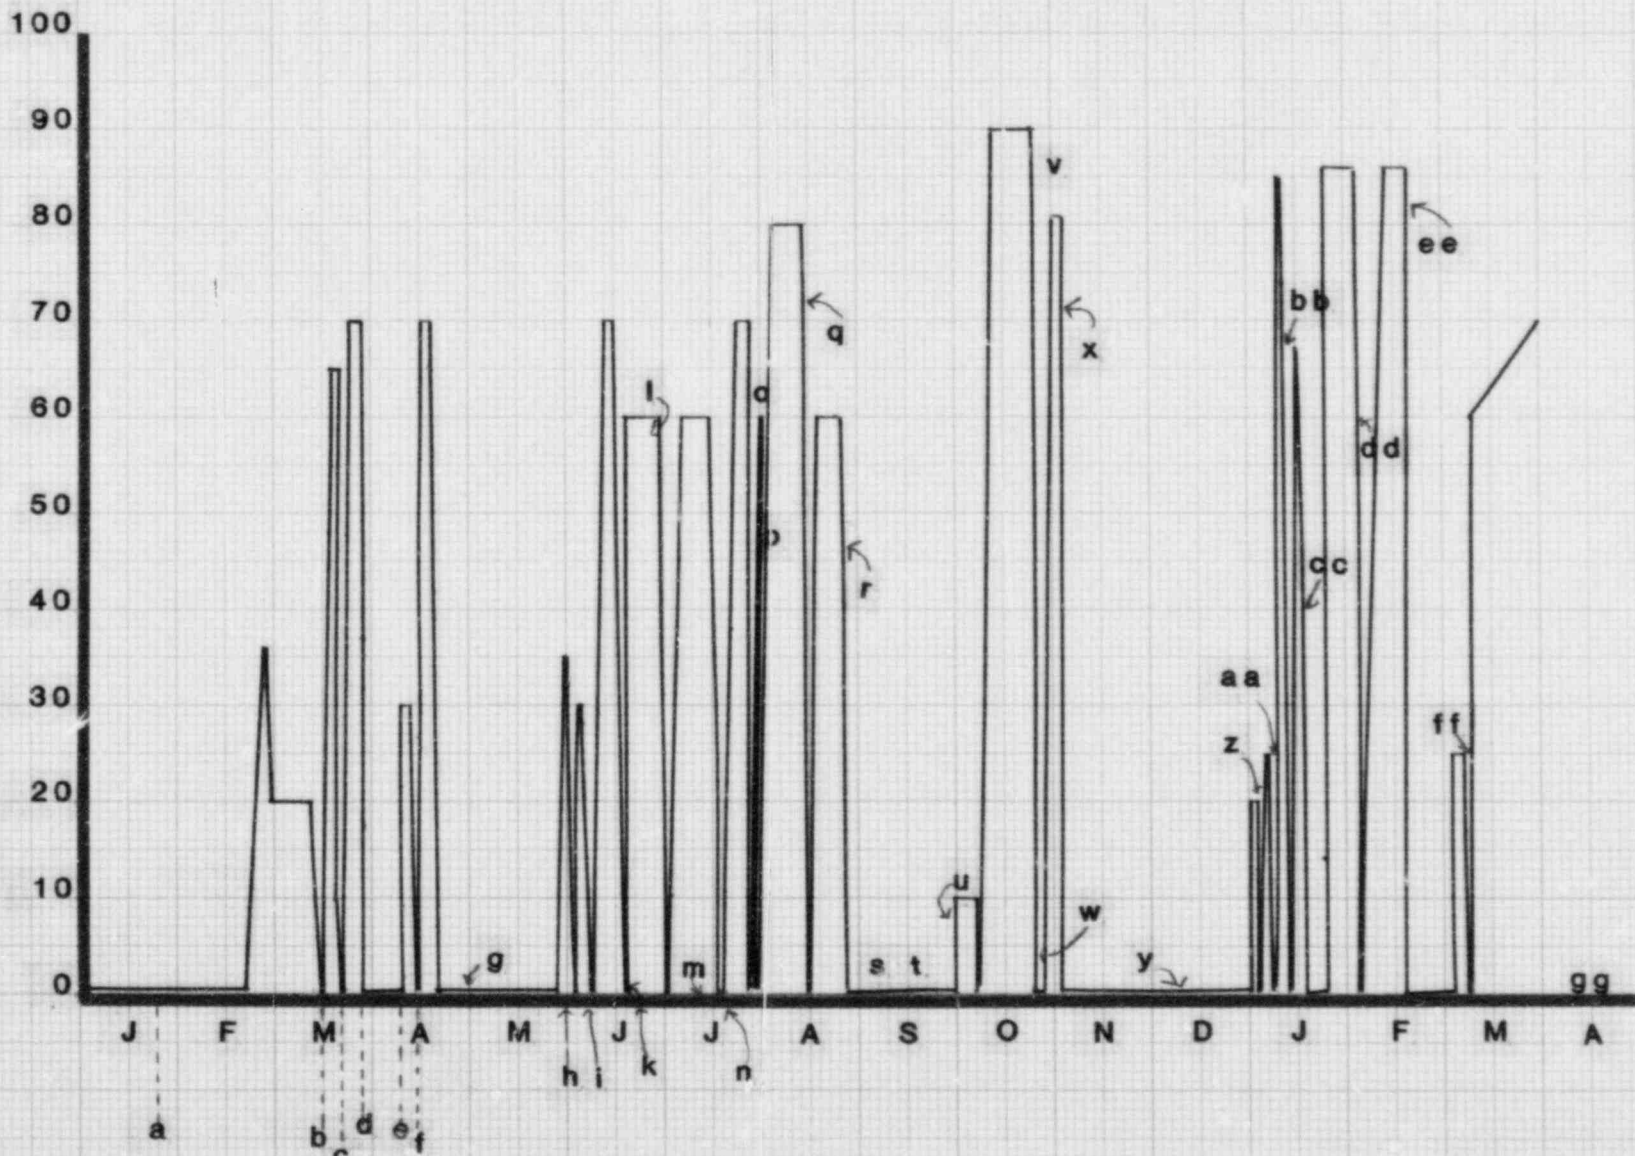
FIGURE 1

LA SALLE SALP4

Unit 1 Average Power Level (%)

January 1, 1983 thru April 30, 1984

Attachment to Figure 1 Outage Summary

- a. Equipment outage - relief valve failure
- b. Scram on high steam tunnel differential temperature
- c. Scram on spurious Turbine Stop Valve closure signal

- f. Autoscrام on reactor vessel low level - feed pump trip
- g. Outage for condenser repairs
- h. Scram due to surveillance error
- i. Scram due to turbine trip on spurious high water level

- p. Scram due to spurious main steam line low pressure
- q. Scram due to surveillance error
- r. Scram on loss of feedwater flow
- s. Outage for recirculation pump seal replacement and modifications to Turbine Control

- t. Scram during startup due to leaking "O" rings on scram solenoids
- u. Scram due to generator trip on neutral ground - water leakage
- v. Planned scame for startup testing

Twenty-eight reactor trips occurred, twenty-two on Unit 1 and six on Unit 2. Fifteen trips were due to material problems, four were planned, six were due to personnel errors, the remaining are classified as other. A detailed breakdown of these reactor trips is given in Figure 1, Section V.

1. During the period January 1, 1983 through January 1, 1984, Unit 1 proceeded through the initial startup testing program. The unit was declared in commercial service on January 1, 1984. The power and outage histories are shown in Figure 1.
2. The Unit 2 preoperational testing program was in progress at the beginning of the assessment program and continued through low power license issuance on December 16, 1983. Initial fuel loading was performed during the period December 30, 1983 through January 11, 1984. Initial criticality occurred on March 10, 1984. Startup testing continued through the end of the assessment period including full power license issuance on March 23, 1984.
