NOTICE OF VIOLATION

Georgia Power Company
Hatch Unit 2

Docket No. 50-366
License No. DPR-7
EA 95-263

AGENDA

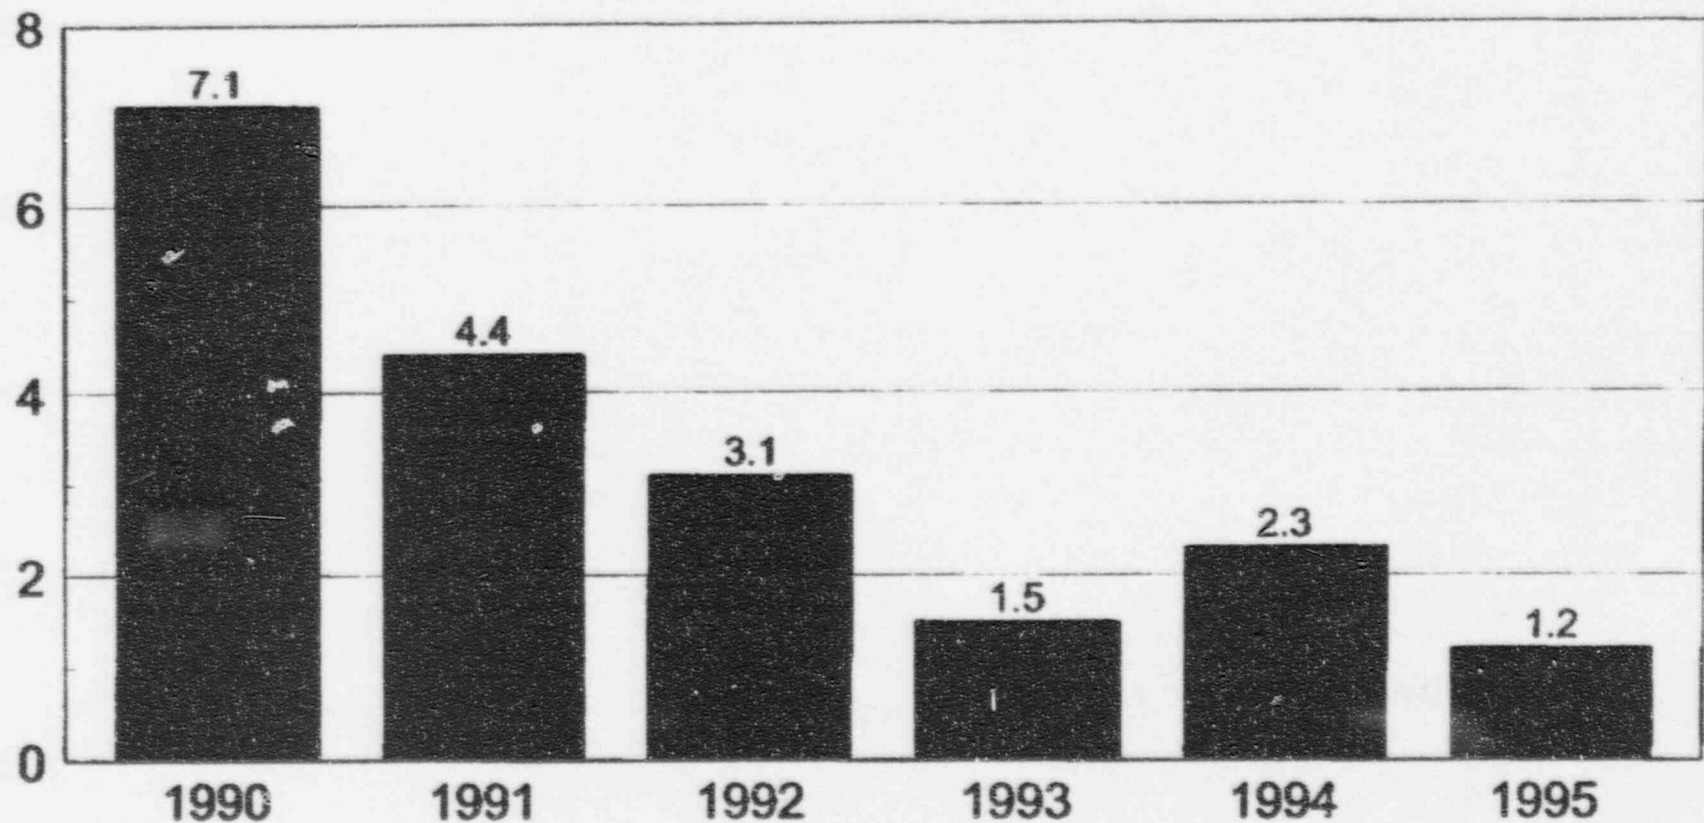
E. I. Hatch Nuclear Plant

Engineering Quality Improvement Program Design and Implementation Related Errors per DCR
