Re: In the Matter of Commonwealth Edison Company
(Byron Nuclear Power Station, Units 1 and 2)
Docket Nos. 50-454 and 50-455 -OC

Please find enclosed for your review a letter dated December 30, 1983 from Mr. Cordell Reed to Mr. R.C. De Young with the attached "Byron IDI [Integrated Design Inspection] Response."

FINDING 2-17: MODERATE ENERGY PIPE CRACK ANALYSES

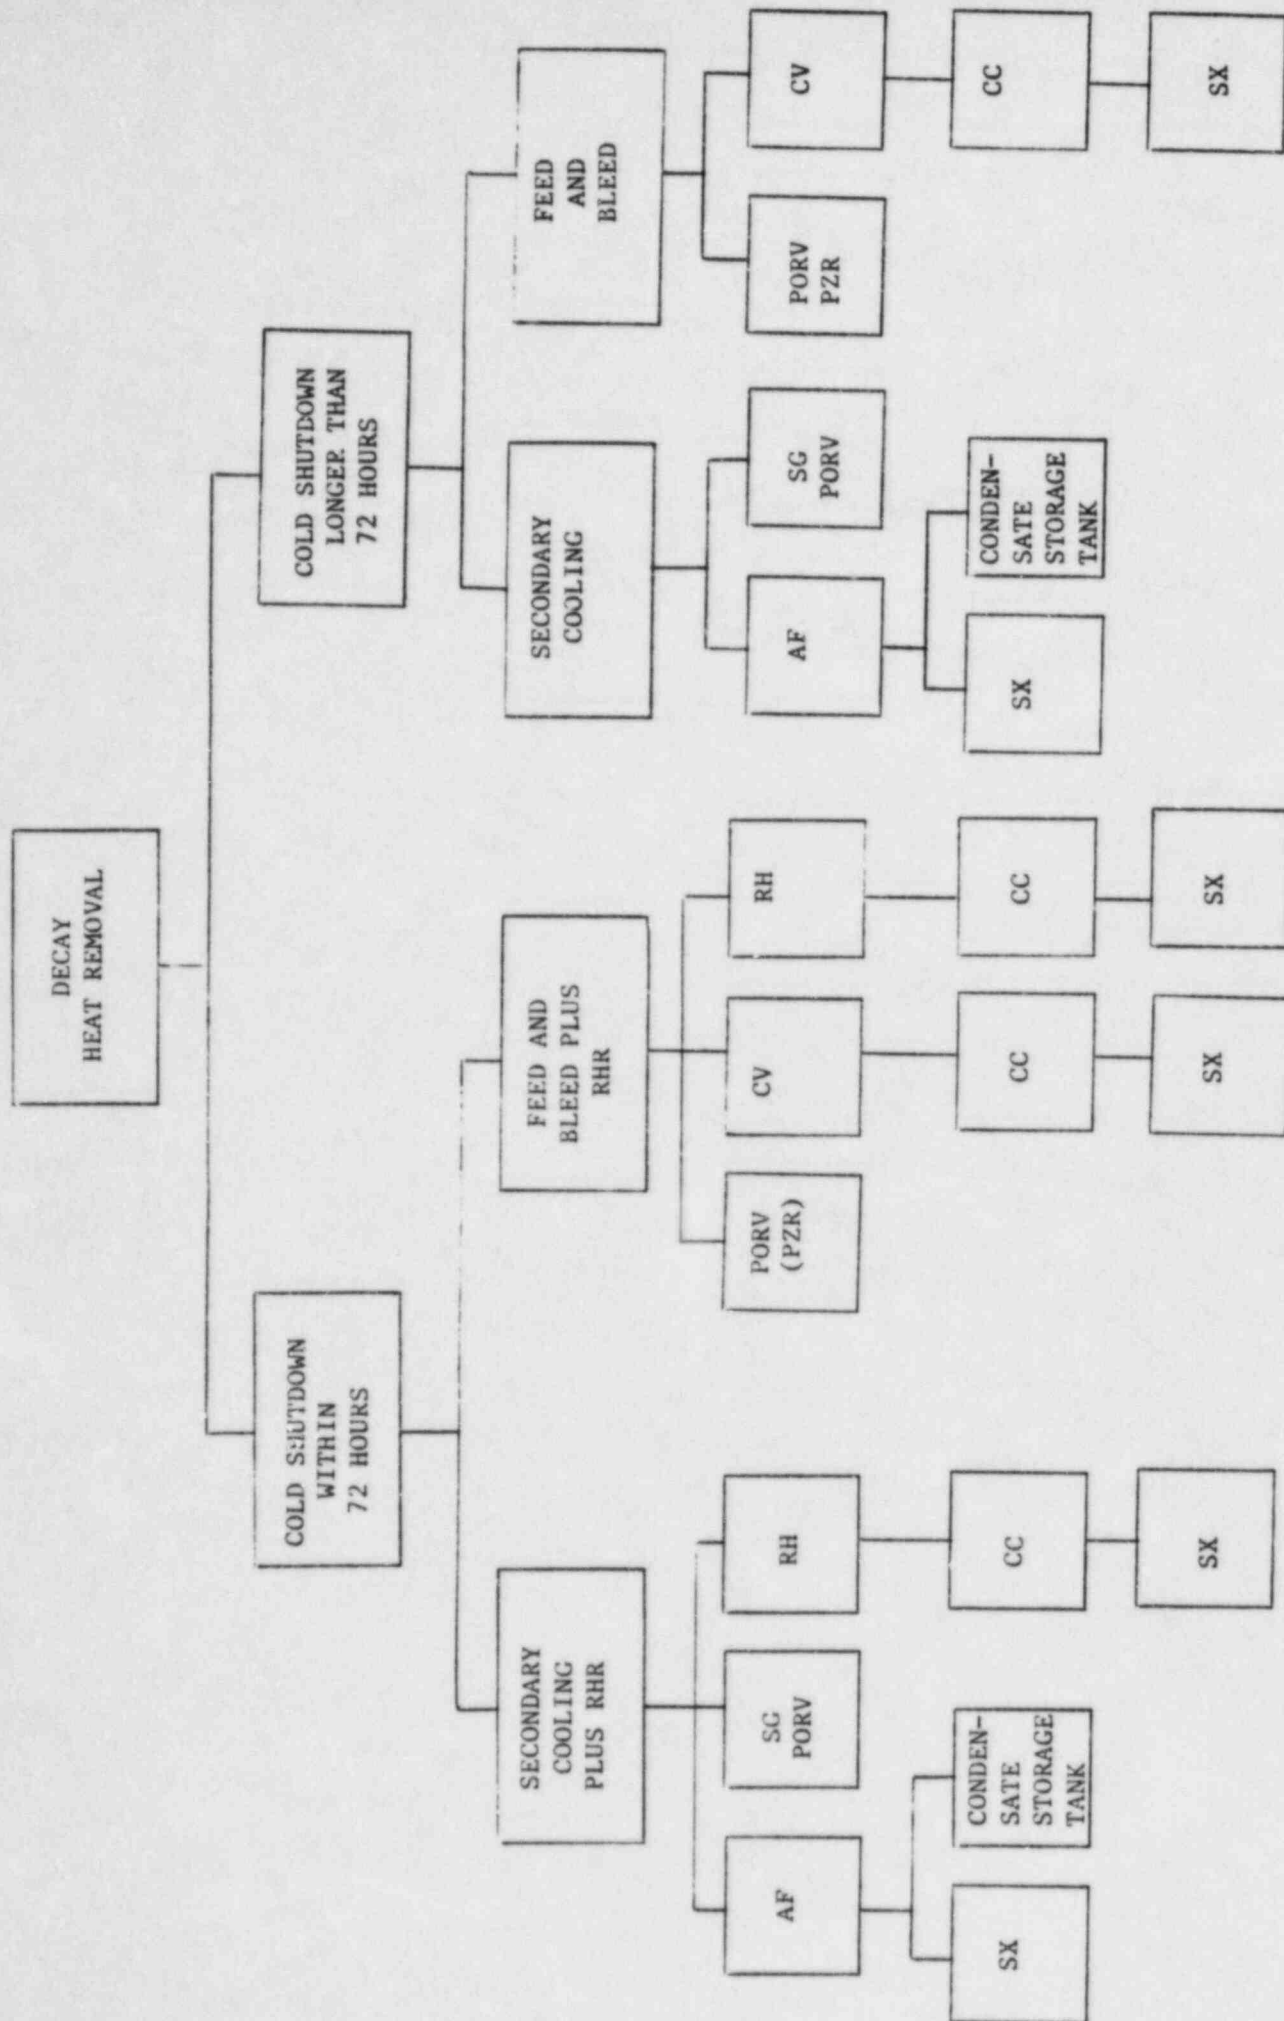
FIGURE 1

The function and redundancy of these systems can best be seen by examining a diagram of the various paths for safe shutdown decay heat removal as shown in Figure 1. This diagram shows four paths. Two of these reach cold shutdown within 72 hours while the other two (without RHR) may taken longer than 72 hours. These paths assume offsite power has been lost.

As shown in Figure 1, the RH system is required only to reach cold shutdown in a short time. The only RH component outside containment which could be affected by spray is the RHR pump motor. This motor is located in a room adjacent to the containment which contains only one train of the RH system. As a result, any crack which causes failure of one RHR train will not require postulation of a single failure in the redundant train.

The essential portion of the CV system consists only of the charging path into the containment. The valves in this path are normally open and fail in that position. The pumps are in cubicles separated from the redundant train and other systems. In the event one centrifugal charging pump fails and the other is disabled by a single active failure, the CV system is backed up by the Safety Injection System. The SI system becomes available when the primary system pressure is reduced to 1700 psig and is not subject to common failure with the CV system. Secondary cooling (per Figure 1) is used to reduce the primary pressure.

The AF system has no components which could be damaged by spray, except for the pump drives. These are in rooms which contain only one AF train. Therefore, water spray will affect only one train of the AF system. The reliability of the AF system has been documented in the response to NRC Question 10.53 and accepted by the NRC. In the event spray disables one AF train and single failure disables the other, safe shutdown can be achieved per Figure 1 by feed and bleed of the primary system with or without RHR.
