Subject: Resolution of Certain Fire Protection Issues

Evaluation of Fire Door R3-13

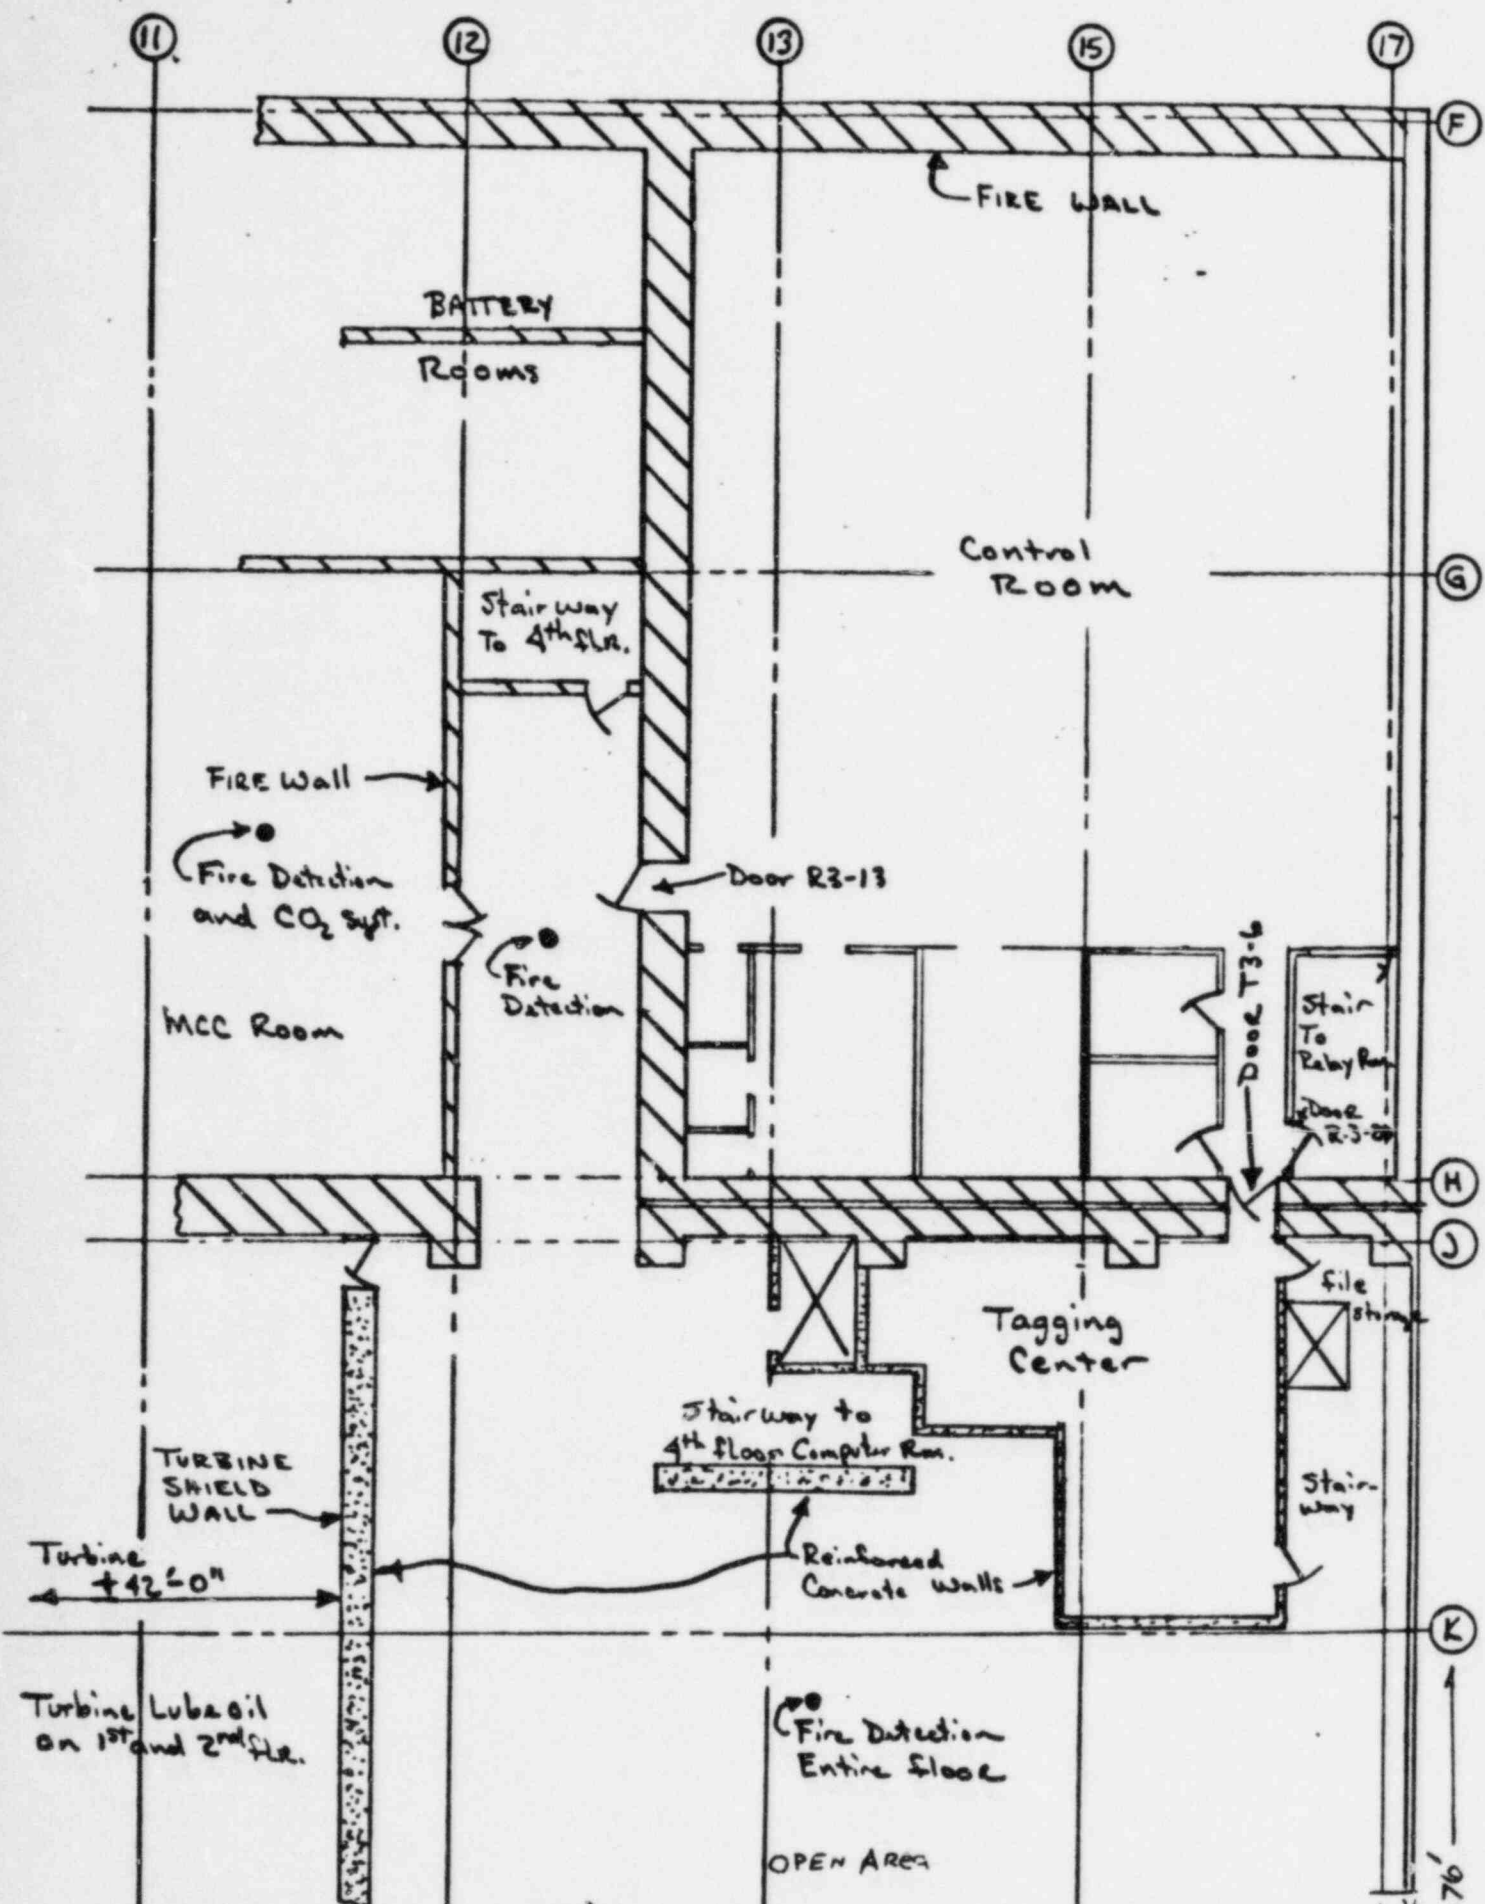
3rd FLOOR CONTROL RM AREA

Scale 1/16" = 1'-0"

Door R3-13 separates the control room from the Turbine Bldg. extension, floor elevation 643'-6". This security door is installed in a 3 hour fire resistance wall on the south side of the control room. This door is located approximately 25ft from the Turbine Building 3rd floor. (Refer to sketch No. 1).
