**LOUISIANA**  
**POWER & LIGHT**

SUBJECT: Waterford 3 SES  
Partial Response to Items  
from Waterford Review Team

ITEM NO.: 6 (Revision 1)

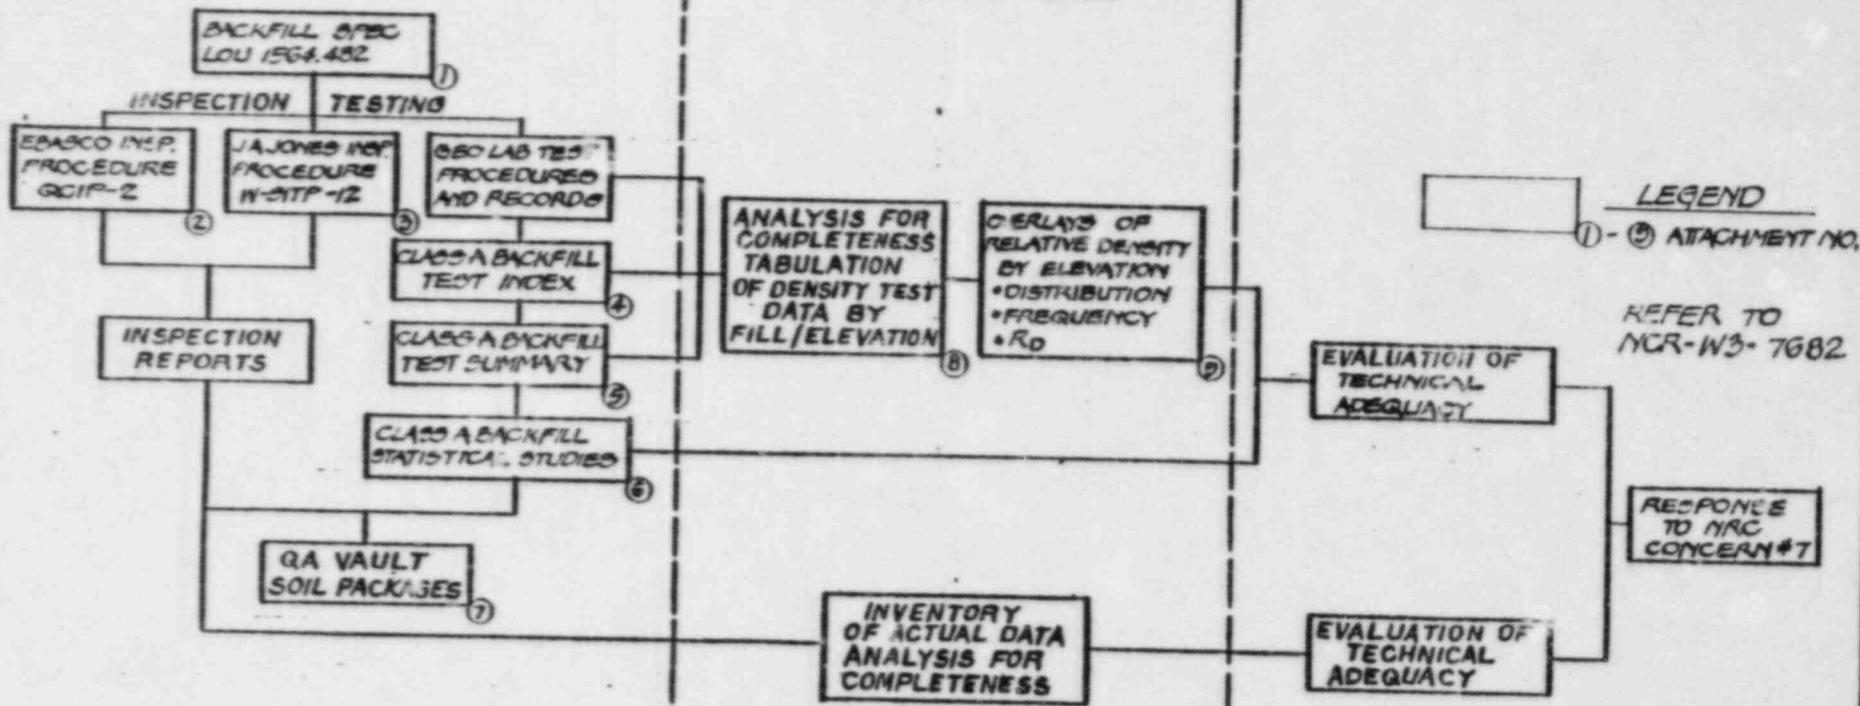
LOUISIANA POWER & LIGHT COMPANY		
WATERFORD S.E.S. UNIT NO. 3		
1983-1985 PHASE I INSTALLATION		
NRC CONCERN NO. 7		
STUDY PLAN		
EBASCO SERVICES INC. - FIELD		
SCALE	RELEASED	DATE
D.W. CONSTR.	<i>Richard</i>	FIELD SKETCH
DR. LME	<i>MT</i>	SK. 1504
CH. MT	<i>MT</i>	TABLE 1

**STAGE II**  
ANALYSIS FOR COMPLETENESS  
COMPILATION OF DATA

**STAGE III**  
EVALUATION OF DATA
