SUBJECT: RISK-BASED INSPECTION GUIDE (RIG)

This document is the eighteenth of a series providing plant-specific inspection guidance for auxiliary feedwater (AFW) systems at pressurized water reactors (PWRs). This guidance is based on information from probabilistic risk assessments (PRAs) for similar PWRs, industry-wide operating experience with AFW systems, plant-specific AFW system descriptions, and plant-specific operating experience. It is not a detailed inspection plan, but rather a compilation of AFW system failure information which has been screened for risk significance in terms of failure frequency and degradation of system performance. The result is a risk-prioritized listing of failure events and their causes that are significant enough to warrant consideration in inspection planning at Davis-Besse.

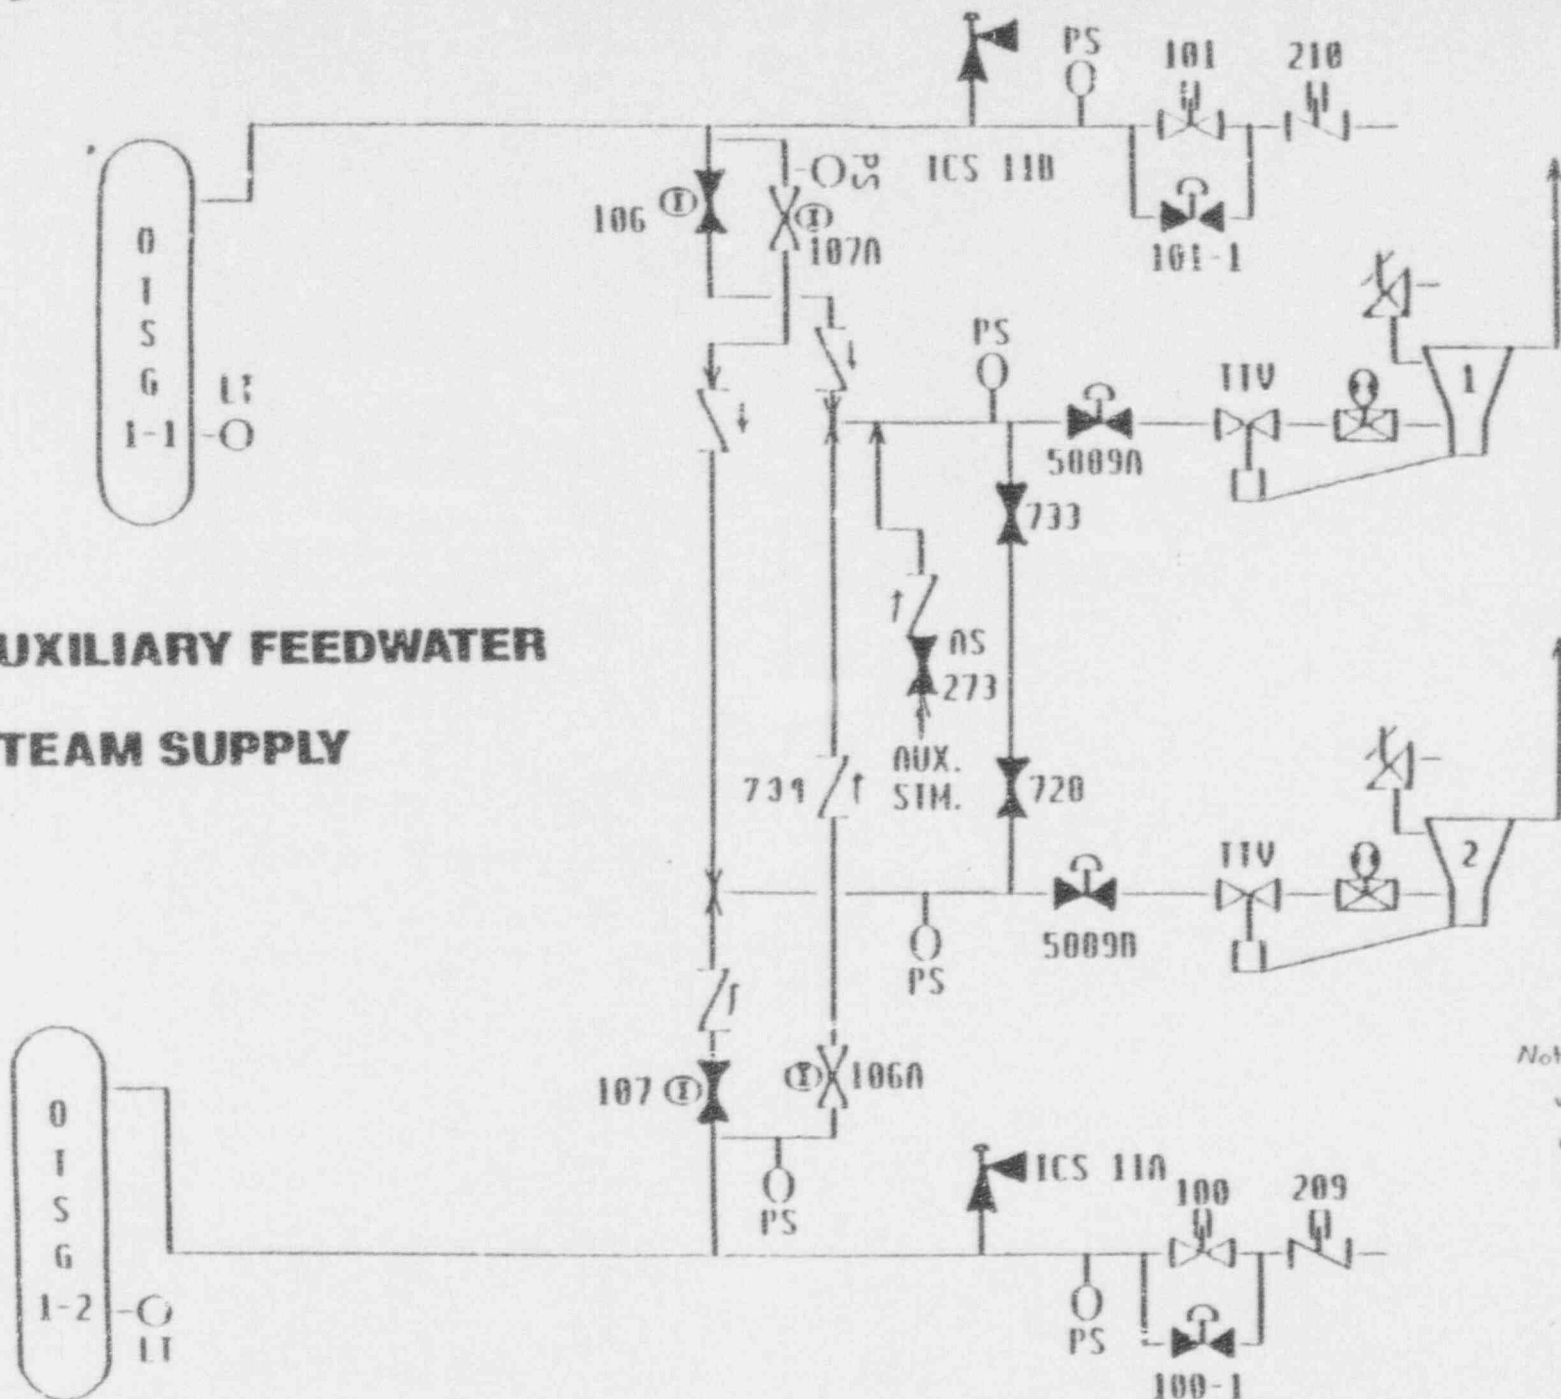
FIGURE 2.2

**AUXILIARY FEEDWATER
STEAM SUPPLY**

Note: This figure will be combined with figure 2.1 for the final report.

The #1 Main Steam line supplies both the #1/#2 TDAFW pumps via MS 106/107A. The #2 MS Line supplies both the #2/#1 TDAFW pumps via MS 107/106A. Normally MS 106A and MS 107A are open and MS 106 and MS 107 are closed. Depending on which Steam Feed and Rupture Control System (SFRCS) trip occurs, both TDAFW pumps can be supplied from both MS lines simultaneously (MS 106, 106A, 107, 107A all open) or both TDAFW pumps can be supplied from either MS line (MS106/107A open and MS 107/106A closed or MS 106/107A closed and MS 107/106A open).
