PACIFIC GAS AND ELECTRIC COMPANY

PGandE Letter No. : DCL-84-195

Re: Docket No. 50-275, OL-DPR-76  
Docket No. 50-323  
Diablo Canyon Units 1 and 2  
Response to 146 Allegations

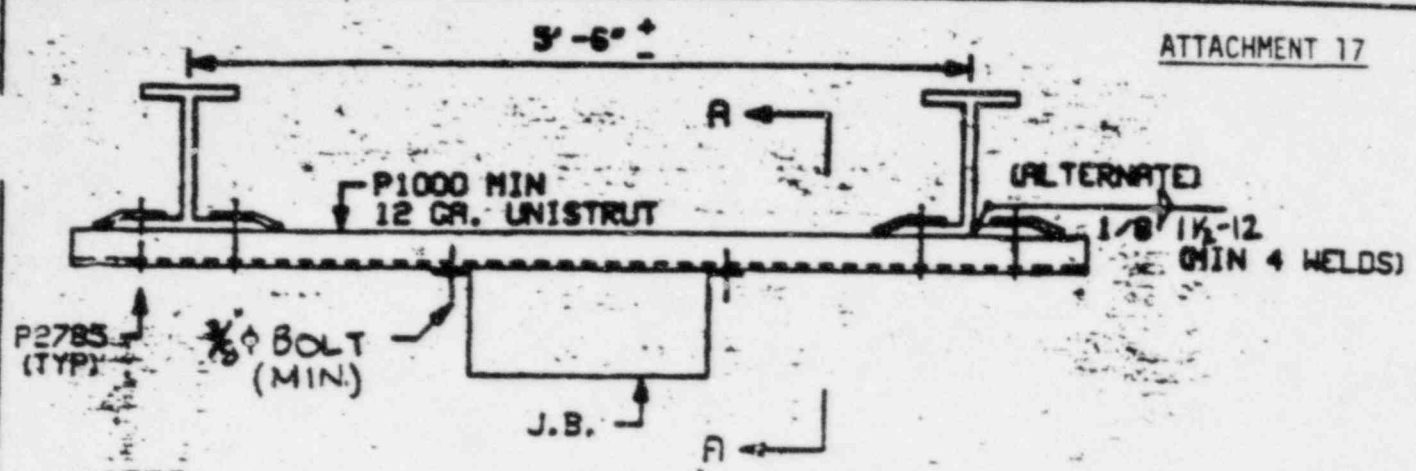
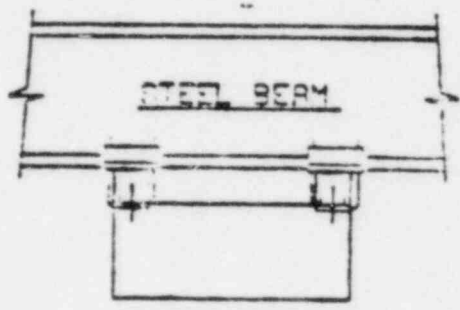
TYPICAL ARRANGEMENT OF ELECTRICAL BOX SUPPORT FROM STEEL BEAMS

1. ALL CONNECTIONS WITH 1/2" Ø UNISTRUT NUTS AND BOLTS EXCEPT AS NOTED
2. MAX LOADING 10" x 36" x 10" 12 GA. ELECTRICAL BOX

SECTION A-A

AREA	ELEVATION
F.G.	117'
FE/FW	117'

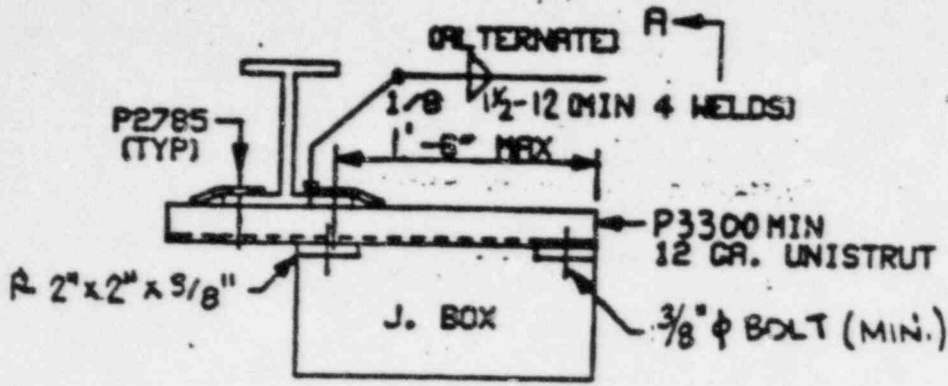
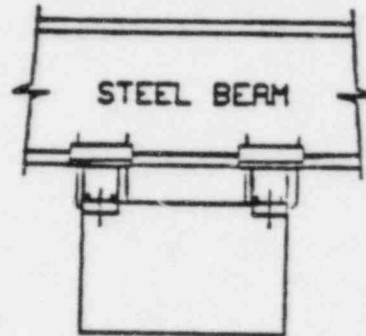
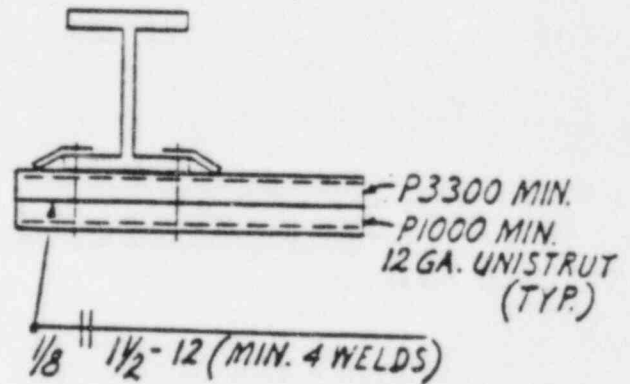
1. ALL CONNECTIONS WITH 1/2" Ø UNISTRUT NUTS AND BOLTS EXCEPT AS NOTED
2. MAX. LOADING 24" x 24" x 12" 12 GA. ELECTRICAL BOX

SECTION A-A

ALT. MOUNTING

AREA	ELEVATION
D	104'
F	117', 165'
FE / FW	117'
G	117', 165'
GE / SW	140' E BELOW
A	85', 104', 119'
