Aging Assessment of Surge Protective Devices in Nuclear Power Plants

Prepared by
J. F. Davis, M. Subudhi, D. P. Carroll

Brookhaven National Laboratory

Prepared for
U.S. Nuclear Regulatory Commission

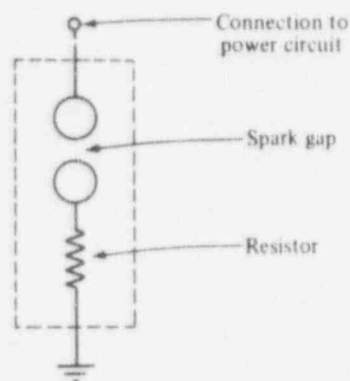
Figure 2.2 A basic surge arrester

Surge arresters, also known as lightning arresters, are devices that protect electrical equipment by limiting overvoltages from lightning strikes (Ref. 2.20). Ideally, a surge arrester is off-line under normal operation, switches on-line when the transient voltage is approximately 20% above normal value to ensure that it does not exceed this value regardless of the nature or source of the overvoltage, and switches off-line when the disturbance is past and normal voltage has been restored. The basic form of a surge arrester consists of a spark gap connected in series with a resistor (Figure 2.2). The gap is set at a sparkover value greater than the normal line voltage; hence, the gap is normally non-conducting. When an overvoltage occurs, the gap sparks over, and then the voltage across the arrester terminals is determined by the current flowing through resistance of the arrester.

The resistor limits the current flow, avoiding the effect of a short circuit. When the overvoltage condition has passed, the arc in the gap ceases, thus disconnecting the arrester from the circuit. If the arc does not go out, current continues to flow through the resistor, and both the resistor and the gap may be destroyed.

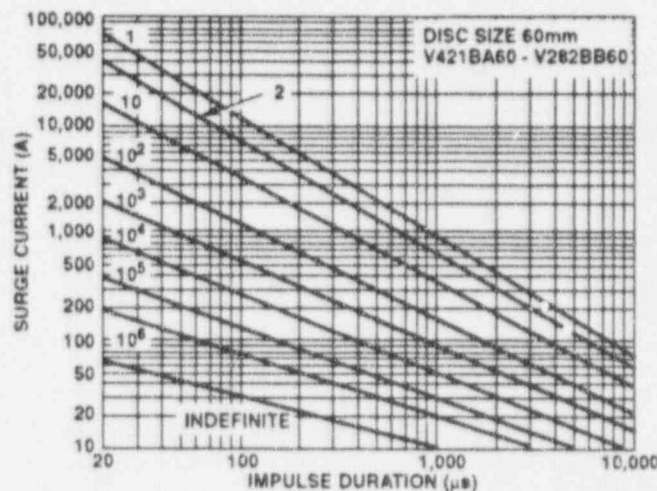
Figure 2.5 Pulse ratings for metal-oxide varistor plotted on log-log scale
(Permission to use copyrighted material granted by HARRIS Corporation, 1995)

The lifetime of a varistor, whether a gapped silicon carbide or a gapless metal-oxide, is a function of the accumulated energy absorptions it was "pulsed" with before it fails its warranty. A plot of peak pulse current against impulse duration for a typical metal-oxide varistor is shown in Figure 2.5 (Refs. 2.22, 2.23). The model varistor shown can take a single peak pulse current of 80,000 A for 20 microseconds, or about 1000 pulses of 2,000 A for 20 microsecond impulses. Although the engineer has some latitude in determining the pulse lifetime for the calendar life of the varistor, the limiting requirement is likely to be the specification of lightning surges rather than switching transients.

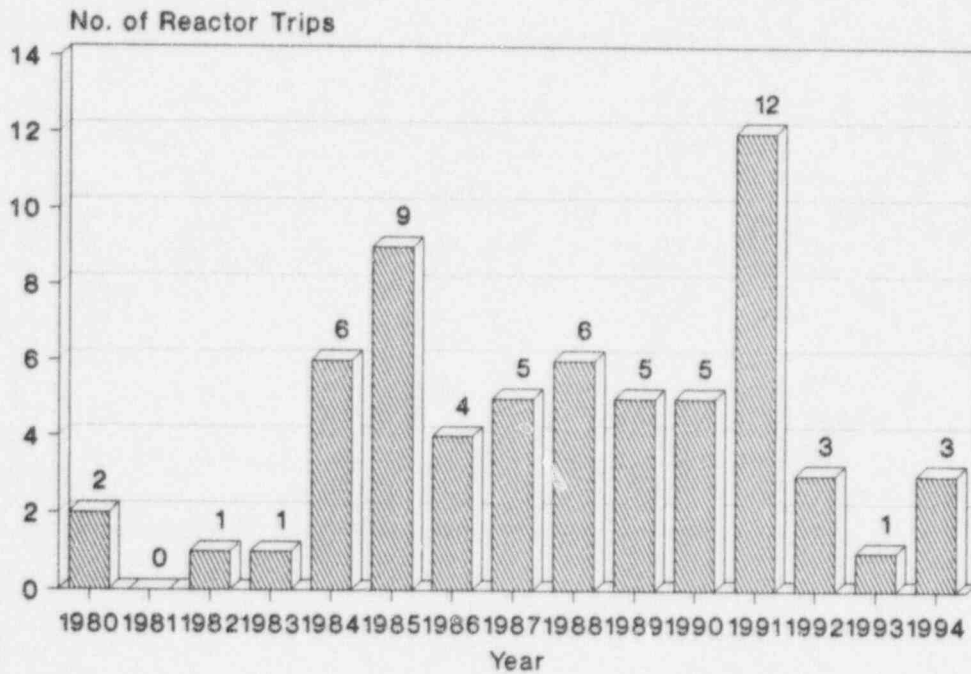
Figure 3.2 Lightning caused reactor trips (1980-1994)

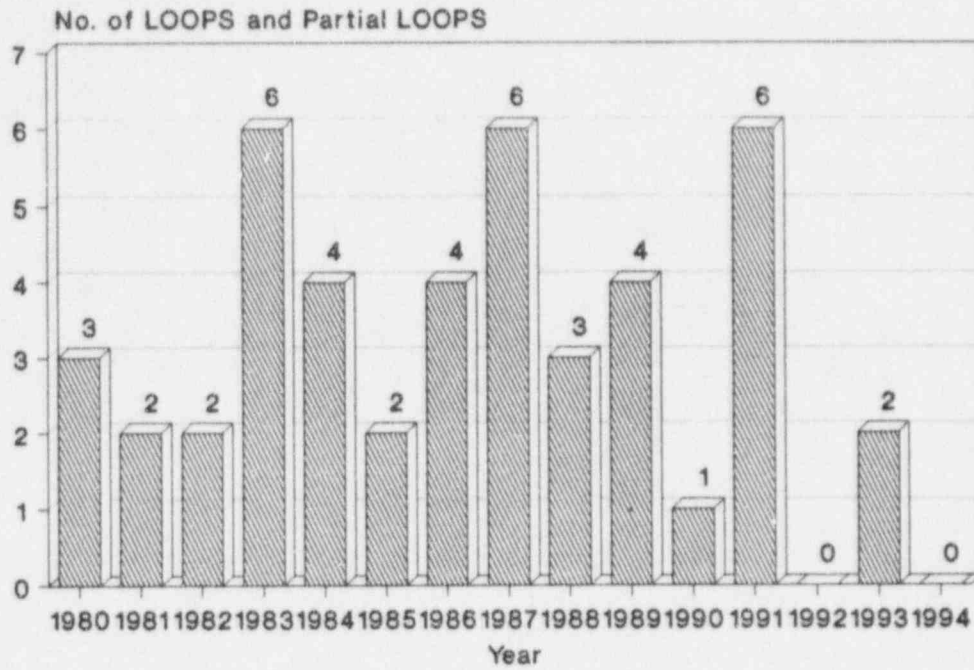
Figure 3.3 Lightning caused losses of offsite power (1980-1994)

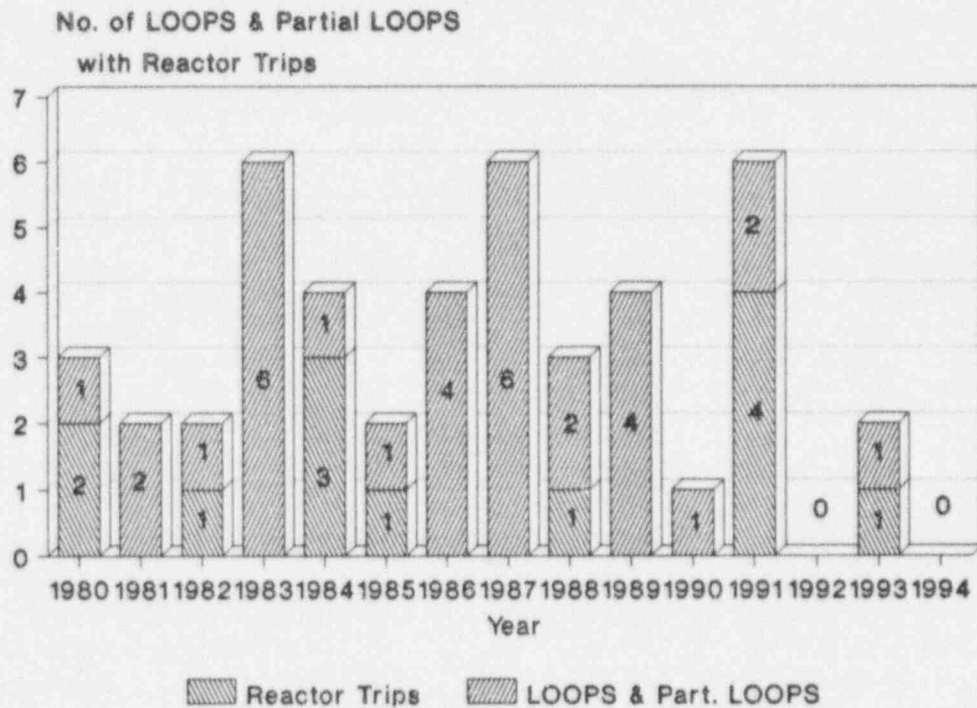
Figure 3.4 Coincident reactor trips with losses of offsite power

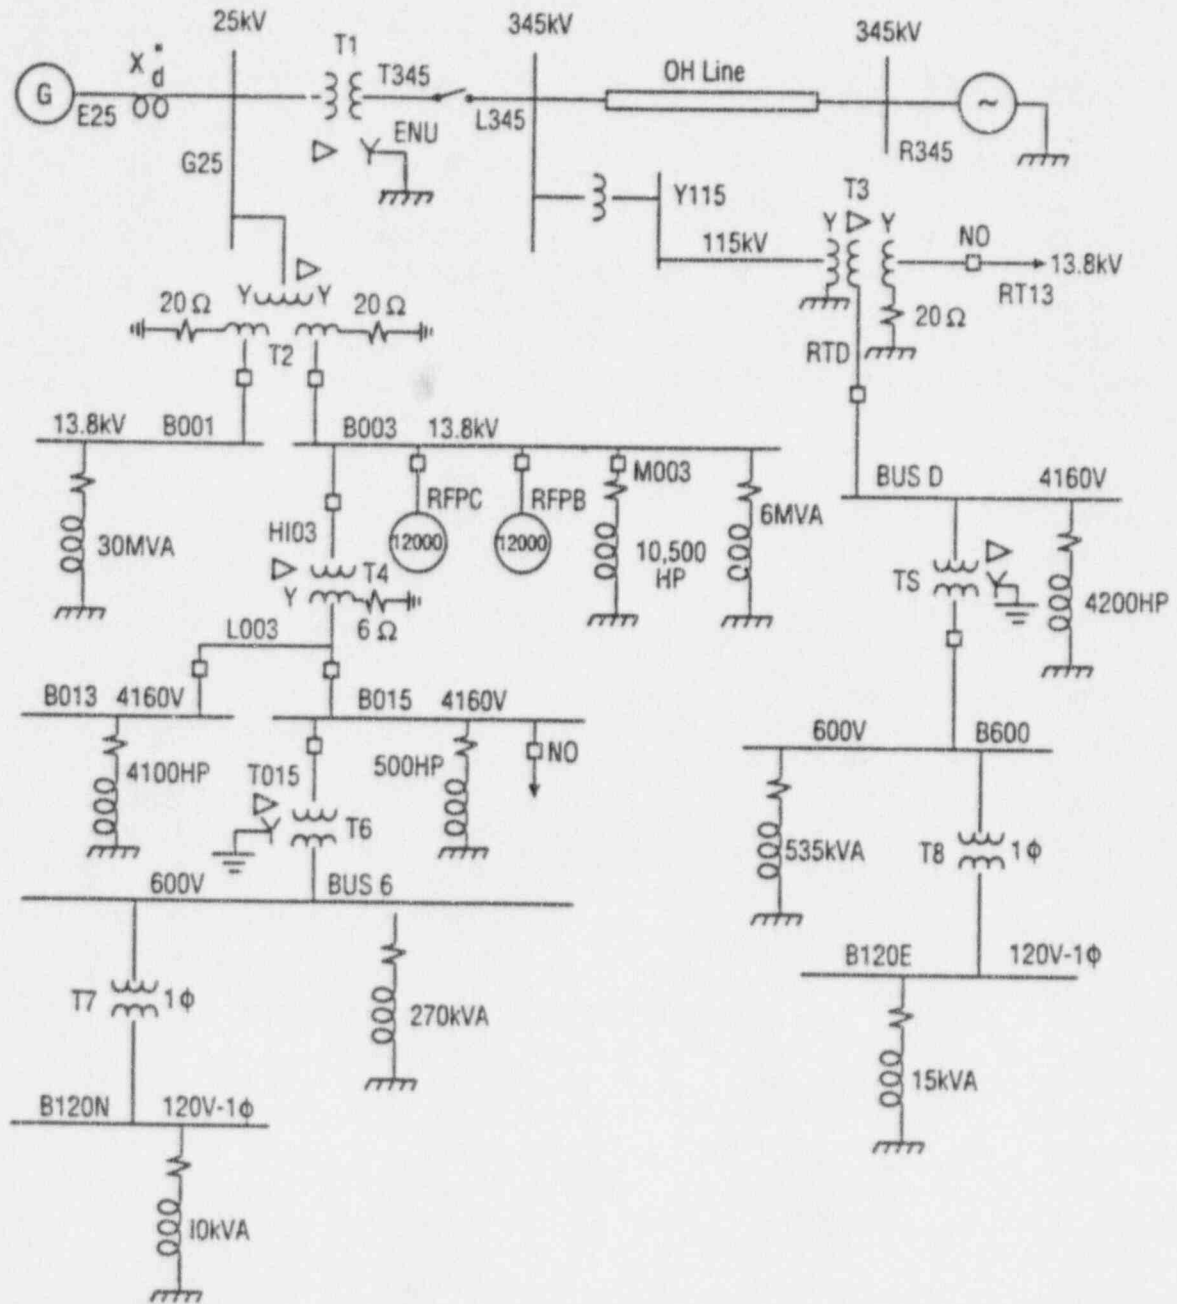
Figure 5.1 EMTP simulation model

Figure 5.1 is a simplified EMTP simulation model used in the surge arrester operation studies (Ref. 5.2), and represents the essential features of both safety and non-safety related systems. The normal operating system configuration includes the normal station-service transformer which feeds the non-safety related network, and the reserve station-transformer feeding the safety-related emergency system. Both the normal and reserve transformers were modelled in full three-phase winding detail, including losses, leakage reactance, winding capacitance, and magnetic saturation. Though the two systems are not coupled, the potential for coupling is provided at the transmission level in the offsite power system.

For the non-safety related system, the normal station-service transformer feeds the 13.8 kV buses B001 and B003. Bus B003 supplies two 12,000 HP pump motors, a static equivalent of several other motors, and a static equivalent of several 600 V loads connected through the 13.8 kV/600 V delta-wye transformers. The 12,000 HP motors are modelled in full transient detail as three-phase rotating machines, including losses, magnetizing current, and rotor/load inertia. Bus B003 also feeds two 4.16 kV buses (Bus B013 and B015) through a delta-wye transformer. These buses are loaded with static

equivalents of several additional motors, and Bus B015 also feeds a 600 V bus (BUS6) through another delta-wye transformer. In turn, BUS6 supplies a 270 kVA static equivalent load, and feeds a 120/240 V bus (B120N) through a single-phase transformer, which supplies power to fire protection panels and miscellaneous control circuits.

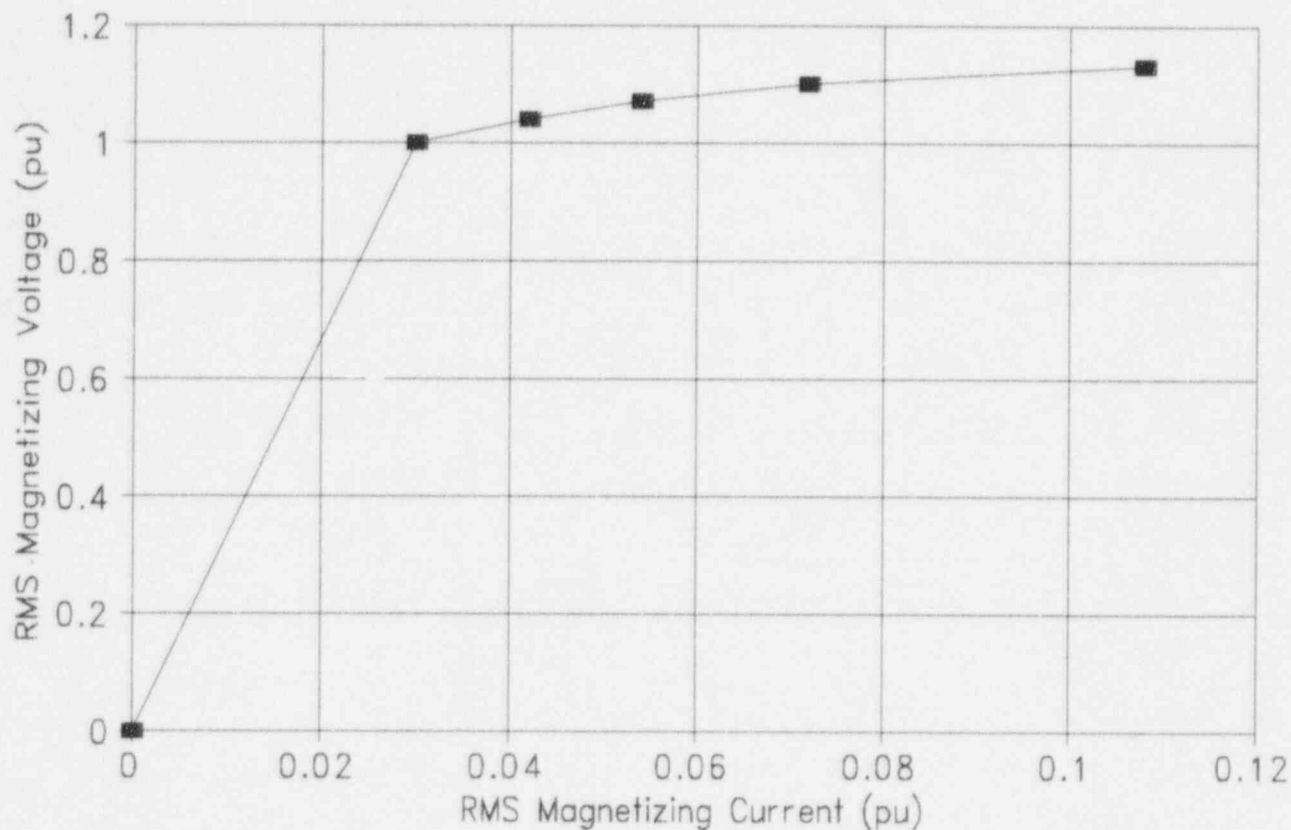
Fig. C-5. Saturation characteristics for reserve station service transformer.

Transformer rating: 42/56/70 MVA (0A/FA/FOA), 115/13.8/4.16 kV

Model parameters: $R_1 = 0.00229 \Omega$, $X_1 = 0.0421 \Omega$ (4.16 kV winding)
 $R_2 = 0.5825 \Omega$, $X_2 = 10.72 \Omega$ (115 kV winding)
 $R_3 = 0.00839 \Omega$, $X_3 = 0.1544 \Omega$ (13.8 kV winding)
 $R_{mag} = 681 \Omega$ (core losses)
 $I_{mag} = 142.79$ A (peak magnetizing current at knee)
 $\lambda_{mag} = 15.605$ V-s (peak flux linkage at knee)
 Magnetizing branch on 4.16 kV winding
 $C_{hg} = 8$ nF, $C_{lg} = 10$ nF, $C_{hl} = 15$ nF
