U. S. NUCLEAR REGULATORY COMMISSION
REGION I

Report No. 50-354/92-80

Facility Name: Hope Creek Generating Station

Areas Inspected: Announced team inspection by regional and contract personnel to review the functionality of the electrical distribution system.

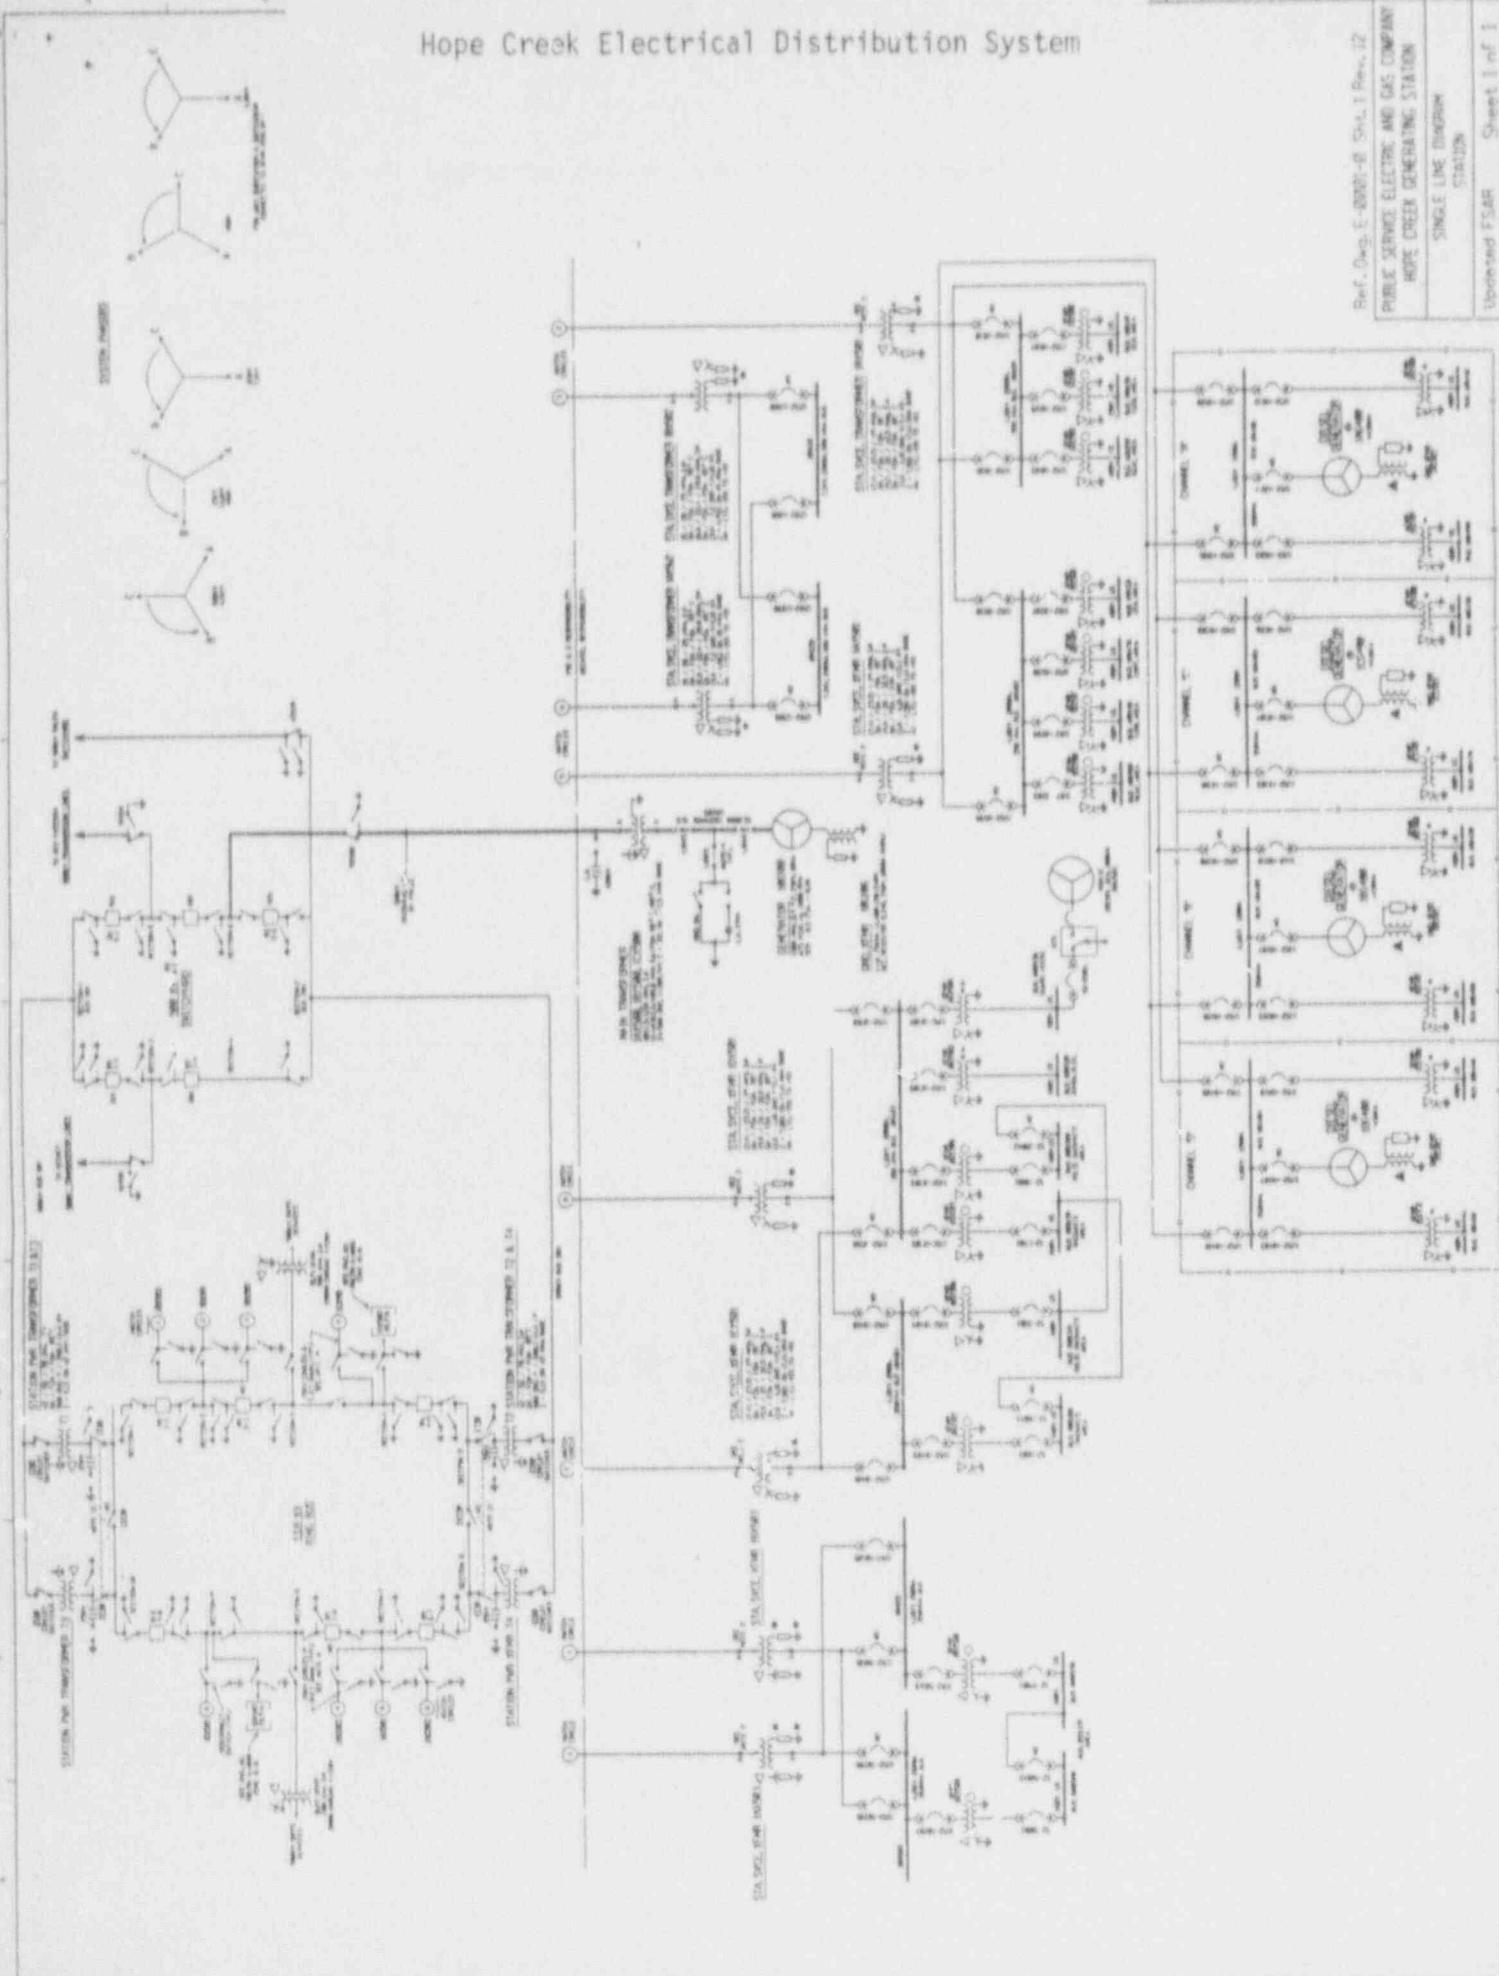
ATTACHMENT 3

Hope Creek Electrical Distribution System

Ref. Doc. E-20007-0, Ch. 1 Rev. 12
PUBLIC SERVICE ELECTRIC AND GAS COMPANY
HOPE CREEK GENERATING STATION
SINGLE LINE DIAGRAM
STATION

Updated FSAR Sheet 1 of 1
Rev. 3 Apr. 10, 1996 Fig. B-3-1
