VIRGINIA ELECTRIC AND POWER COMPANY
NORTH ANNA POWER STATION UNIT NOS. 1 AND 2
SUMMARY OF FACILITY CHANGES, TESTS AND EXPERIMENTS

1995 MODIFICATION SUMMARIES
NORTH ANNA POWER STATION

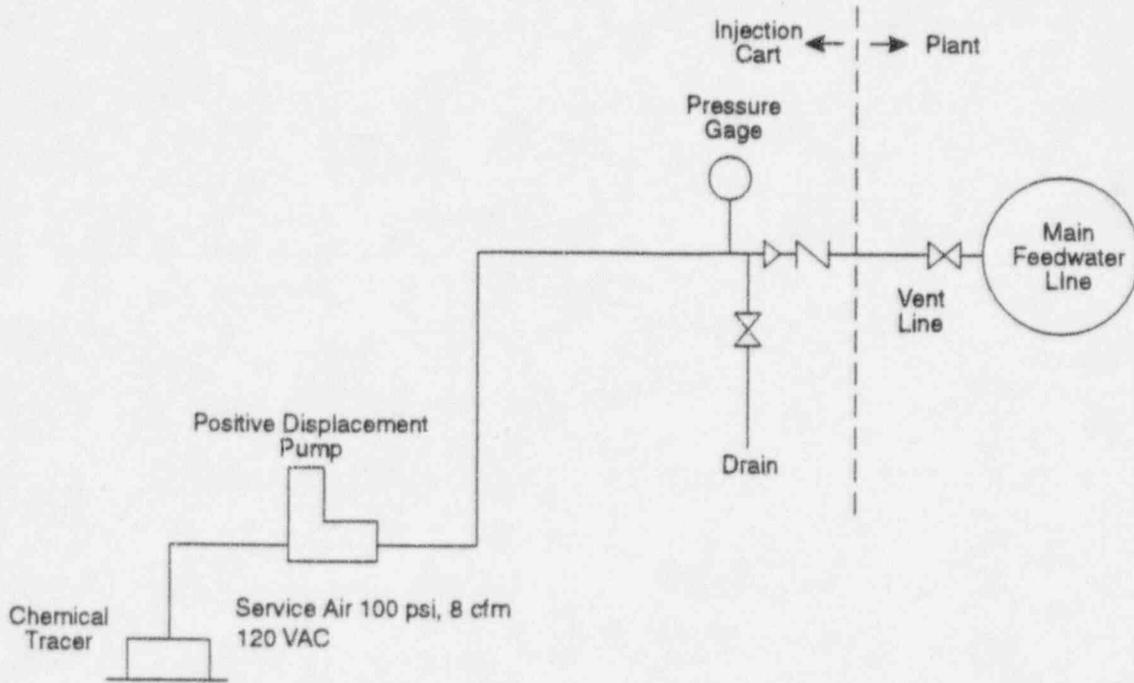
ATTACHMENT 1
(Page 1 of 1)
LITHIUM INJECTION SYSTEM

Services Needed at Injection Point

- De-ionized water
- Service Air at 100 psi, 8 cfm
- Drain location
