# Field Performance Assessment of Synthetic Liners for Uranium Tailings Ponds

Status Report

Prepared by D. H. Mitchell, G. E. Spanner

**Pacific Northwest Laboratory**  
Operated by  
Battelle Memorial Institute

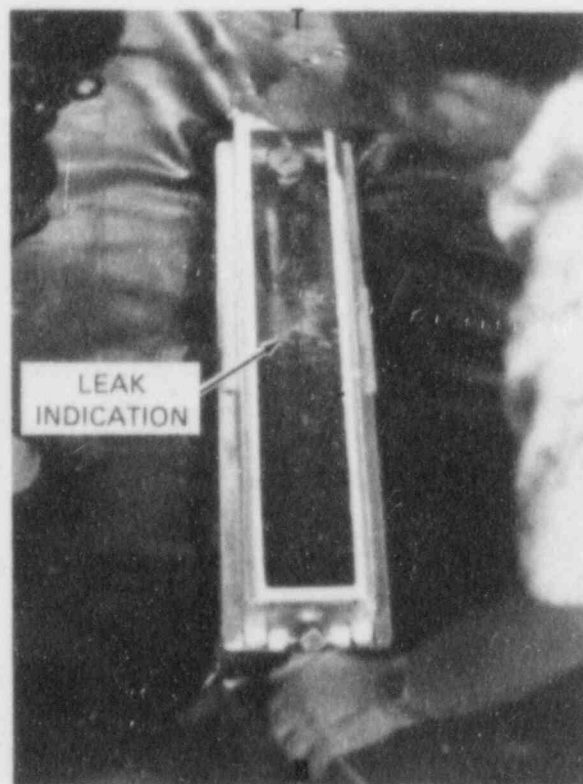
Figure 3 Vacuum chamber detecting a leak in a chlorosulfonated polyethylene

Vacuum Chamber--In the vacuum test, a 1-m long gasketed chamber is placed over a section of seam that has been coated with liquid soap. The chamber, which has a transparent top, is then partially evacuated using an air pump. Any unbonds that extend across the seam are then indicated by the presence of soap bubbles. This test is very sensitive to small leaks, and has the additional feature of stressing the seam to cause marginally bonded areas to become unbonded, thereby indicating a leak (see Figure 3).

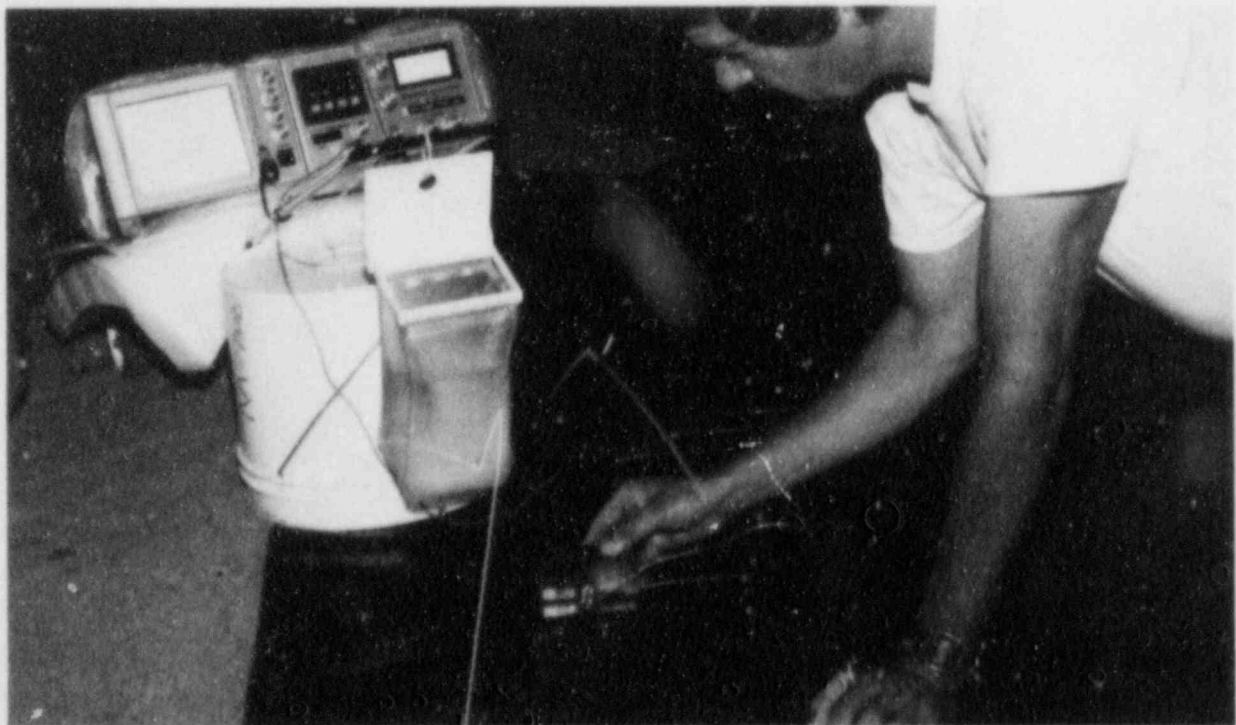
Figure 6 Seam inspection transducer holder with the ultrasonic impedance plane instrument

when calibrating the ultrasonic impedance plane instrument. The only modification we made to either instrument was to build a transducer holder for the ultrasonic impedance plane instrument. As shown in Figures 5 and 6, the holder

is a transparent block that has a water supply line attached to it. A cavity around the transducer retains water so that adequate acoustic coupling is assured at all times. The holder allows observation of the alarm light and is more comfortable for the operator to hold, so it helped increase the ultrasonic impedance plane inspection rate while preventing false alarms from lack of couplant.

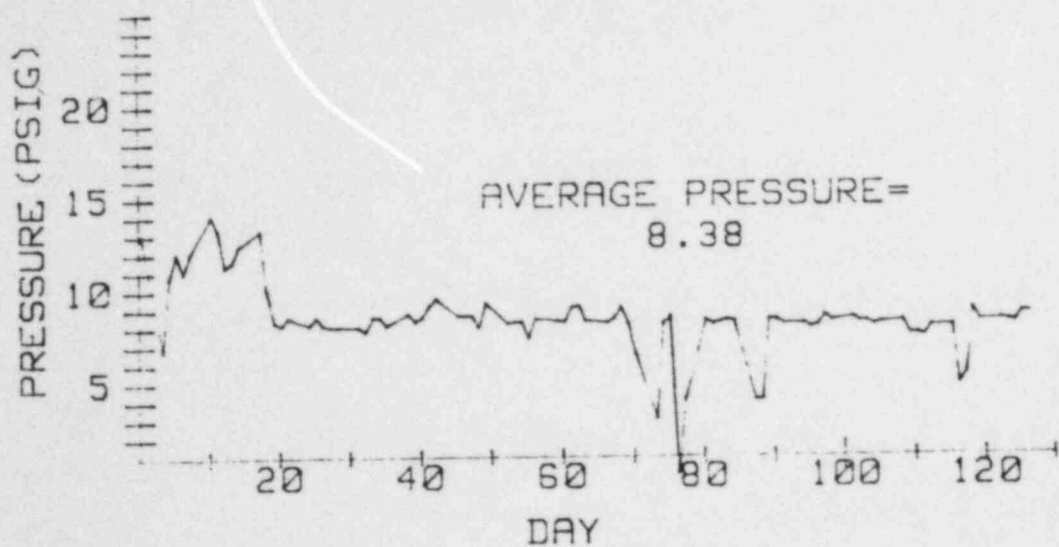
FIGURE C.2. Exposure Conditions for Aging of High Density Polyethylene at 48°C
