SHOREHAM NUCLEAR POWER STATION

SNRC-1141

Fire Protection
Shoreham Nuclear Power Station - Unit 1
Docket No. 50-322

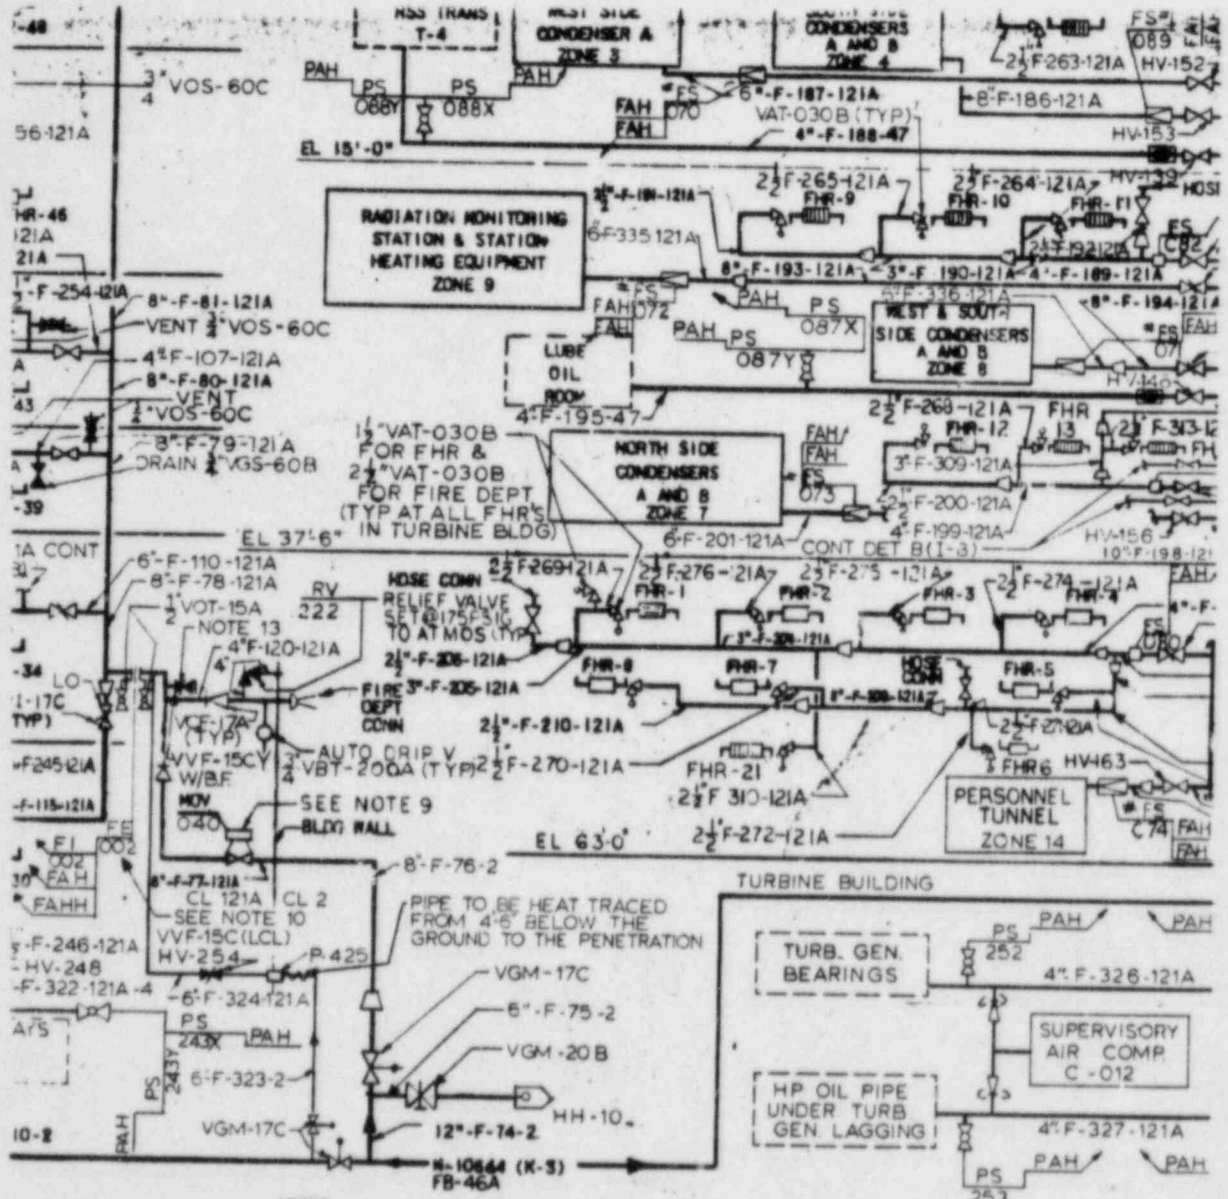
- 1. SOLID BOXED-IN AREAS DENOTE NET PIPE SPRINKLER SYSTEM.
- 2. DOTTED BOXED-IN AREAS DENOTE FIXED DELUGE WATER SPRAY SYSTEM.
- 3. SPRINKLER SYSTEM FOR DIESEL DRIVEN FIRE PUMP AREA M-10664(FB-46A)
- 4. ALL CONNECTIONS FOR PRESSURE INSTS TO BE 3/4" VOT-15A EXCEPT AS NOTED
- 5. ALL INSTR, EQPT & LINE DES. NOS. ARE PREFIXED WITH UNIT & SYS. NO. IM-43, UNLESS OTHERWISE NOTED

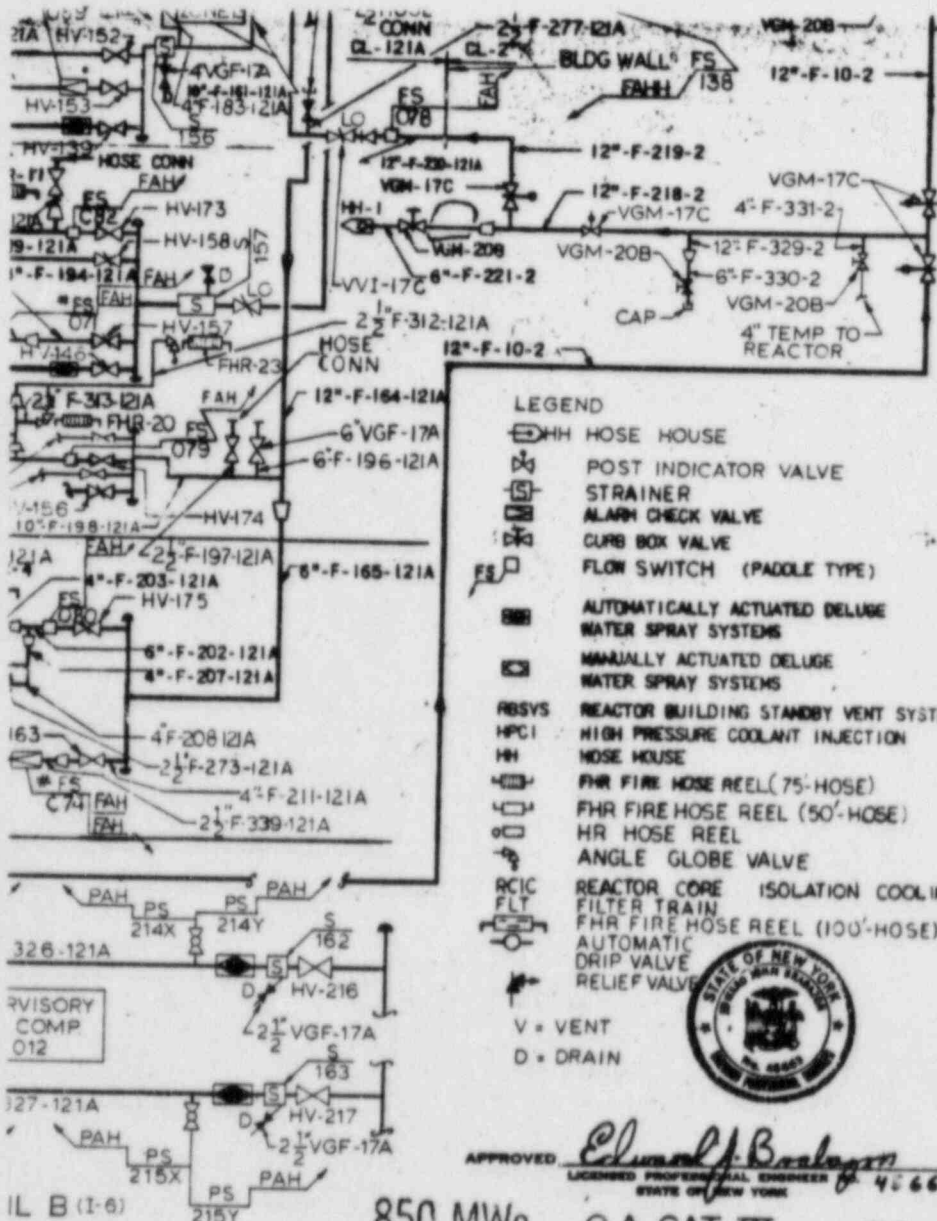
- LEGEND**
- HH HOSE HOUSE
 - POST INDICATOR VALVE
 - STRAINER
 - ALARM CHECK VALVE
 - CURB BOX VALVE
 - FLOW SWITCH (PADDLE TYPE)
 - AUTOMATICALLY ACTUATED DELUGE WATER SPRAY SYSTEMS
 - MANUALLY ACTUATED DELUGE WATER SPRAY SYSTEMS
 - RBSYS REACTOR BUILDING STANDBY VENT SYSTEM
 - HPCI HIGH PRESSURE COOLANT INJECTION
 - HH HOSE HOUSE
 - FHR FIRE HOSE REEL (75'-HOSE)
 - FHR FIRE HOSE REEL (50'-HOSE)
 - HR HOSE REEL
 - ANGLE GLOBE VALVE
 - RCIC REACTOR CORE ISOLATION COOLING FILTER TRAIN
 - FHR FIRE HOSE REEL (100'-HOSE)
 - AUTOMATIC DRIP VALVE
 - RELIEF VALVE
- V = VENT
D = DRAIN
