NUREG/CR-3950  
PNL-5210  
Vol. 7

# Fuel Performance Annual Report for 1989

Prepared by  
W. J. Bailey, F. M. Berting/PNL  
S. Wu/NRC

Pacific Northwest Laboratory  
Operated by  
Battelle Memorial Institute

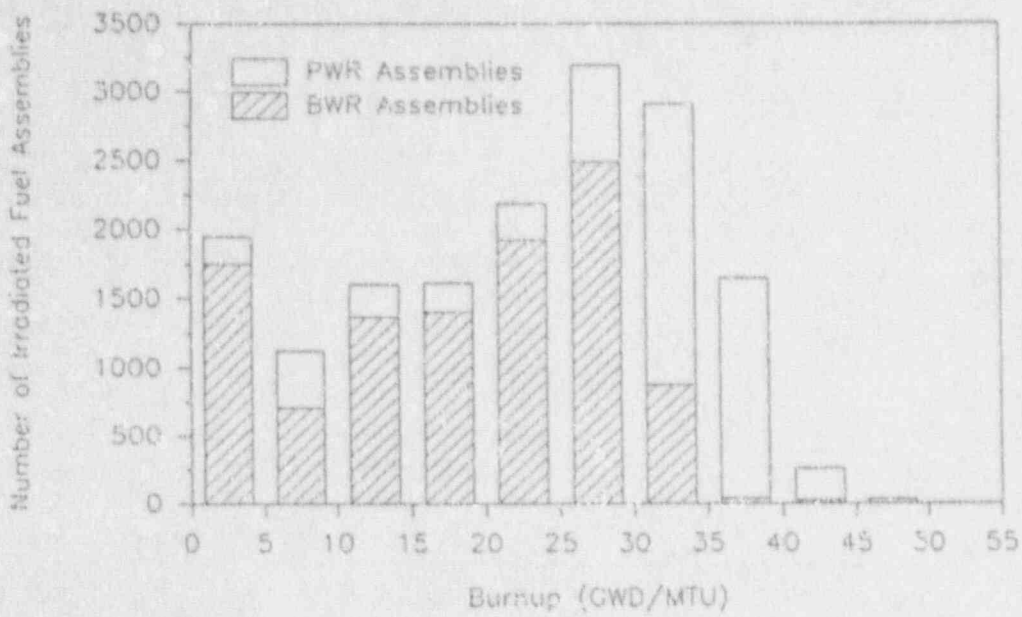
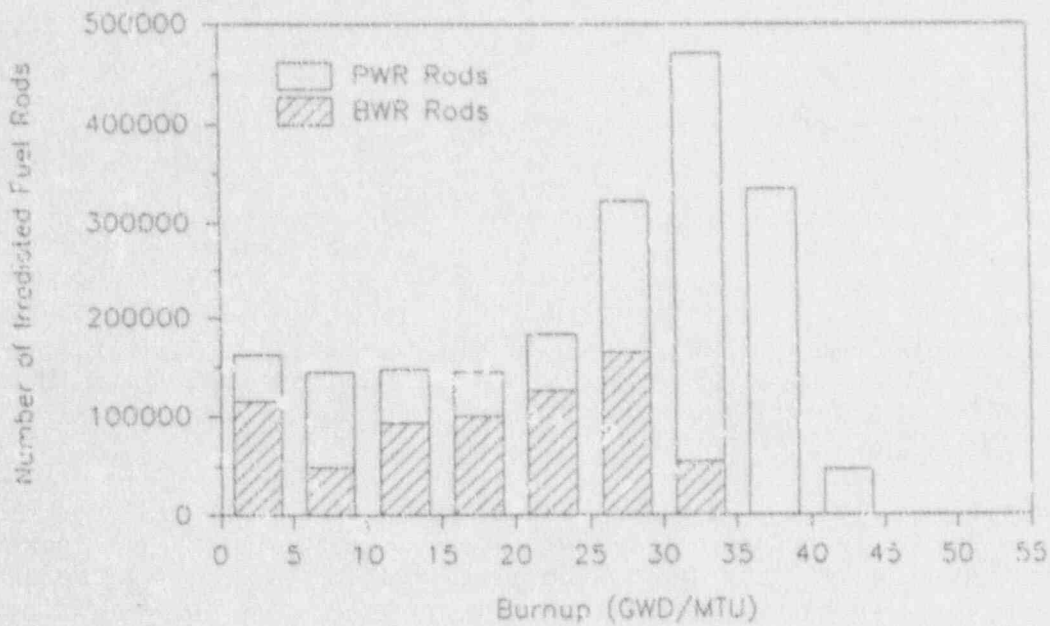
FIGURE 1. Distribution of Irradiated Advanced Nuclear Fuel Corporation's Fuel by Exposure Through the End of 1989<sup>(1)</sup>

The exposure distribution of ANF fuel rods and assemblies, as of the end of 1989, is shown in Figure 1.<sup>(1)</sup> The highest exposure levels reached by ANF fuel to date are 41.1 GWd/MTU in 1985 for a group of BWR fuel rods irradiated at Big Rock Point in Michigan and 50.0 GWd/MTU in 1986 for PWR fuel irradiated at Tihange-1 in Belgium. ANF's BWR 9x9 fuel assemblies and PWR 17x17 fuel assemblies reached new high burnups in 1989: BWR 9x9 fuel at Gundremmingen-3 in Germany reached 40.0 GWd/MTU and PWR 17x17 fuel at Donald C. Cook-2 in Michigan reached 44.0 GWd/MTU.

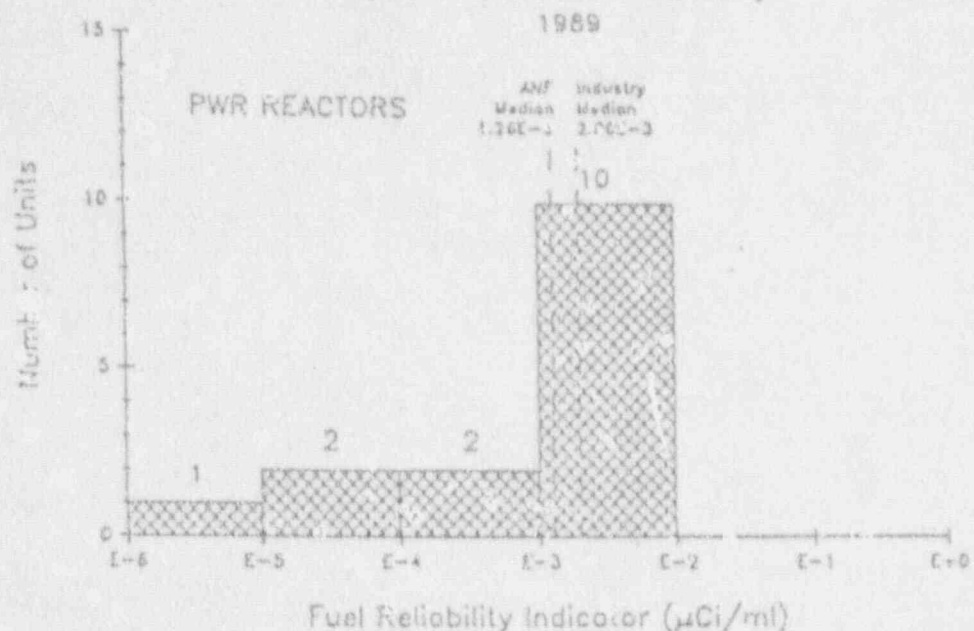
FUEL RELIABILITY INDICATOR -- INPO METHOD  
(Reload Quantities of ANF Fuel)

FIGURE 2. Advanced Nuclear Fuel Corporation PWR Fuel Reliability Indicator (FRI), Using the Institute of Nuclear Power Operations (INPO) Method: Annual Distribution of FRI for PWRs in 1989. (Note:  $1.2\text{E}-04$  is equivalent to  $1.2 \times 10^{-4}$ )

To assess the reliability of ANF fuel, ANF uses the INPO FRI described above. The FRI distribution for ANF PWR and BWR fuel is shown in Figure 2<sup>(1)</sup> and is derived from the 1989 yearly average for each reactor that operated with ANF fuel in the core. The median value for all PWR reactors containing ANF fuel is  $1.26 \times 10^{-3}$   $\mu\text{Ci/ml}$ , which compares well with the INPO PWR median value of  $2.0 \times 10^{-2}$   $\mu\text{Ci/ml}$ . The median value for BWR reactors containing ANF fuel in 1989 is  $3.70 \times 10^{-2}$   $\mu\text{Ci/ml}$ , with the industry median being  $9.30 \times 10^{-1}$   $\mu\text{Ci/ml}$ . ANF did not have any failures attributed to design or manufacturing in 1989. The five-year trend in the ANF FRI indicates a continued improvement in fuel performance.

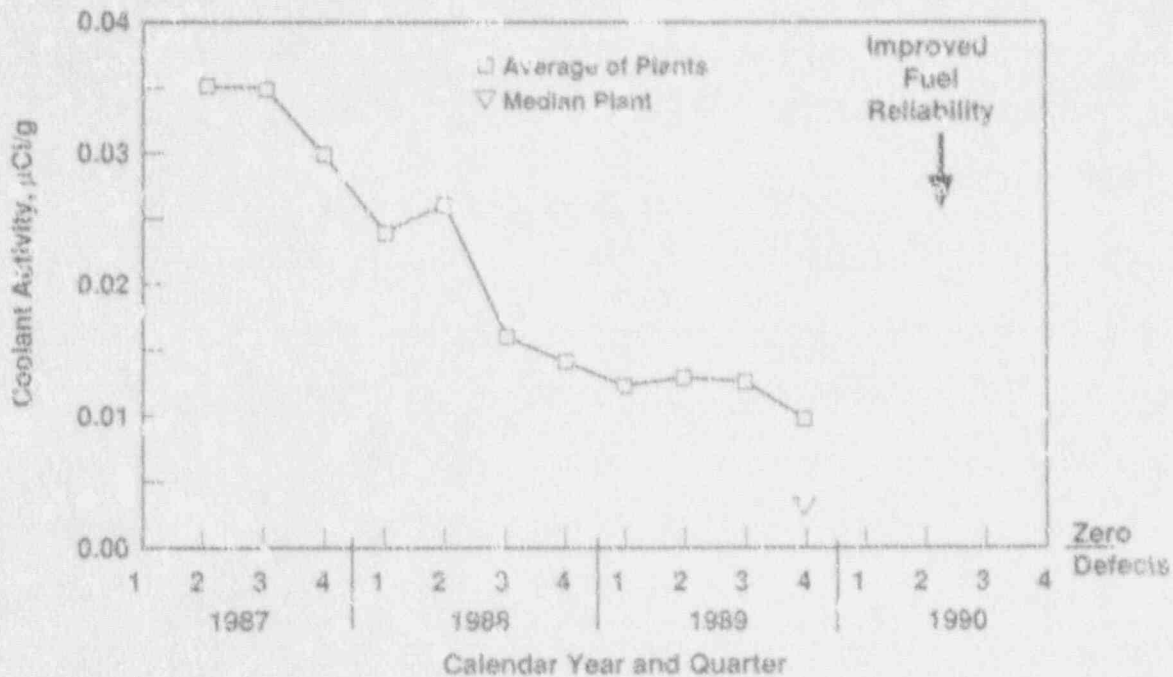
### All U.S. PWR Plants with C-E Fuel

\* INPO Standard Method

December 31, 1989
