FORT CALHOUN STATION

IRRADIATED FUEL INSPECTION
FOLLOWING CYCLE IV OPERATION

November - December 1978

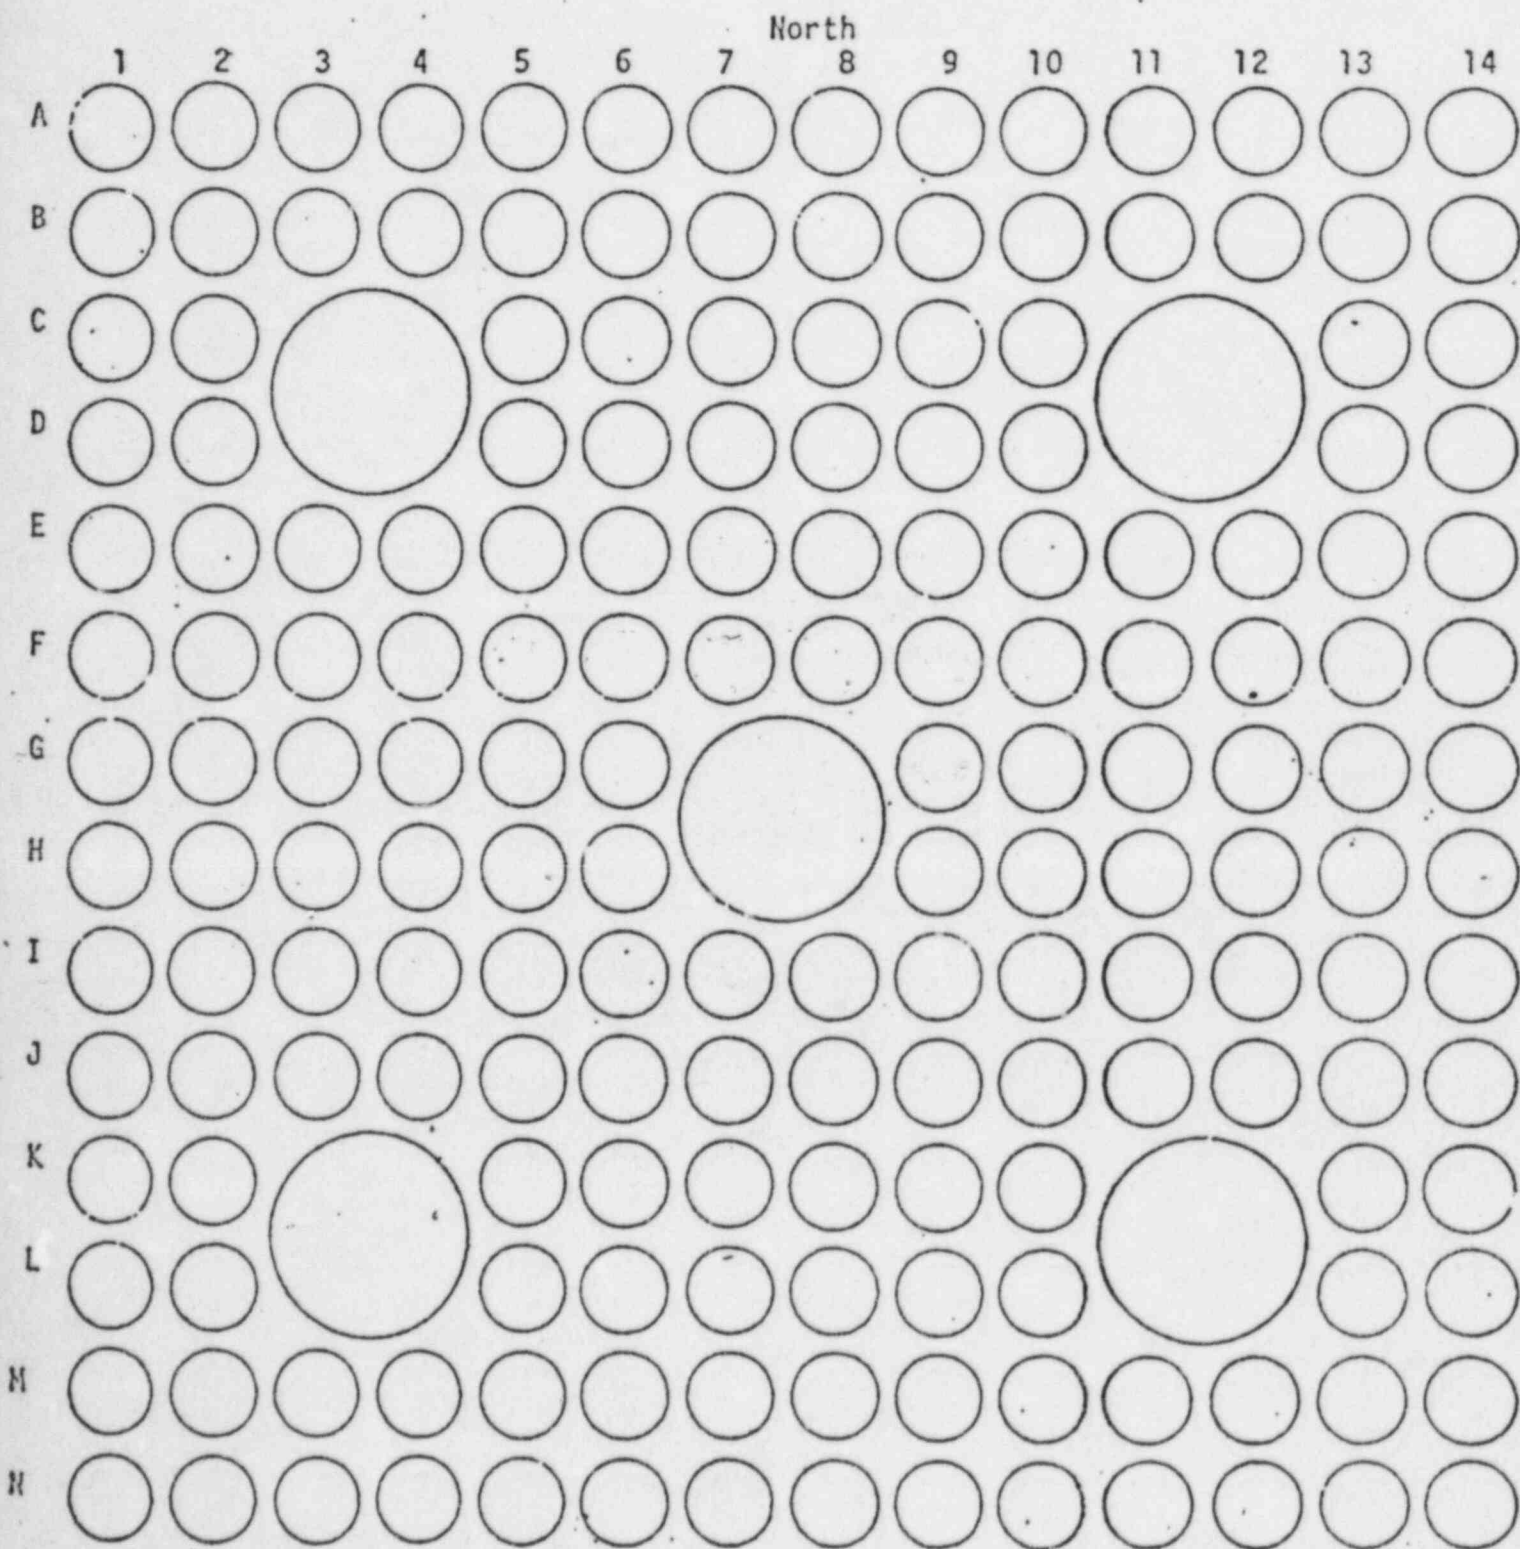
FIGURE 1

ASSEMBLY MAPPING SCHEME

It should be noted that the pool-side television monitor has been modified to eliminate mirror-imaging which results from the use of a right angle mirror on the camera. The video tapes, however, record a mirror image, i. e., images appearing on the right really represent the left side of the object. The auto dubbing comment may refer to the right side of the assembly face but, when the video tape is viewed on a monitor without the mirror-image eliminator, the right side will appear on the left. The notation used to indicate the identity of the face being examined is defined by calling the face which faces the north direction when the assembly is in the southeast orientation as the north face. Figure 1 shows the assembly mapping scheme.
