U.S. NUCLEAR REGULATORY COMMISSION
REGION I

Report Nos. 92-23
92-23

Facility Name: Limerick Generating Station, Units 1 and 2

EXECUTIVE SUMMARY
Limerick Generating Station
Report Nos. 92-23 & 92-23

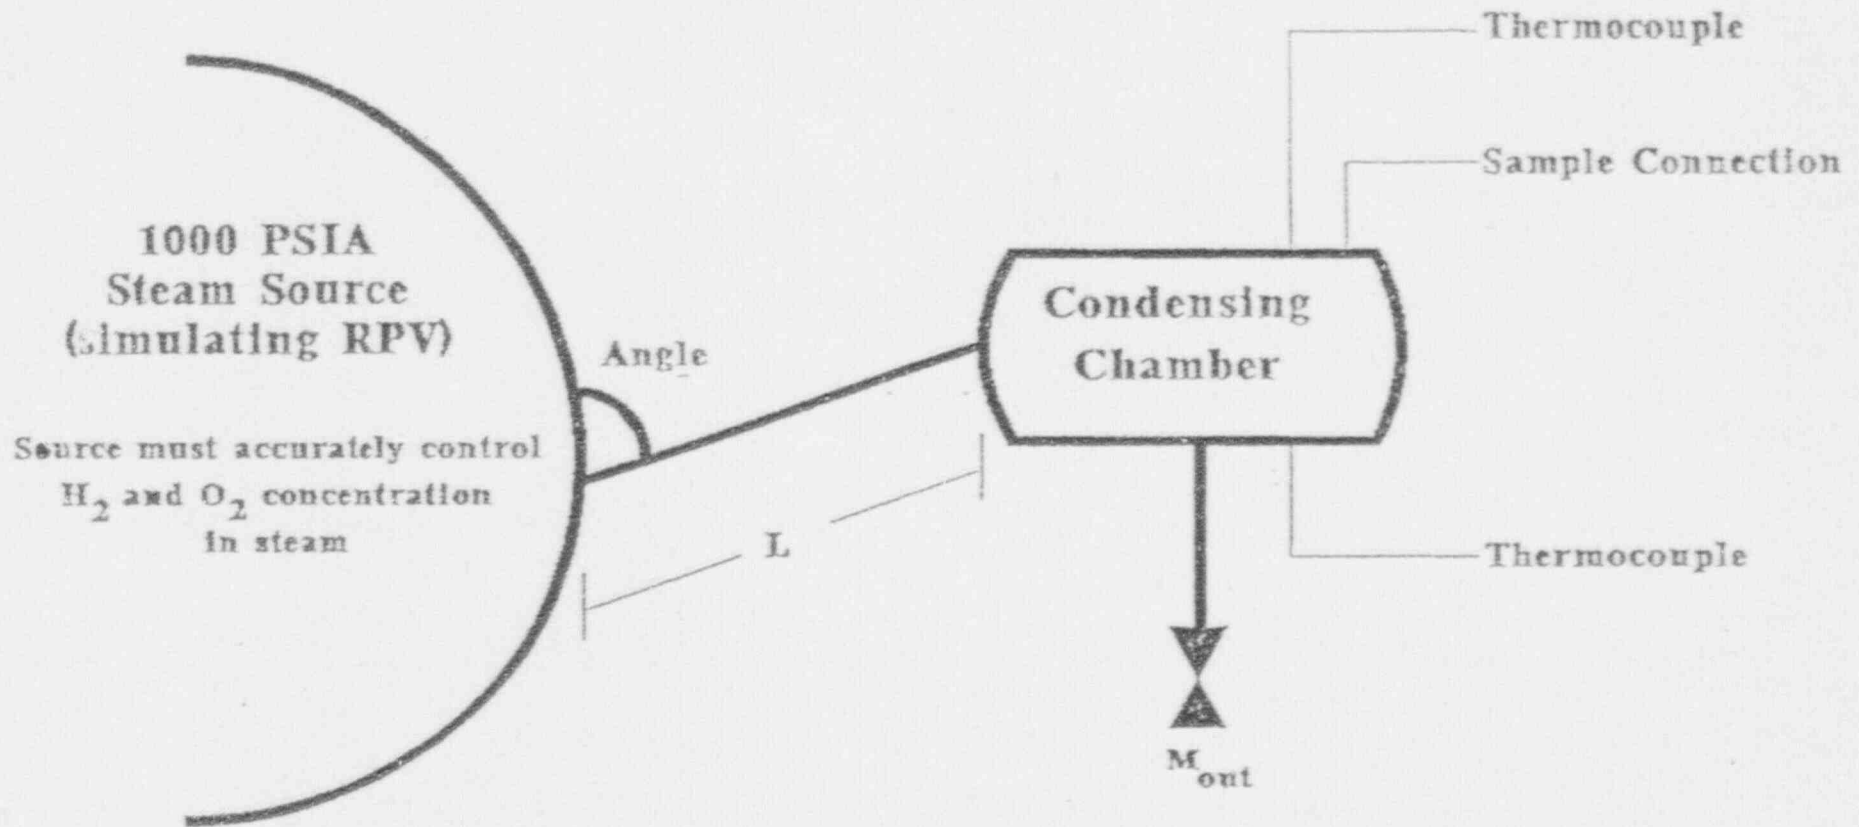
Figure 3

Condensing Chamber Performance Test

Test for inlet length and angle as well as CC geometry to establish data for the concentration of non-condensable gases entering the cold leg.

Data to determine the performance of condensing chambers (CCs) will be obtained from a full scale test prototypical mock-up shown schematically in Figure 3.
