U. S. ATOMIC ENERGY COMMISSION  
REGION I  
DIVISION OF COMPLIANCE

Report of Inspection

CO Report No. 219/71-1

Licensee: JERSEY CENTRAL POWER & LIGHT COMPANY  
Oyster Creek - 1  
License No. DPR-16  
Category C

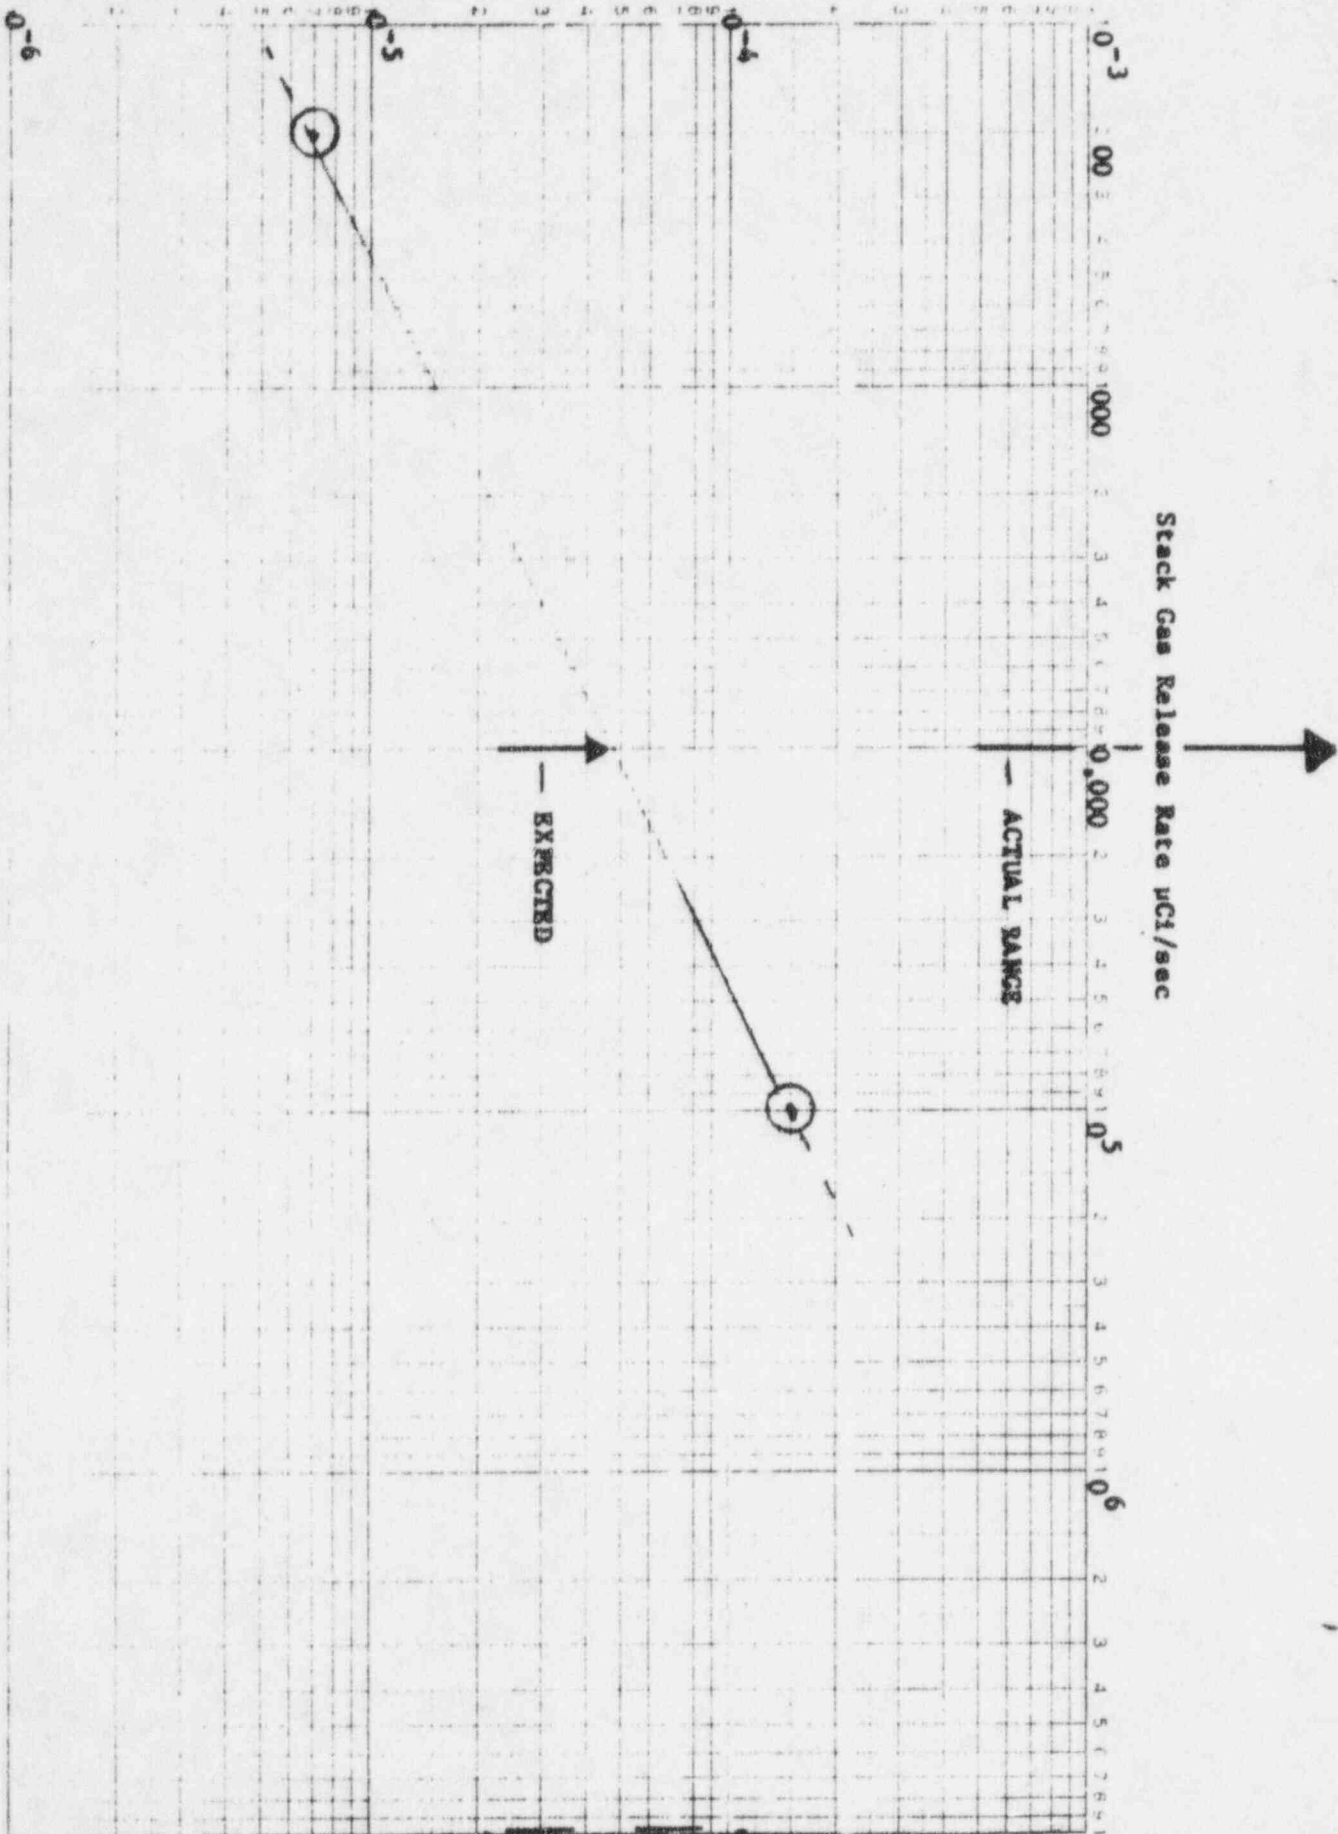
Concentration  $\mu\text{Ci/ml}$  Floor Drain Sample

Figure 1 Floor Drain Concentration Vs Stack Gas Rate

<sup>5/</sup> As shown on Figure 1.
