In the Matter of)
)
LONG ISLAND LIGHTING COMPANY)
)
(Shoreham Nuclear Power Station,)
Unit 1))
)
)
)

Docket No. 50-322-OL-4
(Low Power)

SUFFOLK COUNTY AND STATE OF NEW YORK BRIEF
IN SUPPORT OF APPEAL OF OCTOBER 29, 1984
ASLB DECISION ON LILCO'S EXEMPTION REQUEST

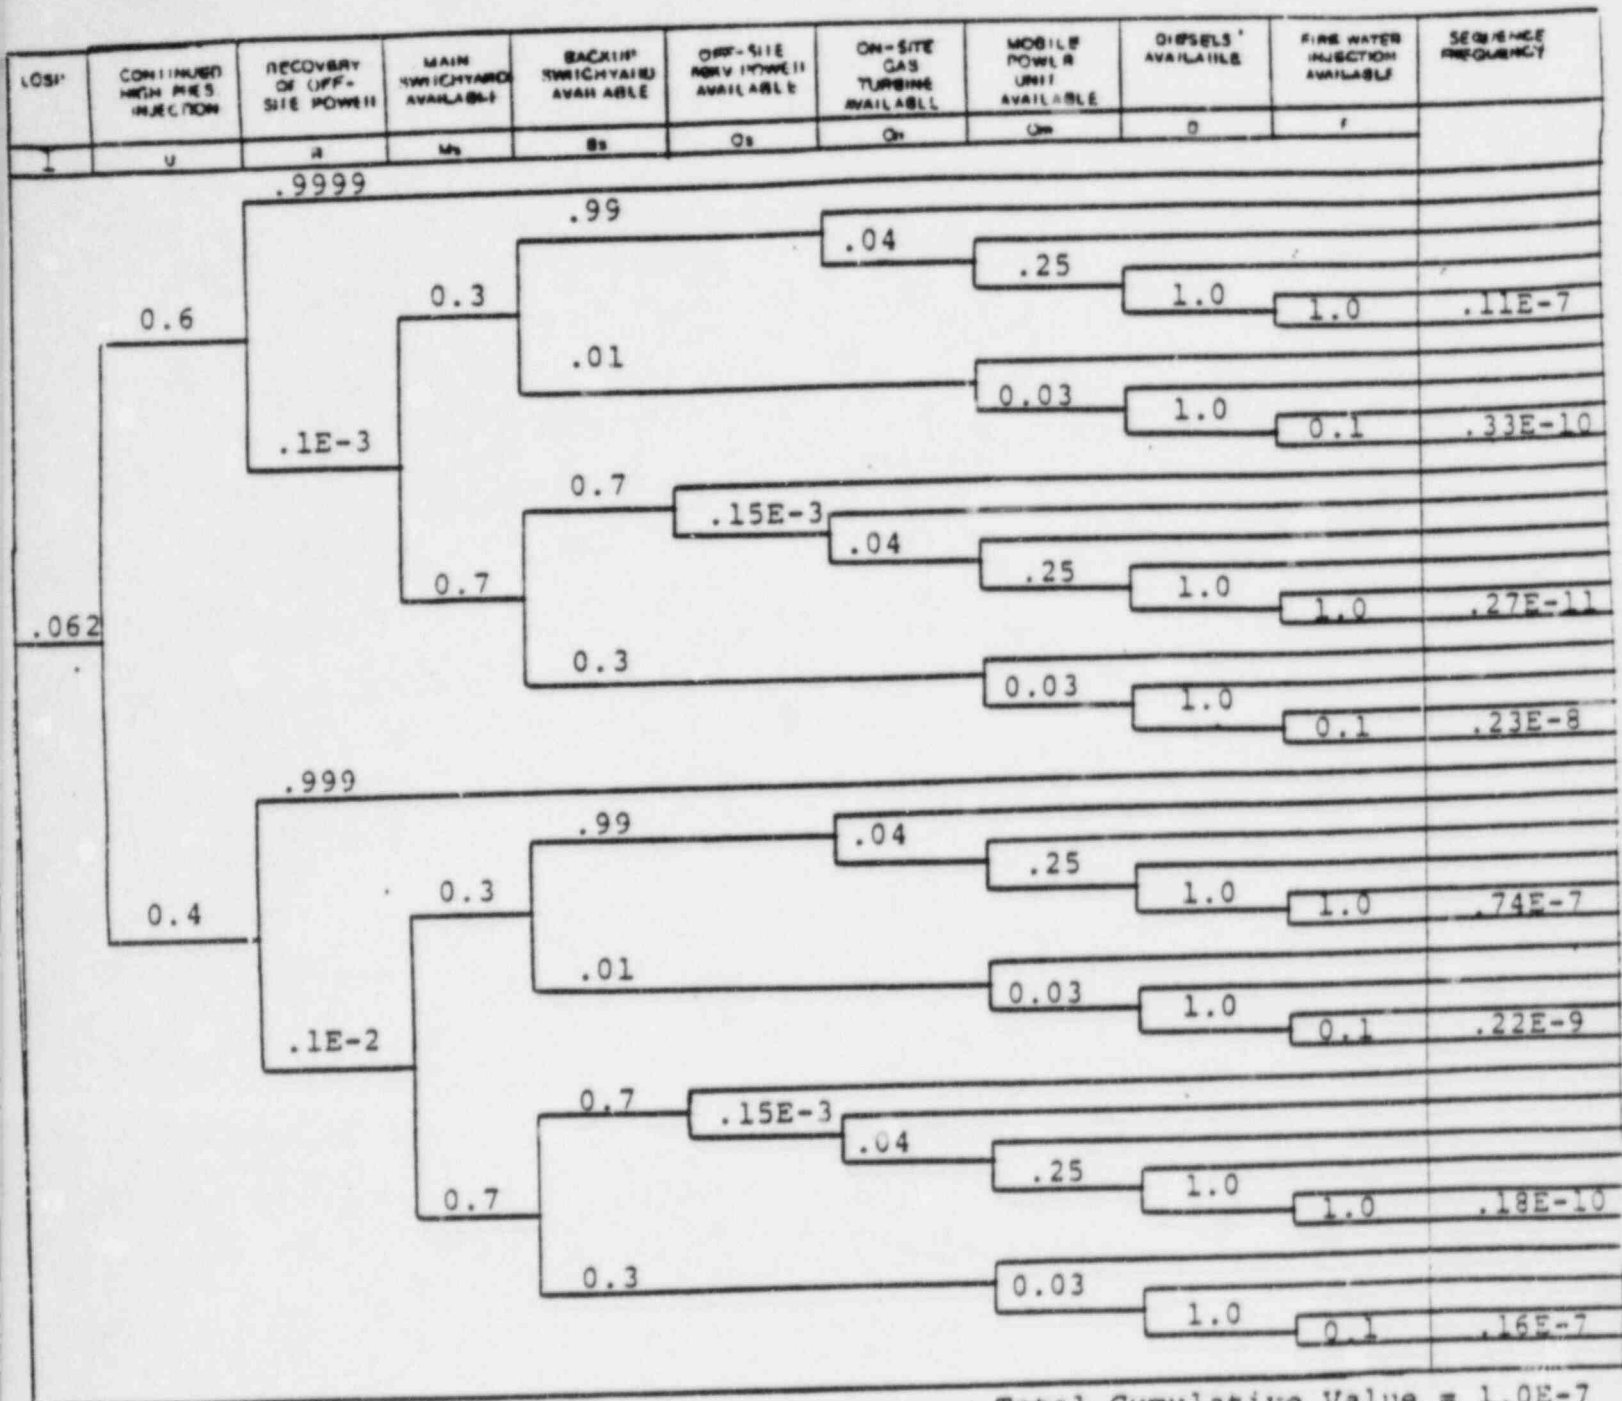
EVENT TREE D-1
(Table 1, Column 3)

Entry Conditions Sequence Type 1: LOSP; Isolation; Reactor Scrammed; Primary System Intact; Coolant Injection Available through 10 hours via HPCI/RCIC; reactor may be depressurized to 150 psia.
