UNITED STATES  
NUCLEAR REGULATORY COMMISSION  
WASHINGTON, D.C. 20555-0001

FACILITY: Byron Station, Unit 1

SUBJECT: SUMMARY OF MAY 14, 1996, MEETING TO DISCUSS THE APPLICATION OF PRIOR BYRON 1 EDDY CURRENT INSPECTION DATA TO ESTABLISH A BASIS FOR THE OPERATING INTERVAL BETWEEN STEAM GENERATOR TUBE INSPECTIONS

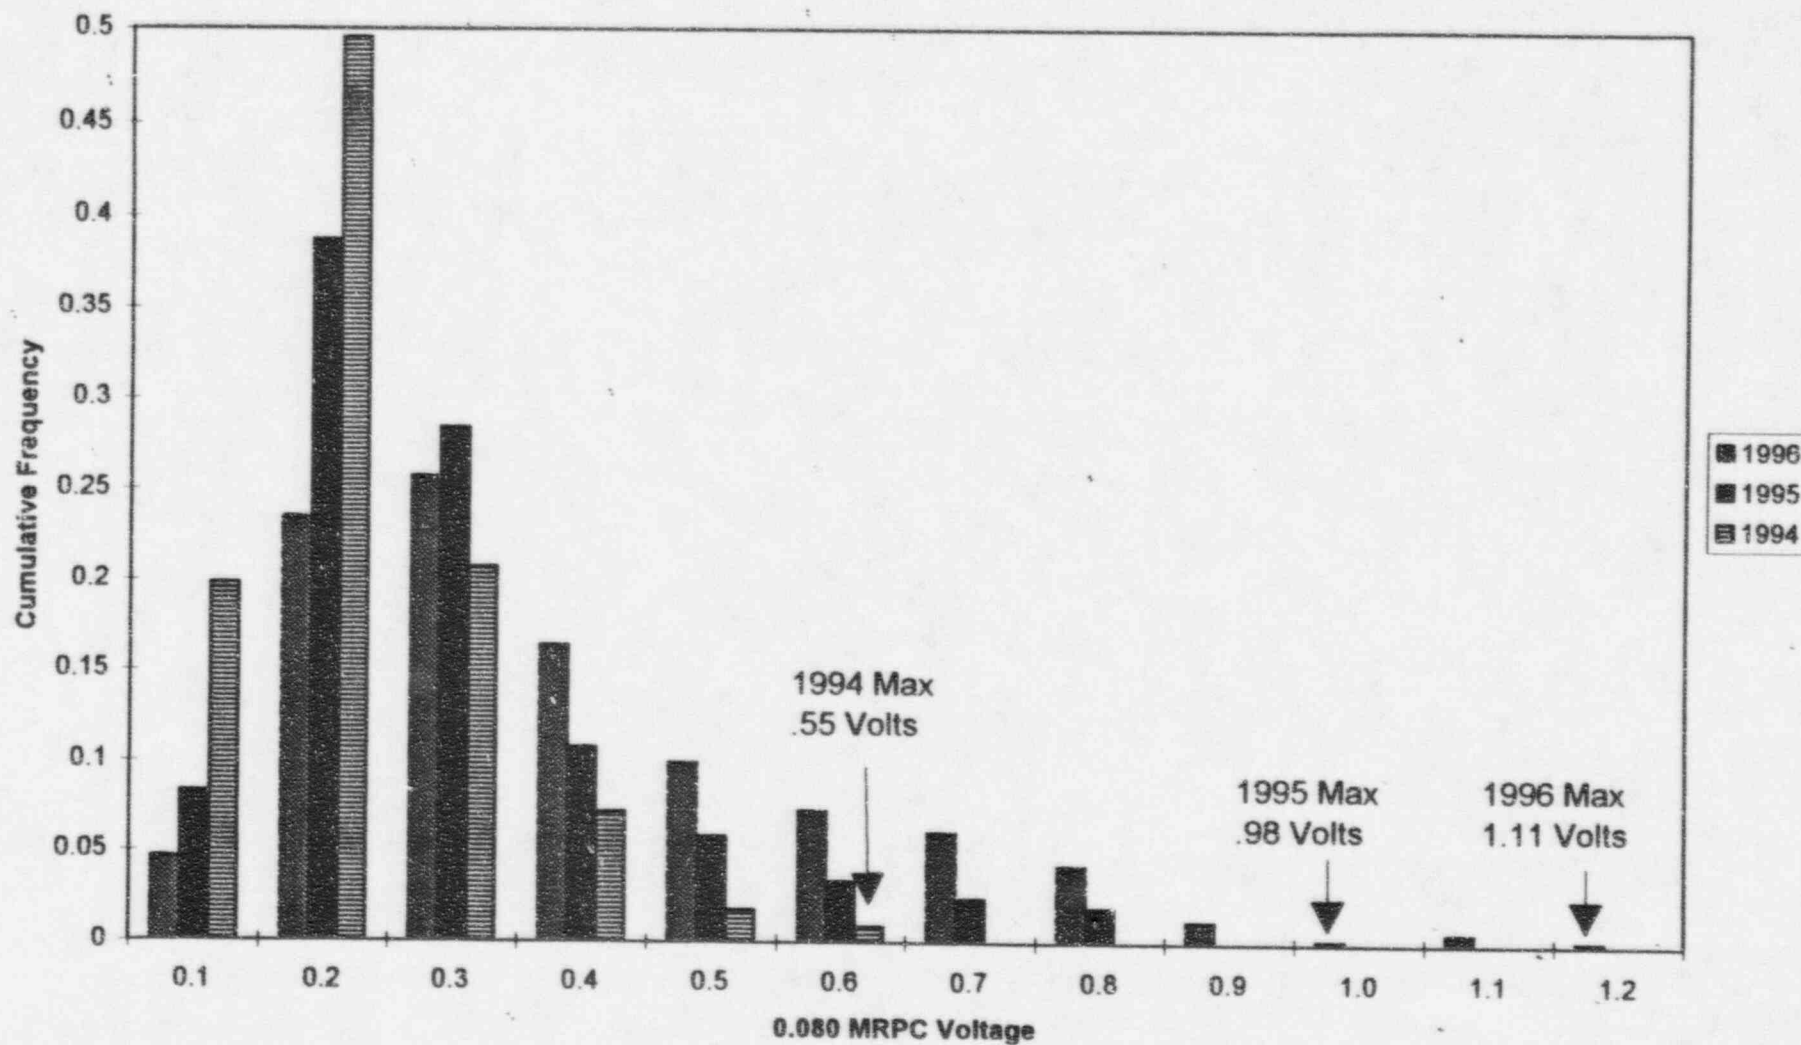
Byron Unit 1 1996 Look-Back Results for 0.080 MRPC Voltage Vs. Cumulative Distribution Frequency (Same Tubes)

Conclusions are Supported by the 1995 Look-Back

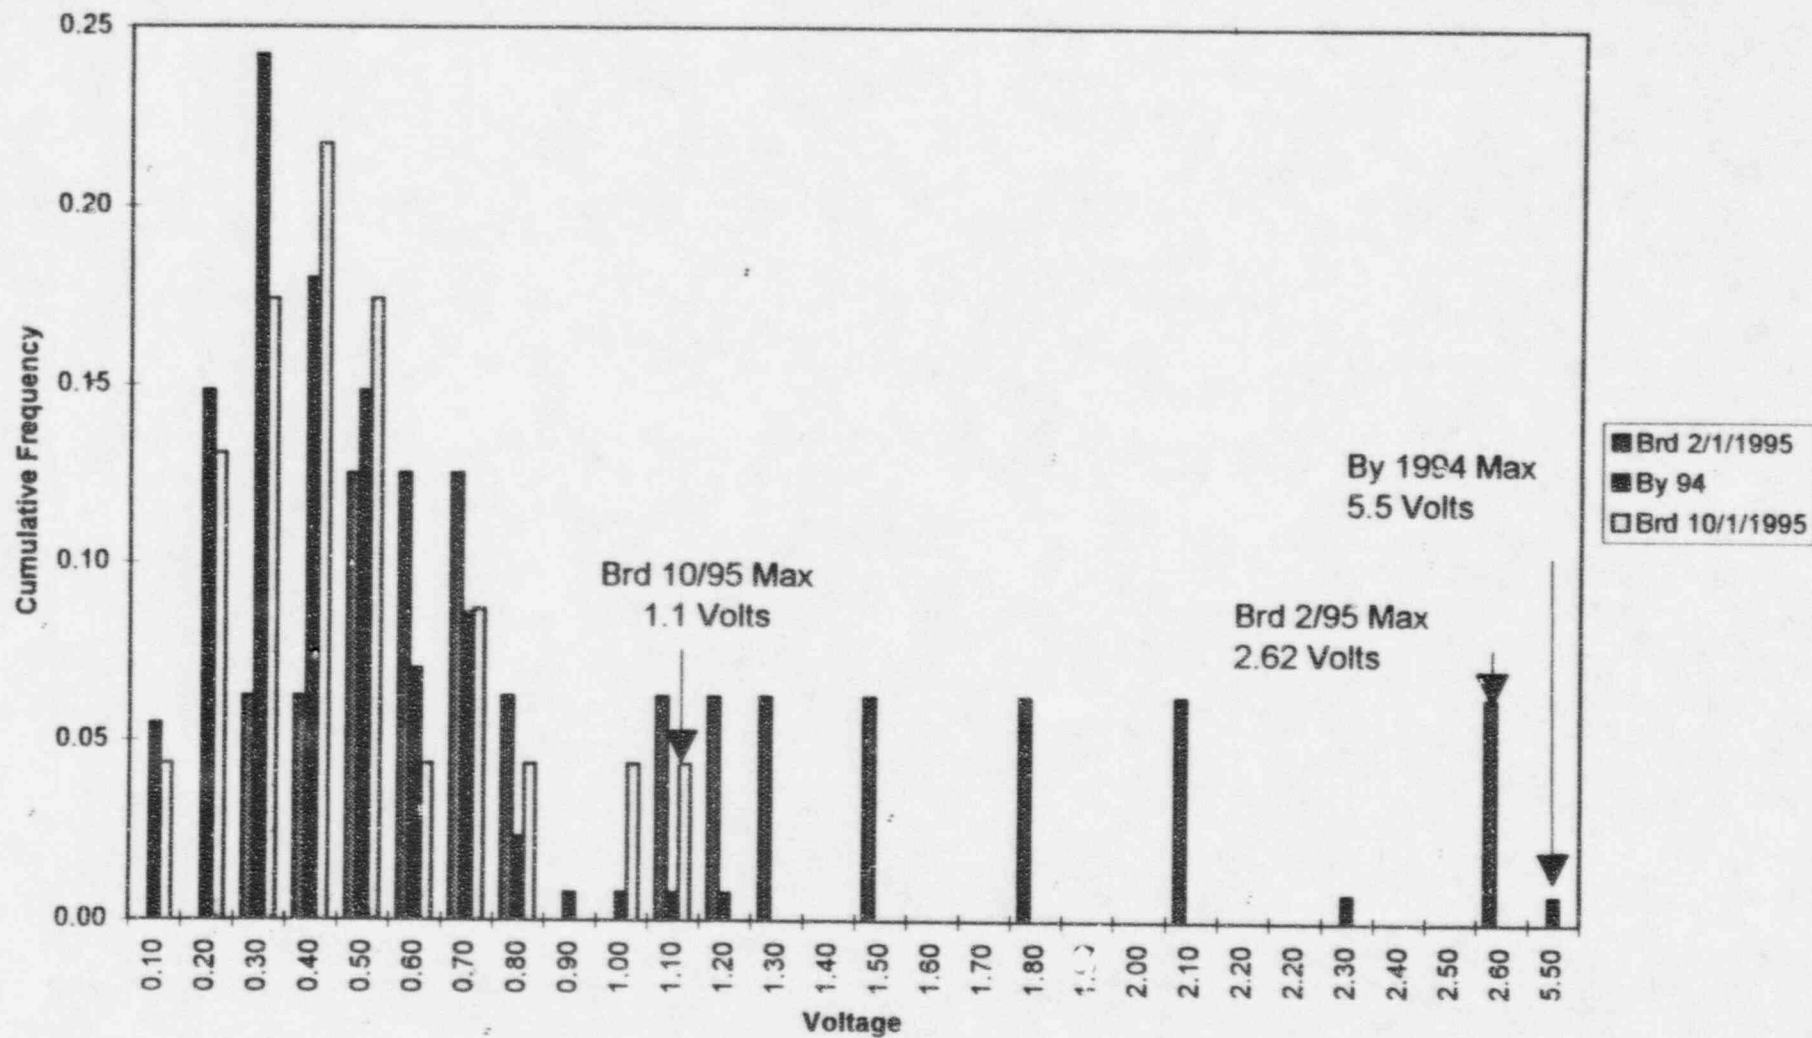
**Braidwood & Byron Unit 1 0.080 MRPC Voltage Vs. Cumulative Distribution Frequency  
(Repaired Tubes)**

Largest Indication in 10/95 Braidwood 1 Inspection is  
Significantly Smaller Than Byron 1 1994 Inspection (4X)

Byron 1 Indications Bound Braidwood 1
