**Results of Quality Programs
for Construction of
Clinton Power Station**

NRC Docket No. 50-461

UPDATE TO
RESULTS OF QUALITY PROGRAMS
FOR CONSTRUCTION OF
CLINTON POWER STATION

ILLINOIS POWER COMPANY
APRIL 1985

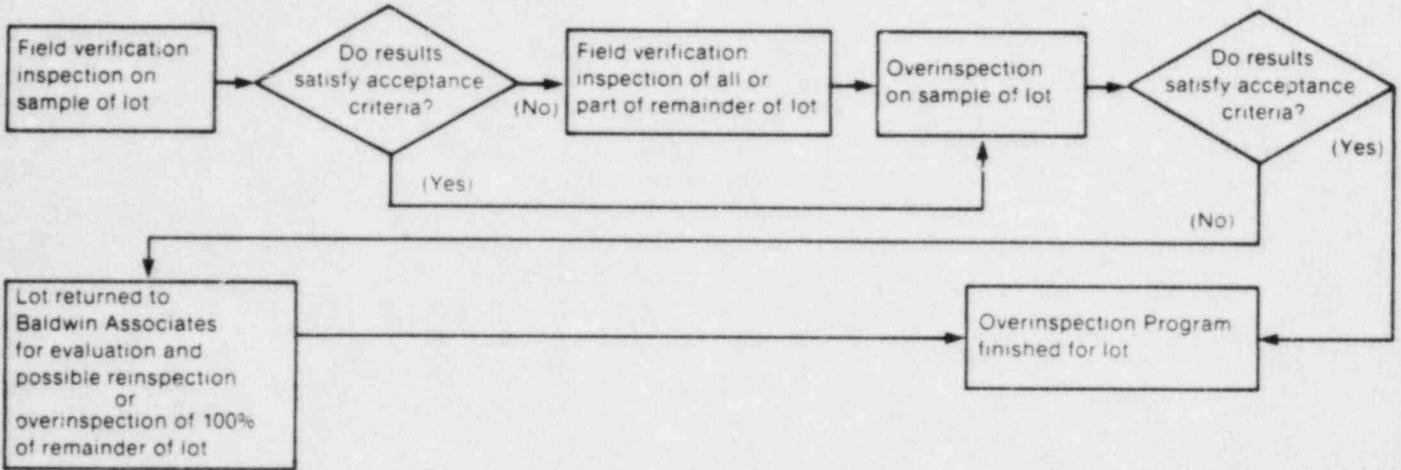
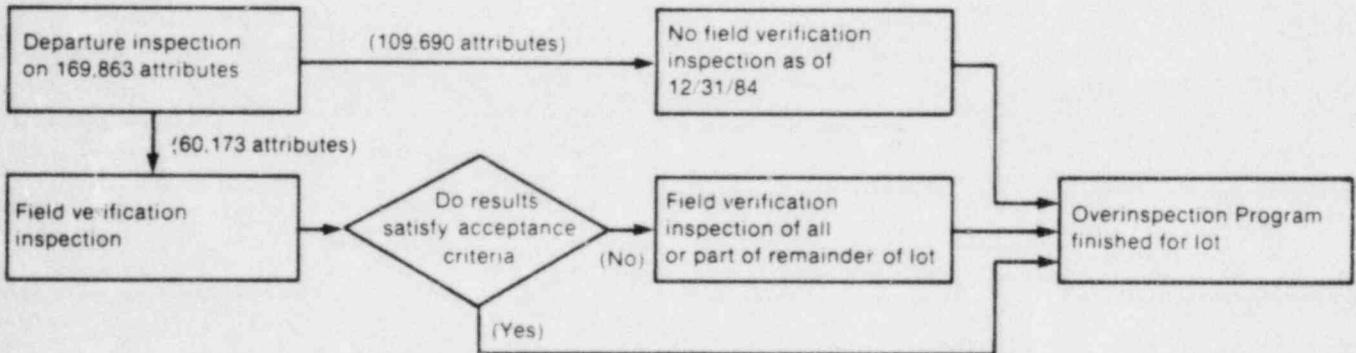
Figure V-1

I. Lots Subject to Field Verification Inspection and Overinspection

II. Lots Subject to Overinspection Departure Inspections (status as of December 31, 1984)
