Grants Project

Homestake Mining Company of California

**Re: Response to “U. S. Nuclear Regulatory Commission Review of Homestake Mining Company of California’s Reply to “Response to the Homestake Mining Company of California Letter, Dated July 26, 2018: Proposed Adjustment in Groundwater Monitoring of the San Andres-Glorieta Aquifer Near the Grants Reclamation Project”, Dated January 23, 2020, Docket No. 040-08903, License No. SUA-1471**

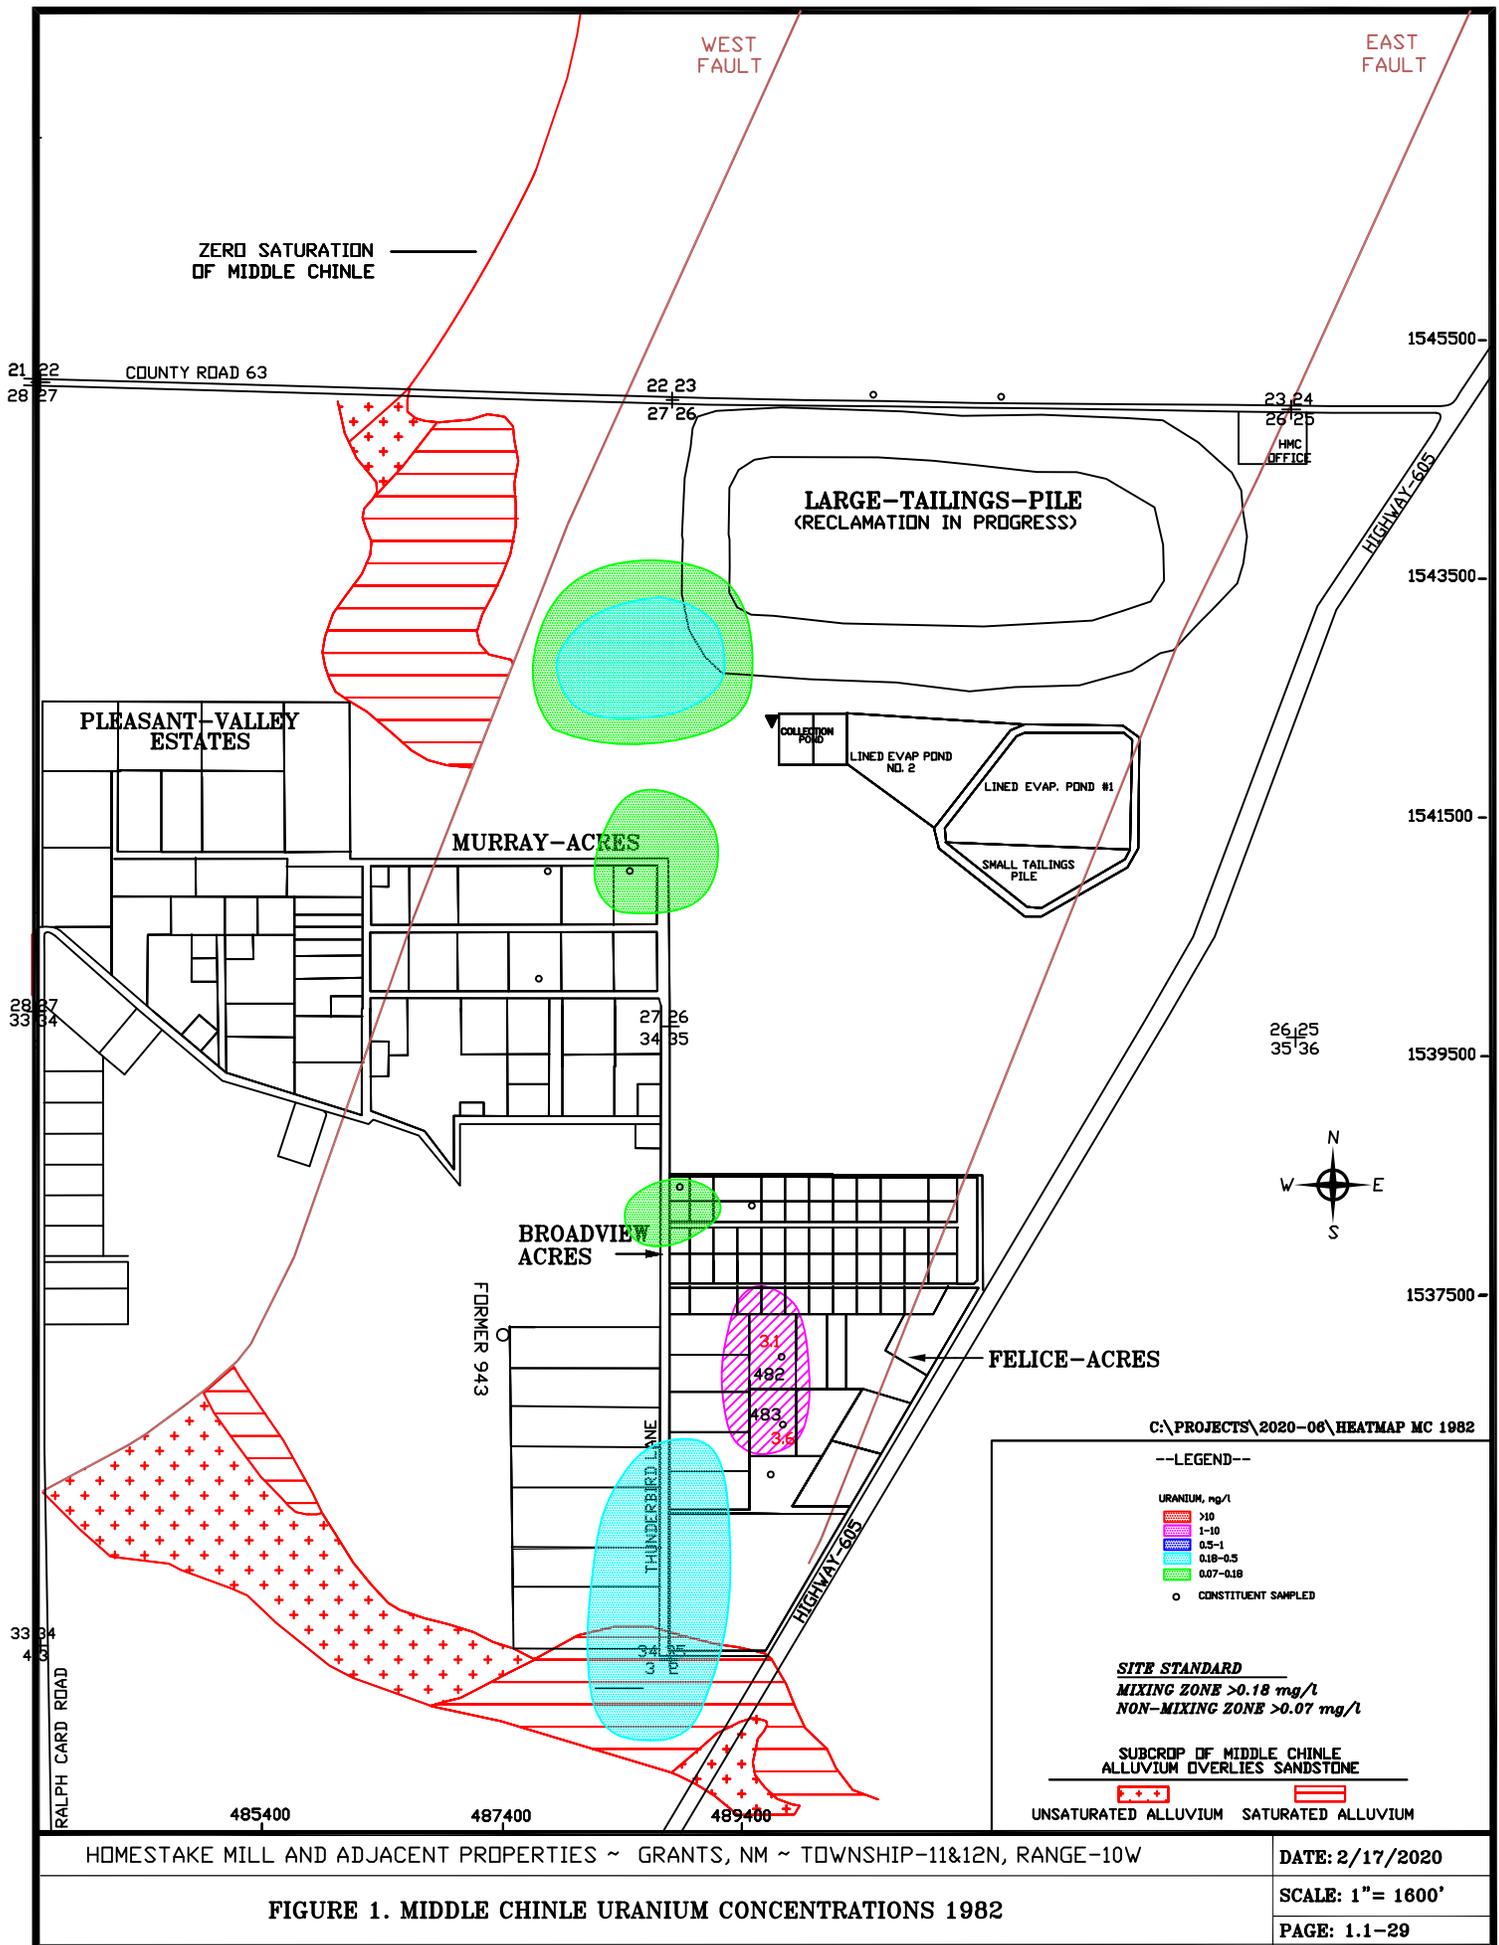
HOMESTAKE MILL AND ADJACENT PROPERTIES ~ GRANTS, NM ~ TOWNSHIP-11&12N, RANGE-10W

FIGURE 1. MIDDLE CHINLE URANIUM CONCENTRATIONS 1982

The higher uranium concentrations in the Middle Chinle aquifer in northern Felice Acres is a likely source for the higher uranium concentrations in the overlying aquifer at well 943. Higher uranium concentrations existed in the early 1980's in northern Felice Acres in Middle Chinle wells 482 and 483. Figure 1 shows the 1982 uranium pattern for the Middle Chinle aquifer with the addition of the wells 482 and 483 labels and the location of former well 943. The 1982 uranium concentrations of 3.1 and 3.6 mg/L for wells 482 and 483 respectively and a pattern showing that these concentrations are above one mg/L were added to this figure. If the leakage into well 943 was causing a continual drain of 50 gpm from the Middle Chinle aquifer, this could have caused these concentrations to migrate in the Middle Chinle to the west toward well 943. As previously stated, the higher heads in the overlying aquifer would have controlled the leakage rate and the pumping of well 943 would not have appreciably changed the leakage rate.

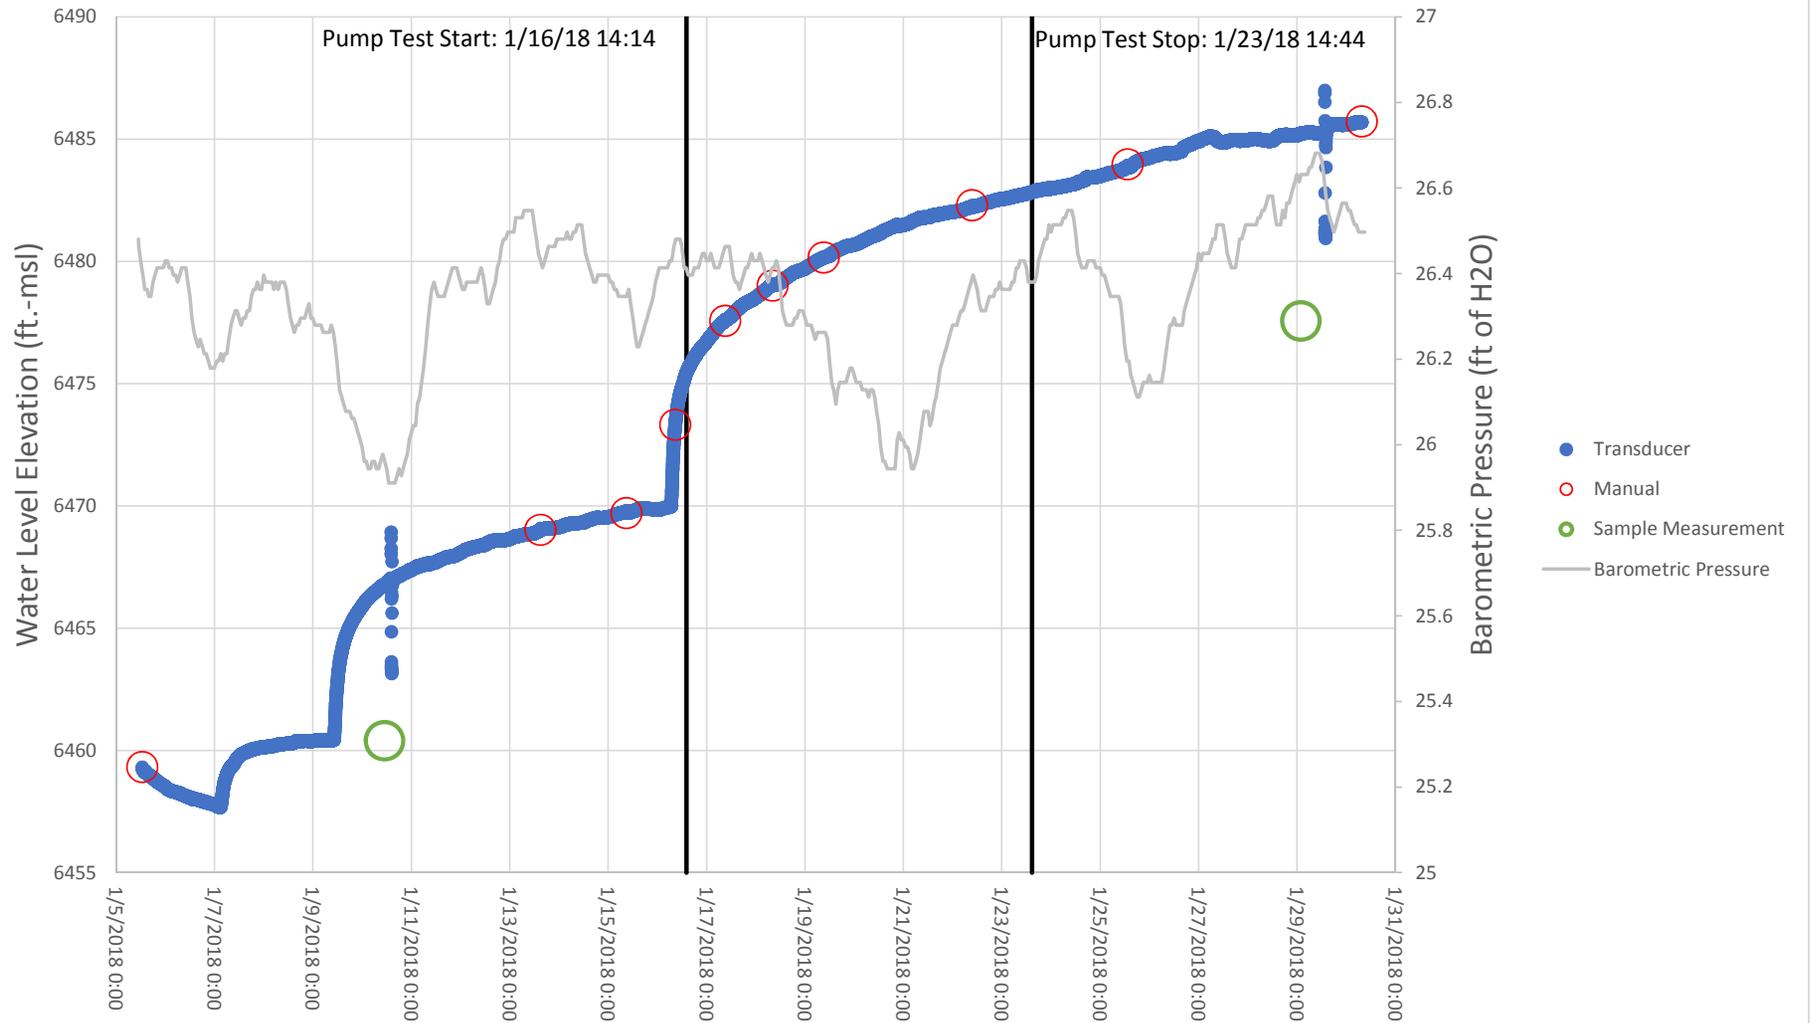
Figure 3. Water Level Elevation Versus Time for Observation Well CW76

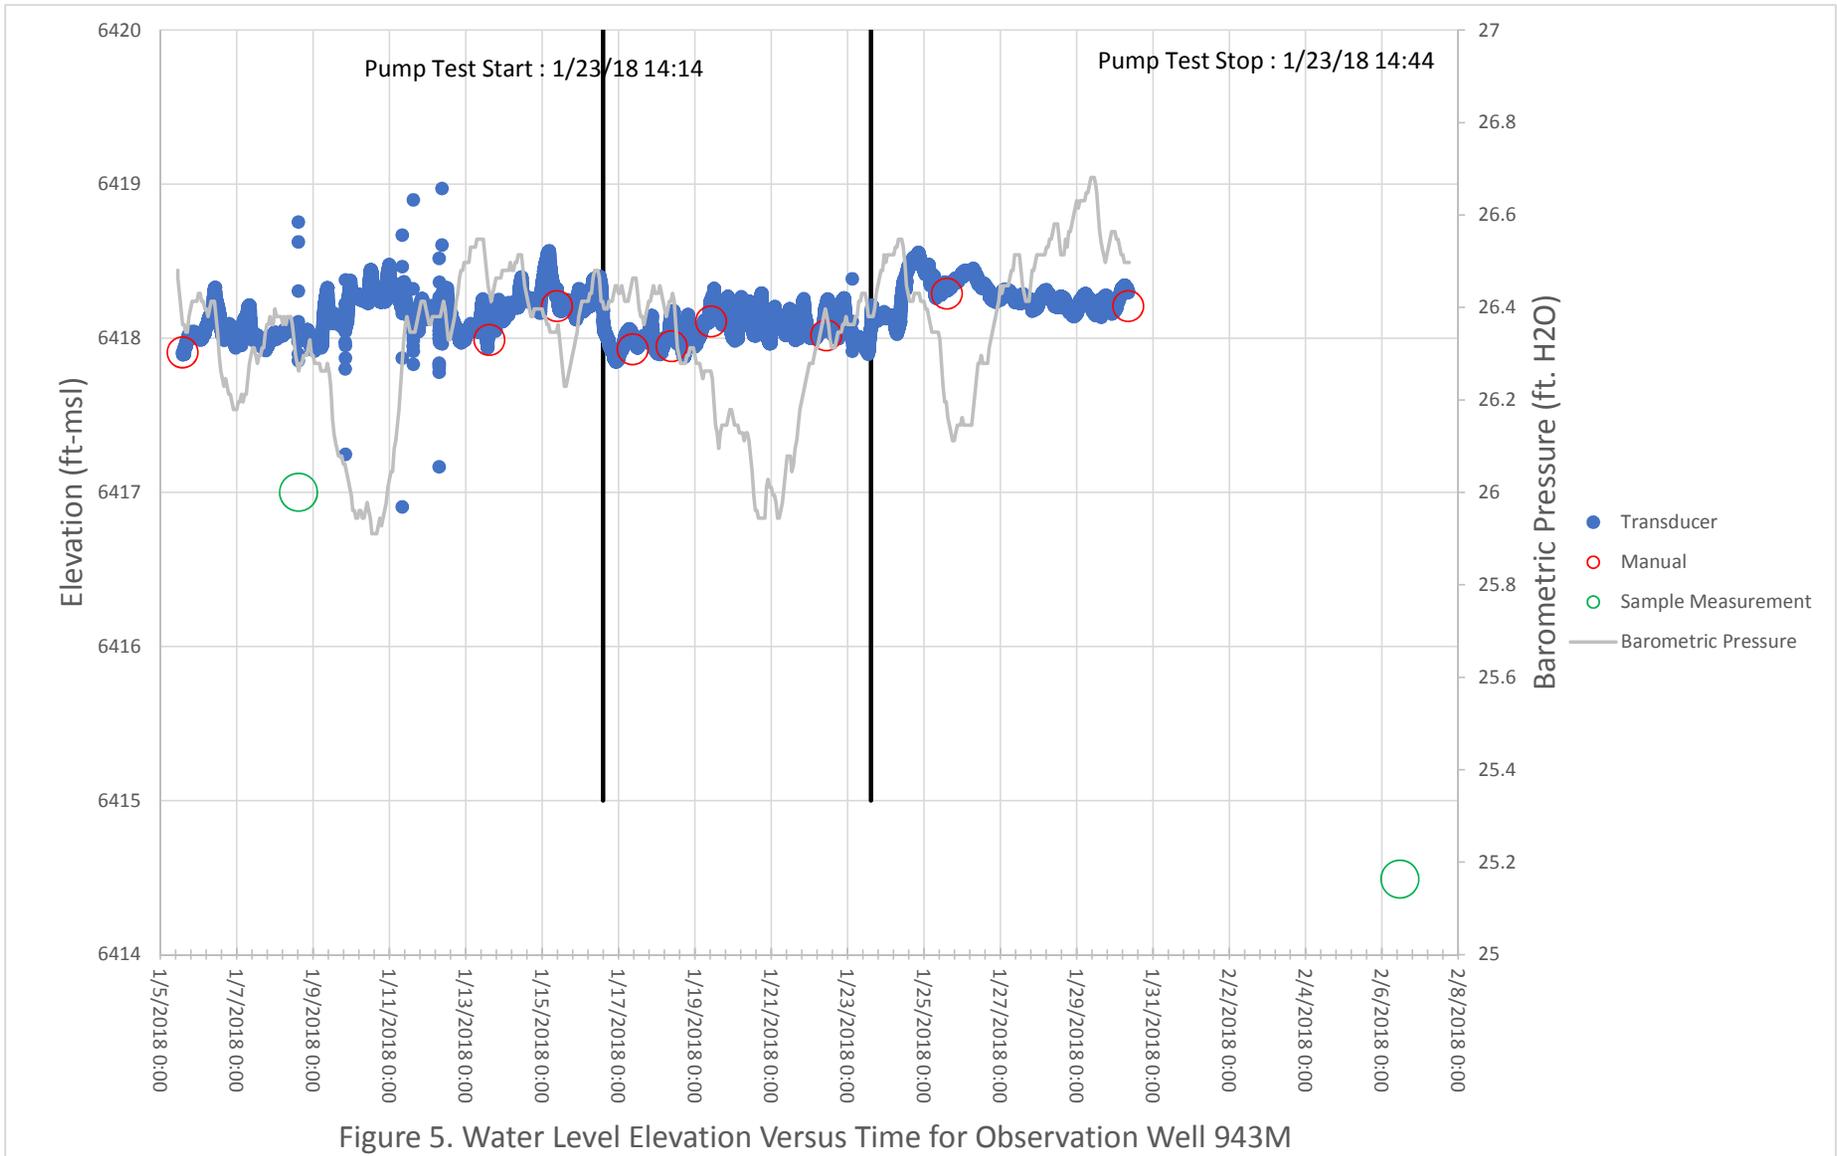
Figure 5. Water Level Elevation Versus Time for Observation Well 943M

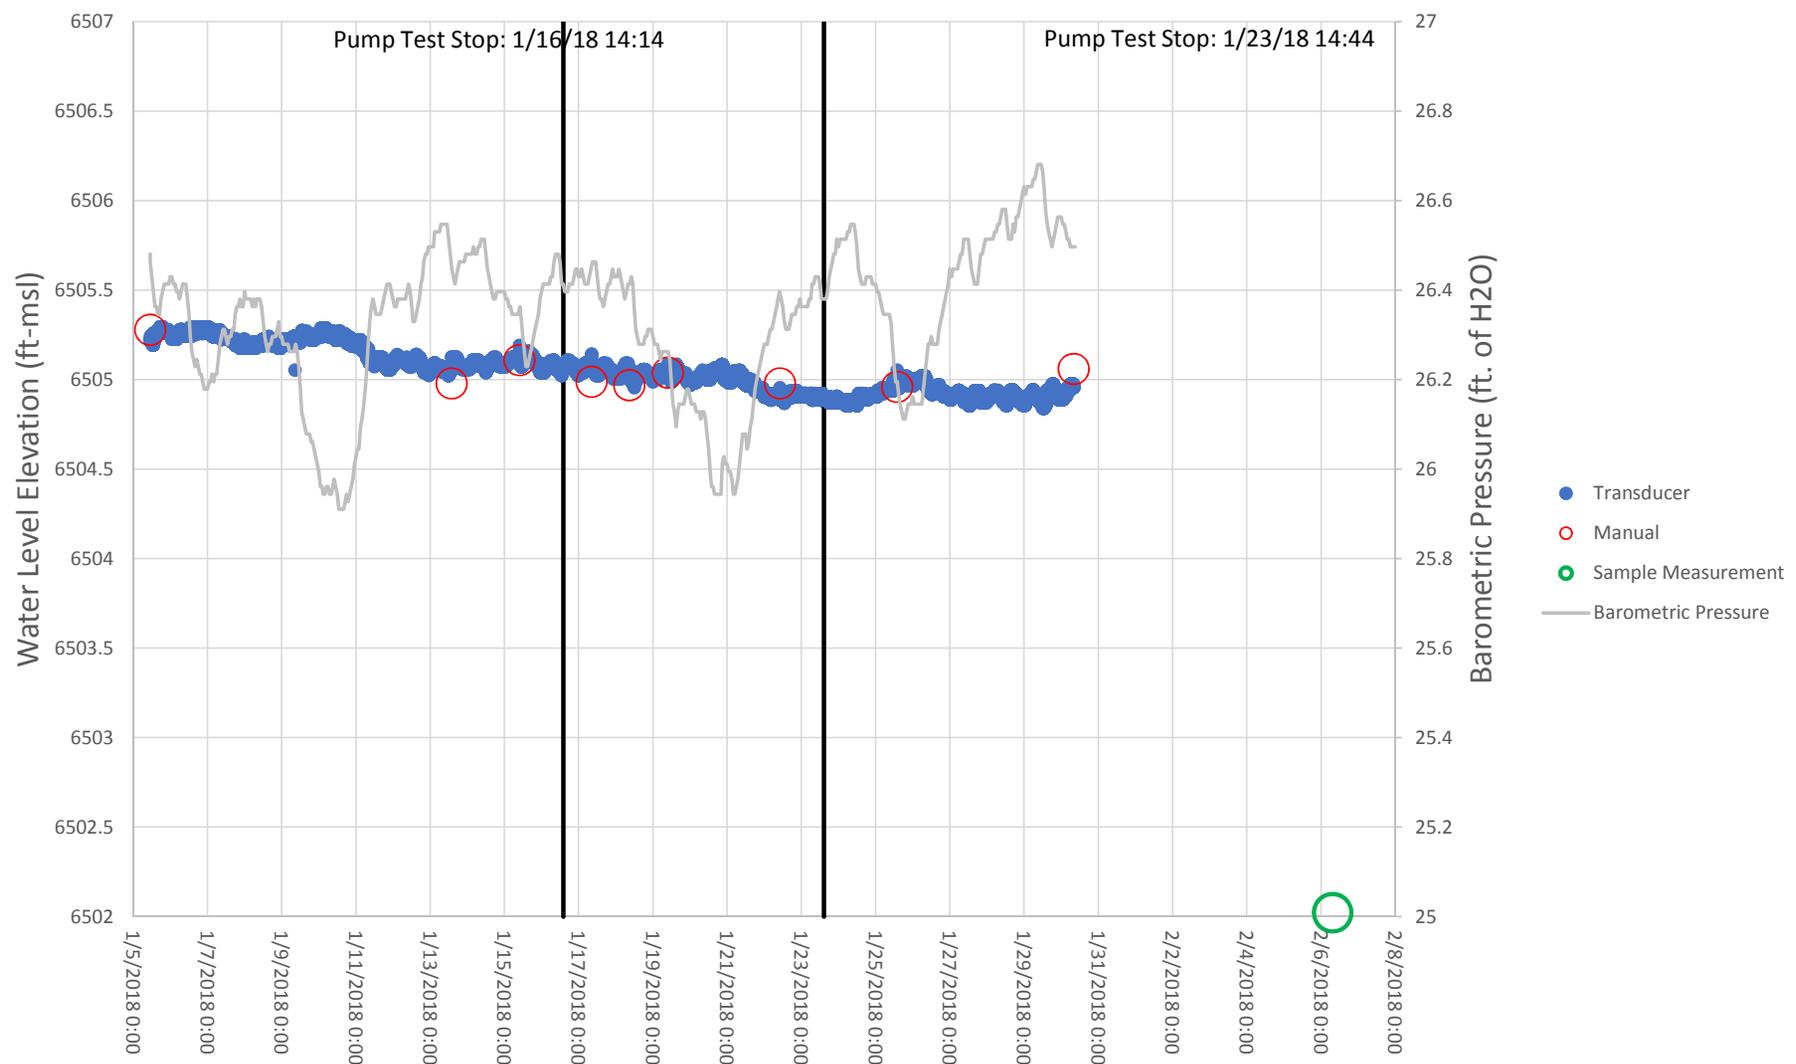
Figure 7. Water Level Elevation Versus Time for Alluvial Observation Well 556

and other manual water levels (red circles) taken before, during and after the sampling on 1/29/2018. For clarification, the transducer data (blue dots) during sampling of the observation wells show a vertical stringing of the water level data on the graphs indicating the rapid drawdown during pumping for sample followed by a quick recovery to near the static water level. The water level measured prior to sampling on 2/6/2018 also indicates a dramatic water level drop from the final measurements taken during the pump test or approximately five feet of apparent drawdown occurring more than 11 days after pumping of well 943 ended. The static water levels measured during sampling events for Middle Chinle well CW76 (Figure 3), Lower Chinle well V1 (Figure 4) and San Andres well 943M (Figure 5) are also significantly lower than the corresponding transducer and pump test manual water level measurements. It should be noted that the water level monitoring during the pump test was performed by professional contractor staff and senior HMC personnel while the observation well water sampling was performed by HMC's technical staff. The consistency of the transducer data (blue dots) and the manual water levels (red circles) collected during the test reflects the careful and consistent use of the same water level measurement equipment throughout the test. In contrast, water level measurement equipment used during sampling (green circles) may have differed during the multiple sampling events depending on the assigned technical staff. Therefore, the significantly lower sampling water level measurements are very likely errors and are not a correct representation of water levels in these wells. These erroneous water levels were likely caused by use of a malfunctioning or improperly repaired or corrected water level measurement instrument during specific sampling events or cycles.
