SUBJECT: RISK-BASED INSPECTION GUIDE

The U.S. Nuclear Regulation Commission is developing a risk-based inspection guide (RIG) to be published as a NUREG report under our Technical Assistance Program with National Laboratories. The RIG is intended to provide guidance for USNRC inspection activities.

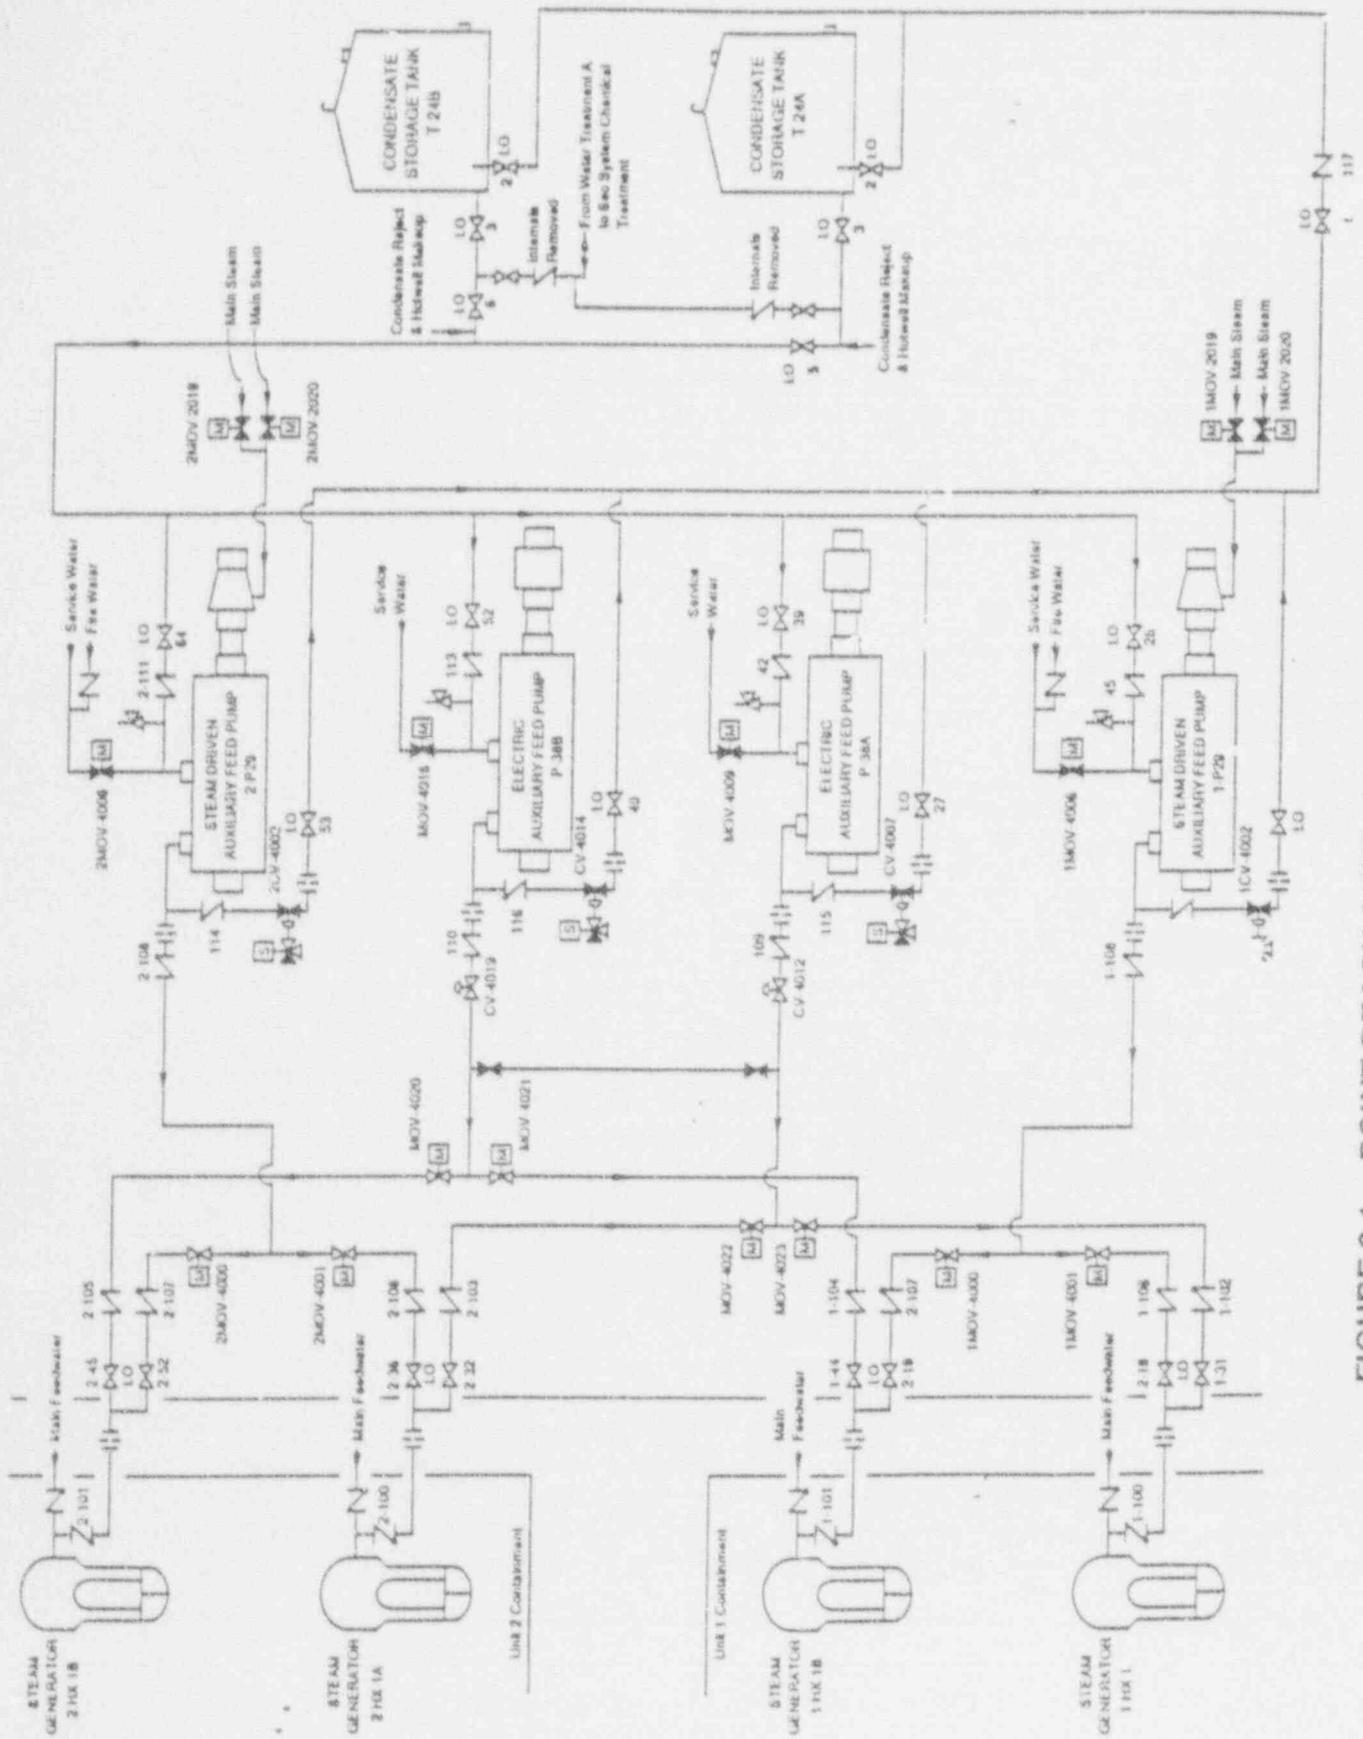
FIGURE 2.1 POINT BEACH AUXILIARY FEEDWATER SYSTEM

The AFW system provides feedwater to the steam generators (SG) to allow secondary-side heat removal from the primary system when main feedwater is unavailable. The system is capable of functioning for extended periods, which allows time to restore main feedwater flow or to proceed with an orderly cooldown of the plant to where the residual heat removal (RHR) system can remove decay heat. A simplified schematic diagram of the Point Beach AFW system is shown in figure 2.1.

The common discharge headers from each motor-driven auxiliary feedwater pump can be cross-connected downstream of the air-operated control valves. Normal system alignment, however, requires that both valves in the cross-connection be locked in the shut position. To protect the auxiliary feedwater pumps from excessive temperature rise during low flow conditions, each pump is equipped with an orificed recirculation line which provides the required minimum flow through the pumps by returning feedwater to the condenser storage tanks. An air-operated valve in the recirculation line interrupts flow when adequate discharge flow is sensed.
