# Licensee Contractor and Vendor Inspection Status Report

Quarterly Report  
April – June 1996

**U.S. Nuclear Regulatory Commission**

**Office of Nuclear Reactor Regulation**

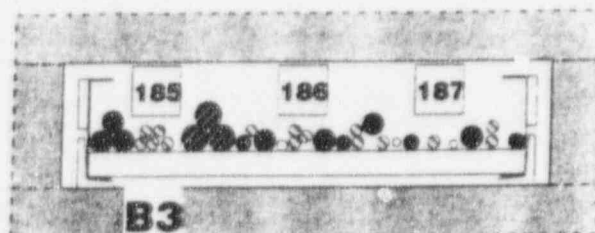
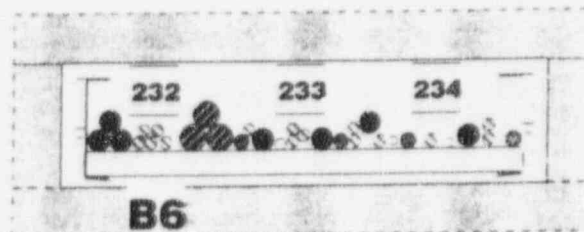
● 300 MCM   ● 4/0   ○ #2   ● 2/0 (8KV)  
 ○ 2/0   ○ 3/C#10   ○ #6

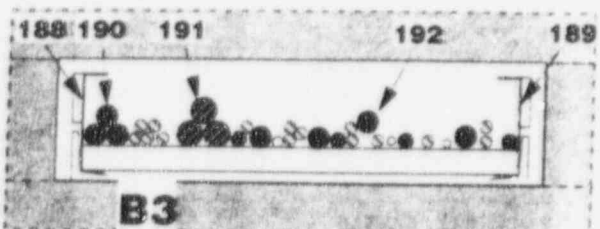
● 300 MCM   ● 4/0   ○ #2   ● 2/0 (8KV)  
 ○ 2/0   ○ 3/C#10   ○ #6
