(Vogtle Electric Generating Plant,
Units 1 and 2)

Docket Nos. 50-424
50-425
(OL)

AFFIDAVIT OF CARL H. BERLINGER IN SUPPORT
OF NRC STAFF RESPONSE TO APPLICANTS'
MOTION FOR SUMMARY DISPOSITION OF CONTENTION 14

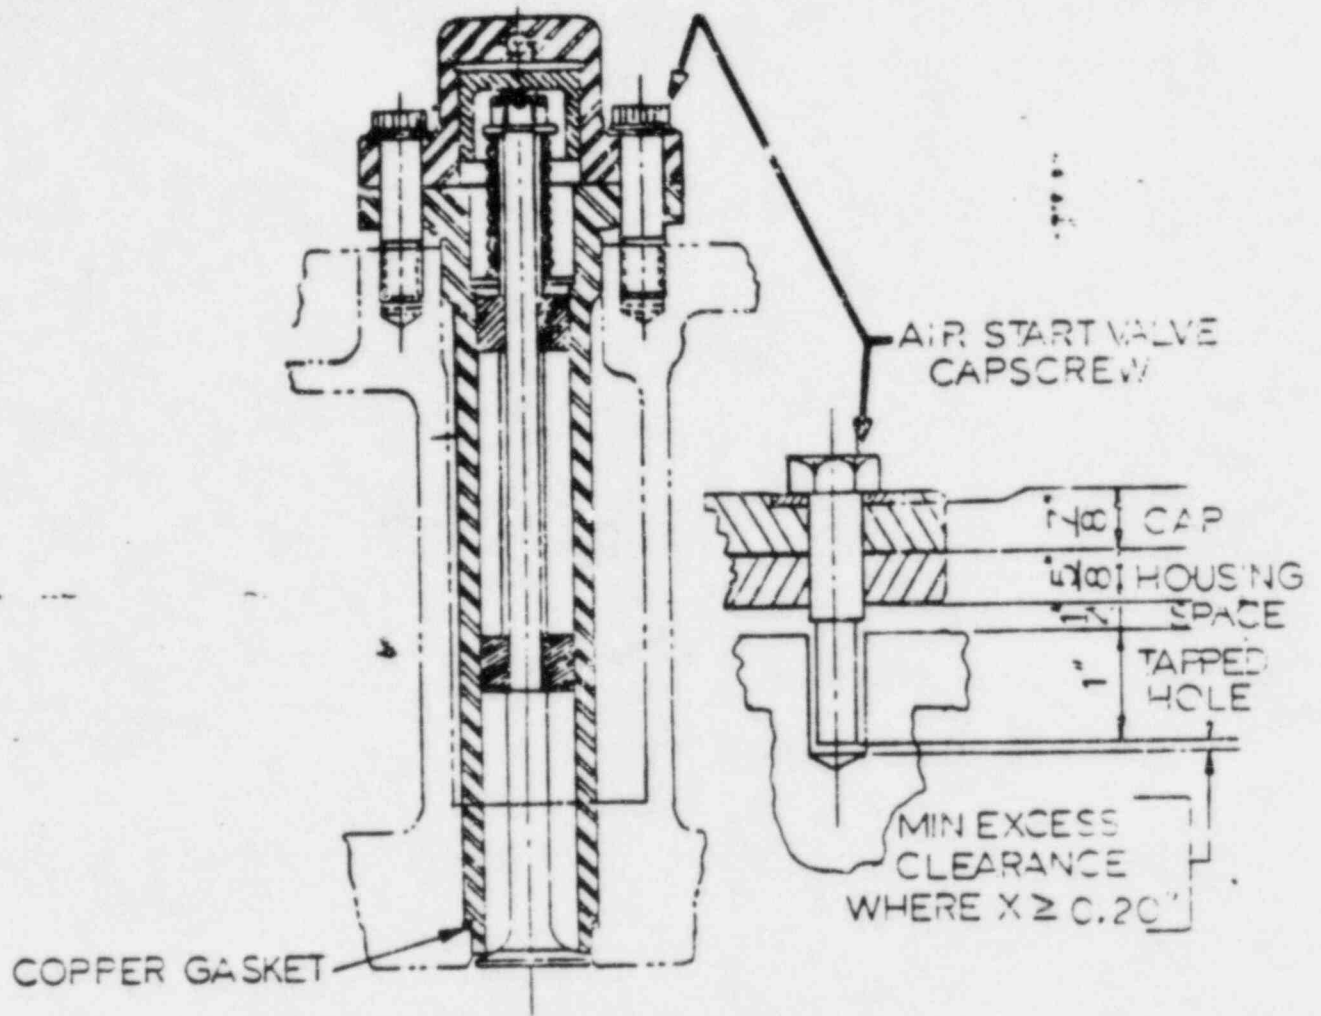
The shortened air start valve capscrews are fabricated from SAE grade 5 (min.) material, 2.75 inches long, with 3/4-inch 10N-3A type threads. Figure 1 illustrates the dimensions and installation of the capscrews.

FIGURE 1. Air Start Valve Assembly

- A dimensional check indicates that a 0.2-inch minimum clearance exists within the cylinder head tapped hole. As a result, the air start valve capscrew will not "bottom out" upon torquing.
- Fatigue failure in capscrews is avoided if two criteria are met: 1) the total applied mean stress (S_t) is below the yield point (S_y) for the component material and 2) the endurance strength exceeds the cyclic stress by an acceptable margin. The total applied mean stress
