NUCLEAR REGULATORY COMMISSION

SUBJECT:

MOLF CREEK (DN 50-482) ENFORCEMENT HISTORY FOR CALENDAR

YEARS 1983 and 1984

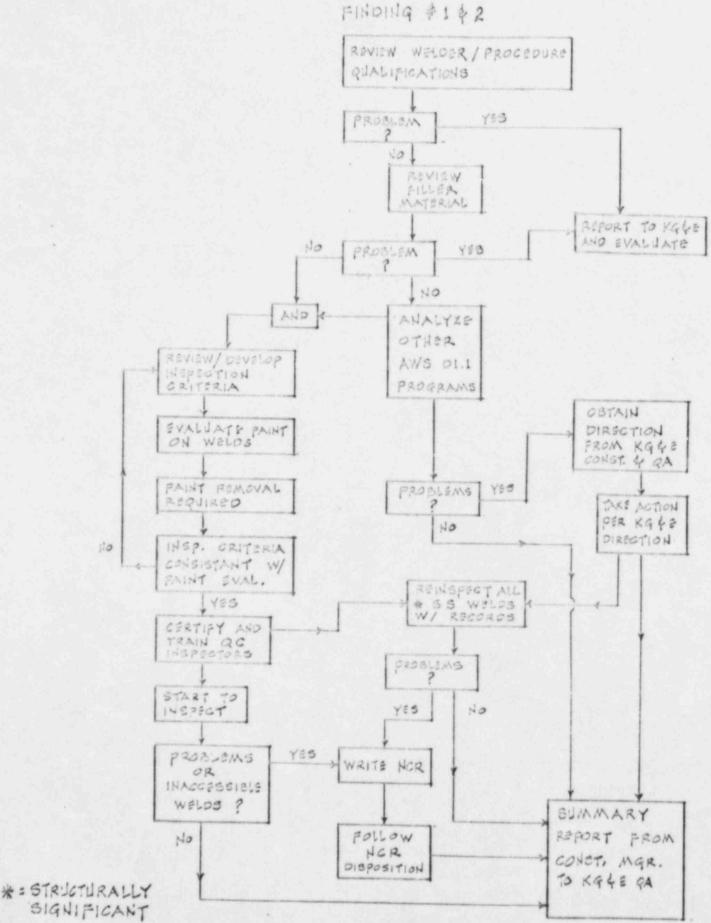
ACTION FLOW DIAGRAM

RECOMMENDED CORRECTIVE

F. Recommended Corrective Action Flow Diagrams
