Docket No.: 50-412

SUBJECT: REQUEST FOR ADDITIONAL INFORMATION (RAI) REGARDING PREVENTIVE MAINTENANCE PROGRAM FOR REACTOR TRIP BREAKERS/MAINTENANCE AND TRENDING - BEAVER VALLEY, UNIT ?

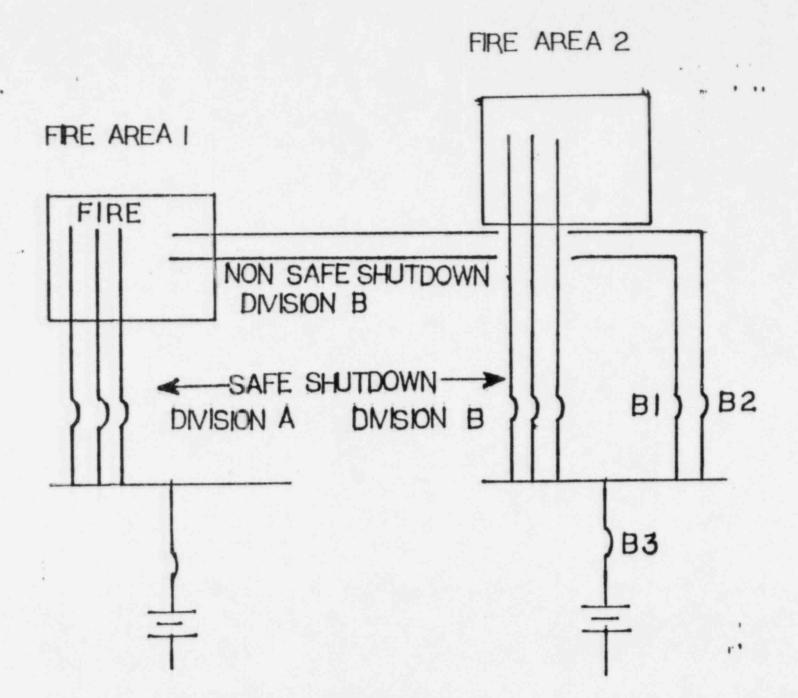
- 2. We have a concern regarding the potential for multi-high impedance faults in AC power circuits which could result in the loss of power to safe shutdown equipment. Figure 1 contains a sketch of circuit designs which could result in the loss of needed power to safe shutdown equipment. As can be seen in Figure 1, redundant divisions of safe shutdown cables are properly separated in accordance with Appendix R criteria. However, a fire in fire area A would result in loss of Division A safe shutdown equipment and cause damage to nonsafe shutdown cables associated with the Division A bus. Further, the individual fault current resulting from the fire damage in the nonsafe shutdown cables may not be enough to trip the individual breakers

$(B_1 \text{ and } B_2)$ , but the sum of the faults may be sufficient to trip the main breaker,  $B_3$ ). If this were to occur, the Division B bus and the corresponding redundant Division B safe shutdown would be lost. You must show that multi-high impedance faults in AC power circuits resulting from a single fire cannot result in the loss of function of any safety-related system as outlined above.
