40. Surveillance and reporting programs in place at VEGP, including those established pursuant to 10 C.F.R. Part 21 and § 50.35(e), will continue to identify, monitor, and resolve any future problems with the TDI diesel generators. Id., ¶¶ 12-14.

Attorneys for Applicants

DATED: July 31, 1985

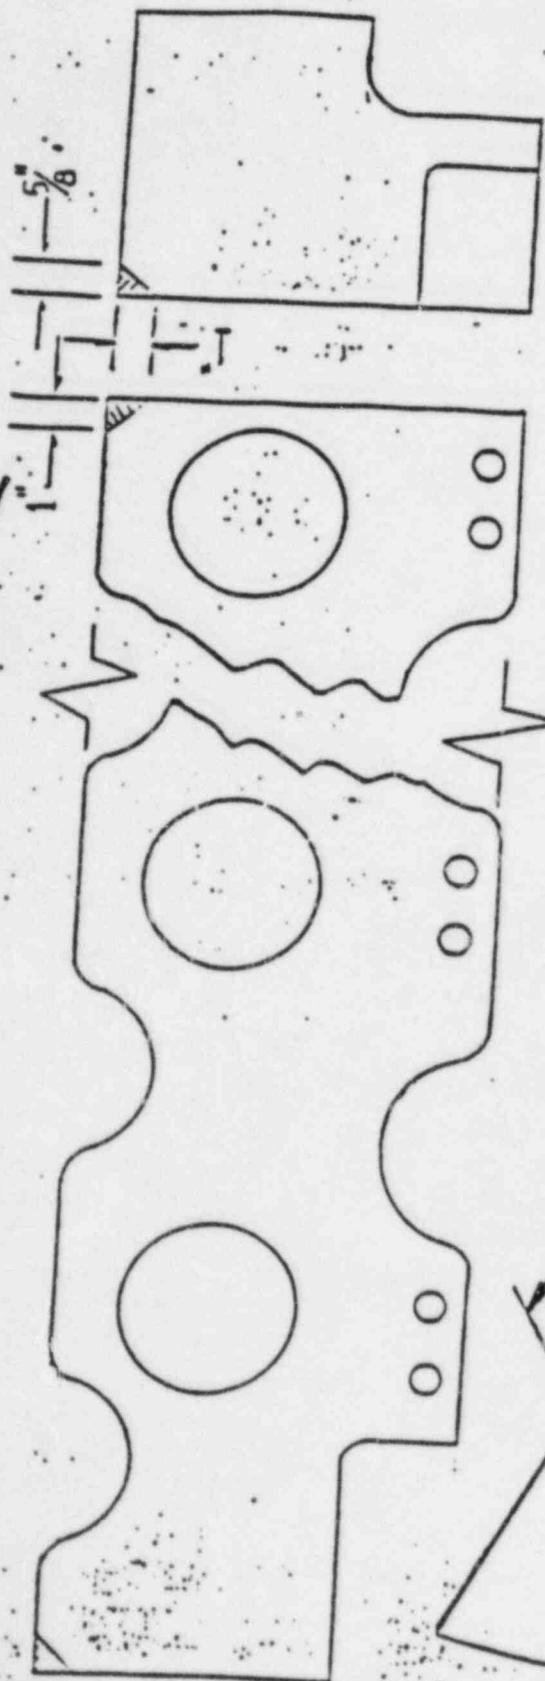
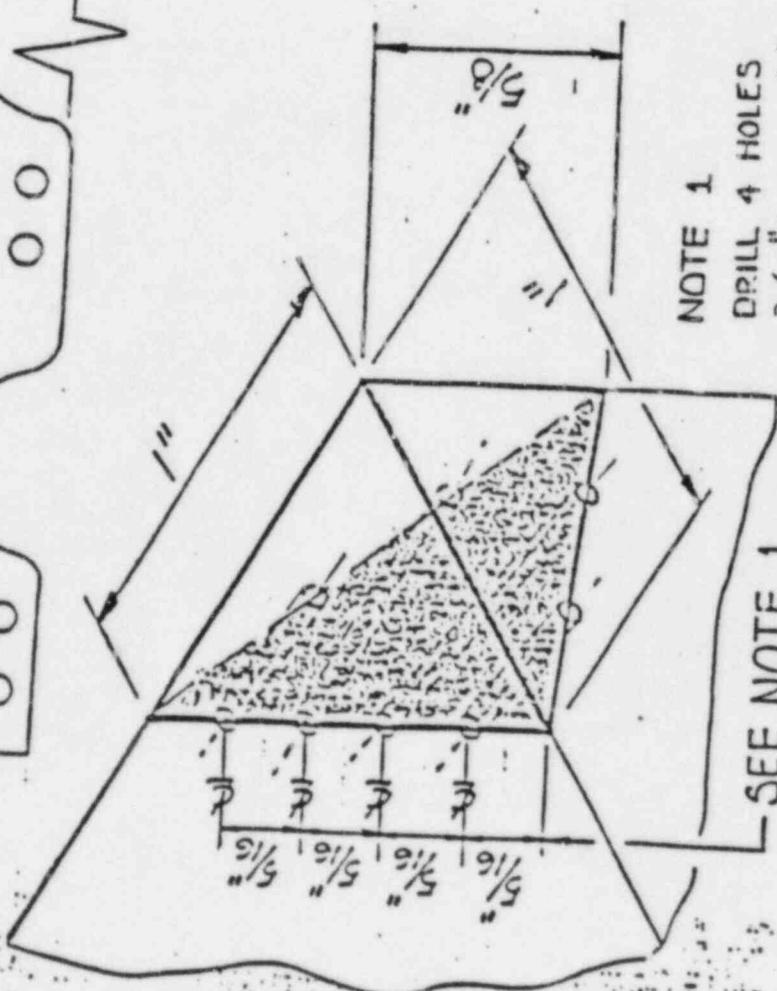
TYP: EITHER END

SEE ISOMETRIC DETAIL A-A

NOTE 1  
 DRILL 4 HOLES  
 3/32" DIA. 45°  
 CUT OUT PIECE

SEE NOTE 1
